**ANNUAL INSPECTION REPORT**  
**ASH LANDFILL AREA**  
**SPRINGERVILLE GENERATING STATION**  
**SPRINGERVILLE, ARIZONA**

Prepared for  
Tucson Electric Power Company

January 18, 2019

Project No. 1004.06

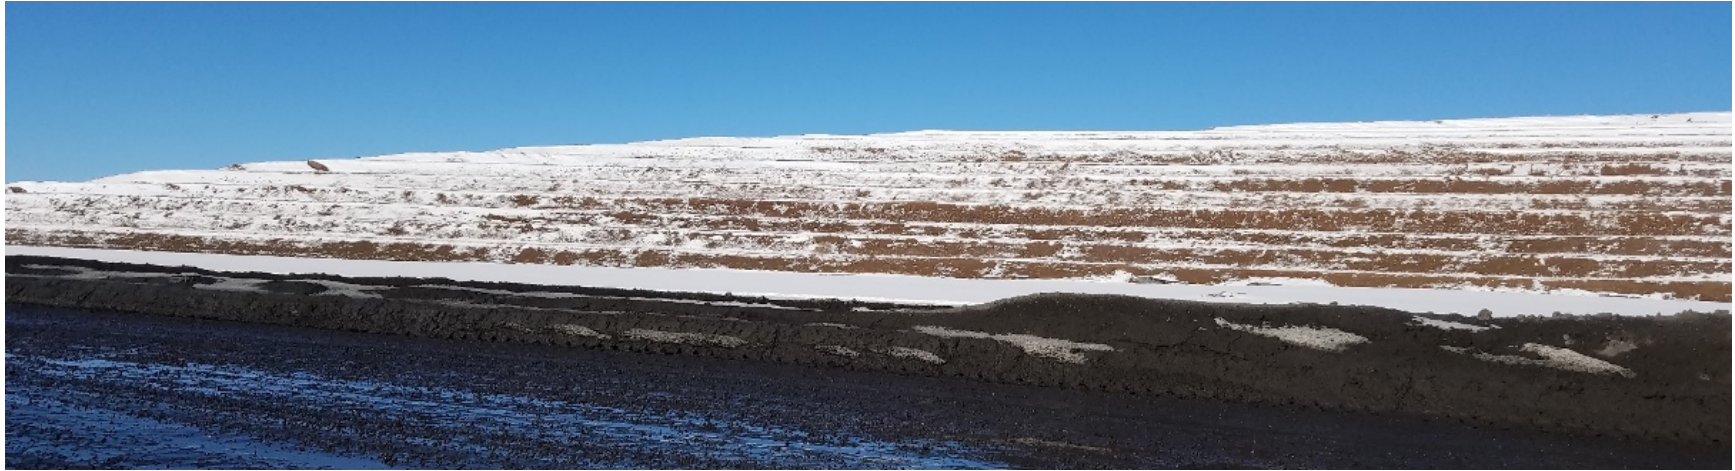
**PHOTOGRAPH 1.**

South slope of the Ash Landfill showing ash/waste benches. View looking from South to North.

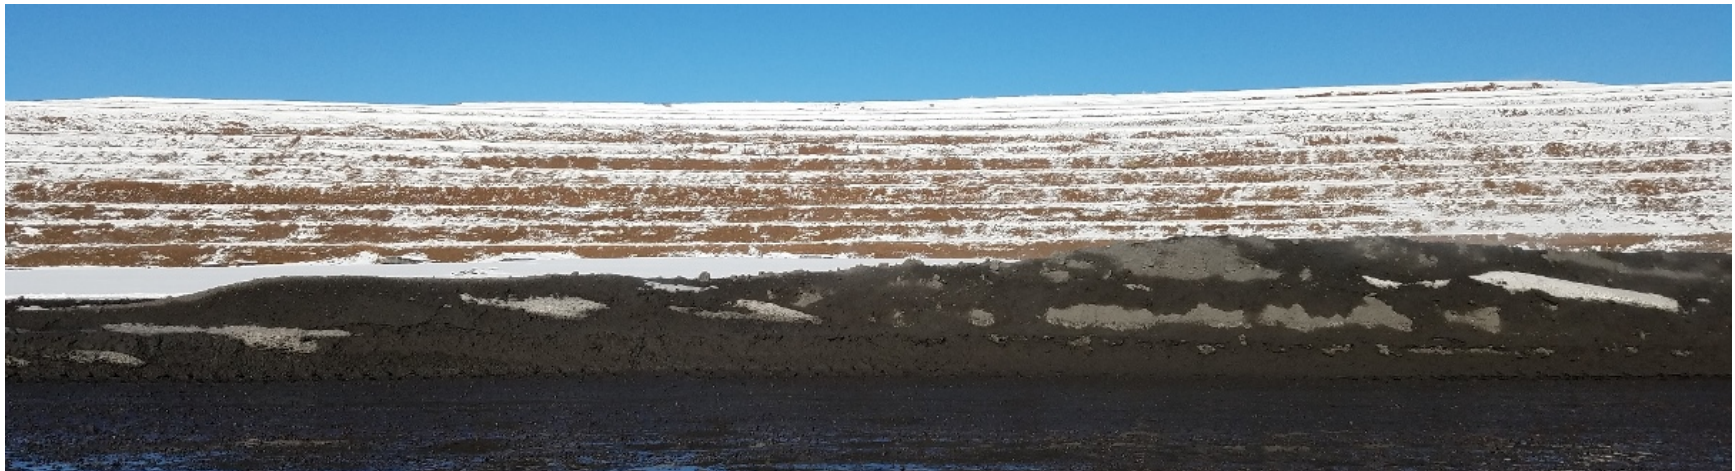
**PHOTOGRAPH 2.**

South slope of the Ash Landfill. View looking South to North.
