Subject: 2023 Annual Inspection by a Qualified Professional Engineer  
Ash Landfill  
Springerville Generating Station  
Springerville, Arizona

**REPORT ON**  
**2023 ANNUAL INSPECTION BY A QUALIFIED PROFESSIONAL**  
**ENGINEER**  
**ASH LANDFILL**  
**SPRINGVILLE GENERATING STATION**  
**SPRINGVILLE, ARIZONA**

File No. 0208568-001  
January 2024

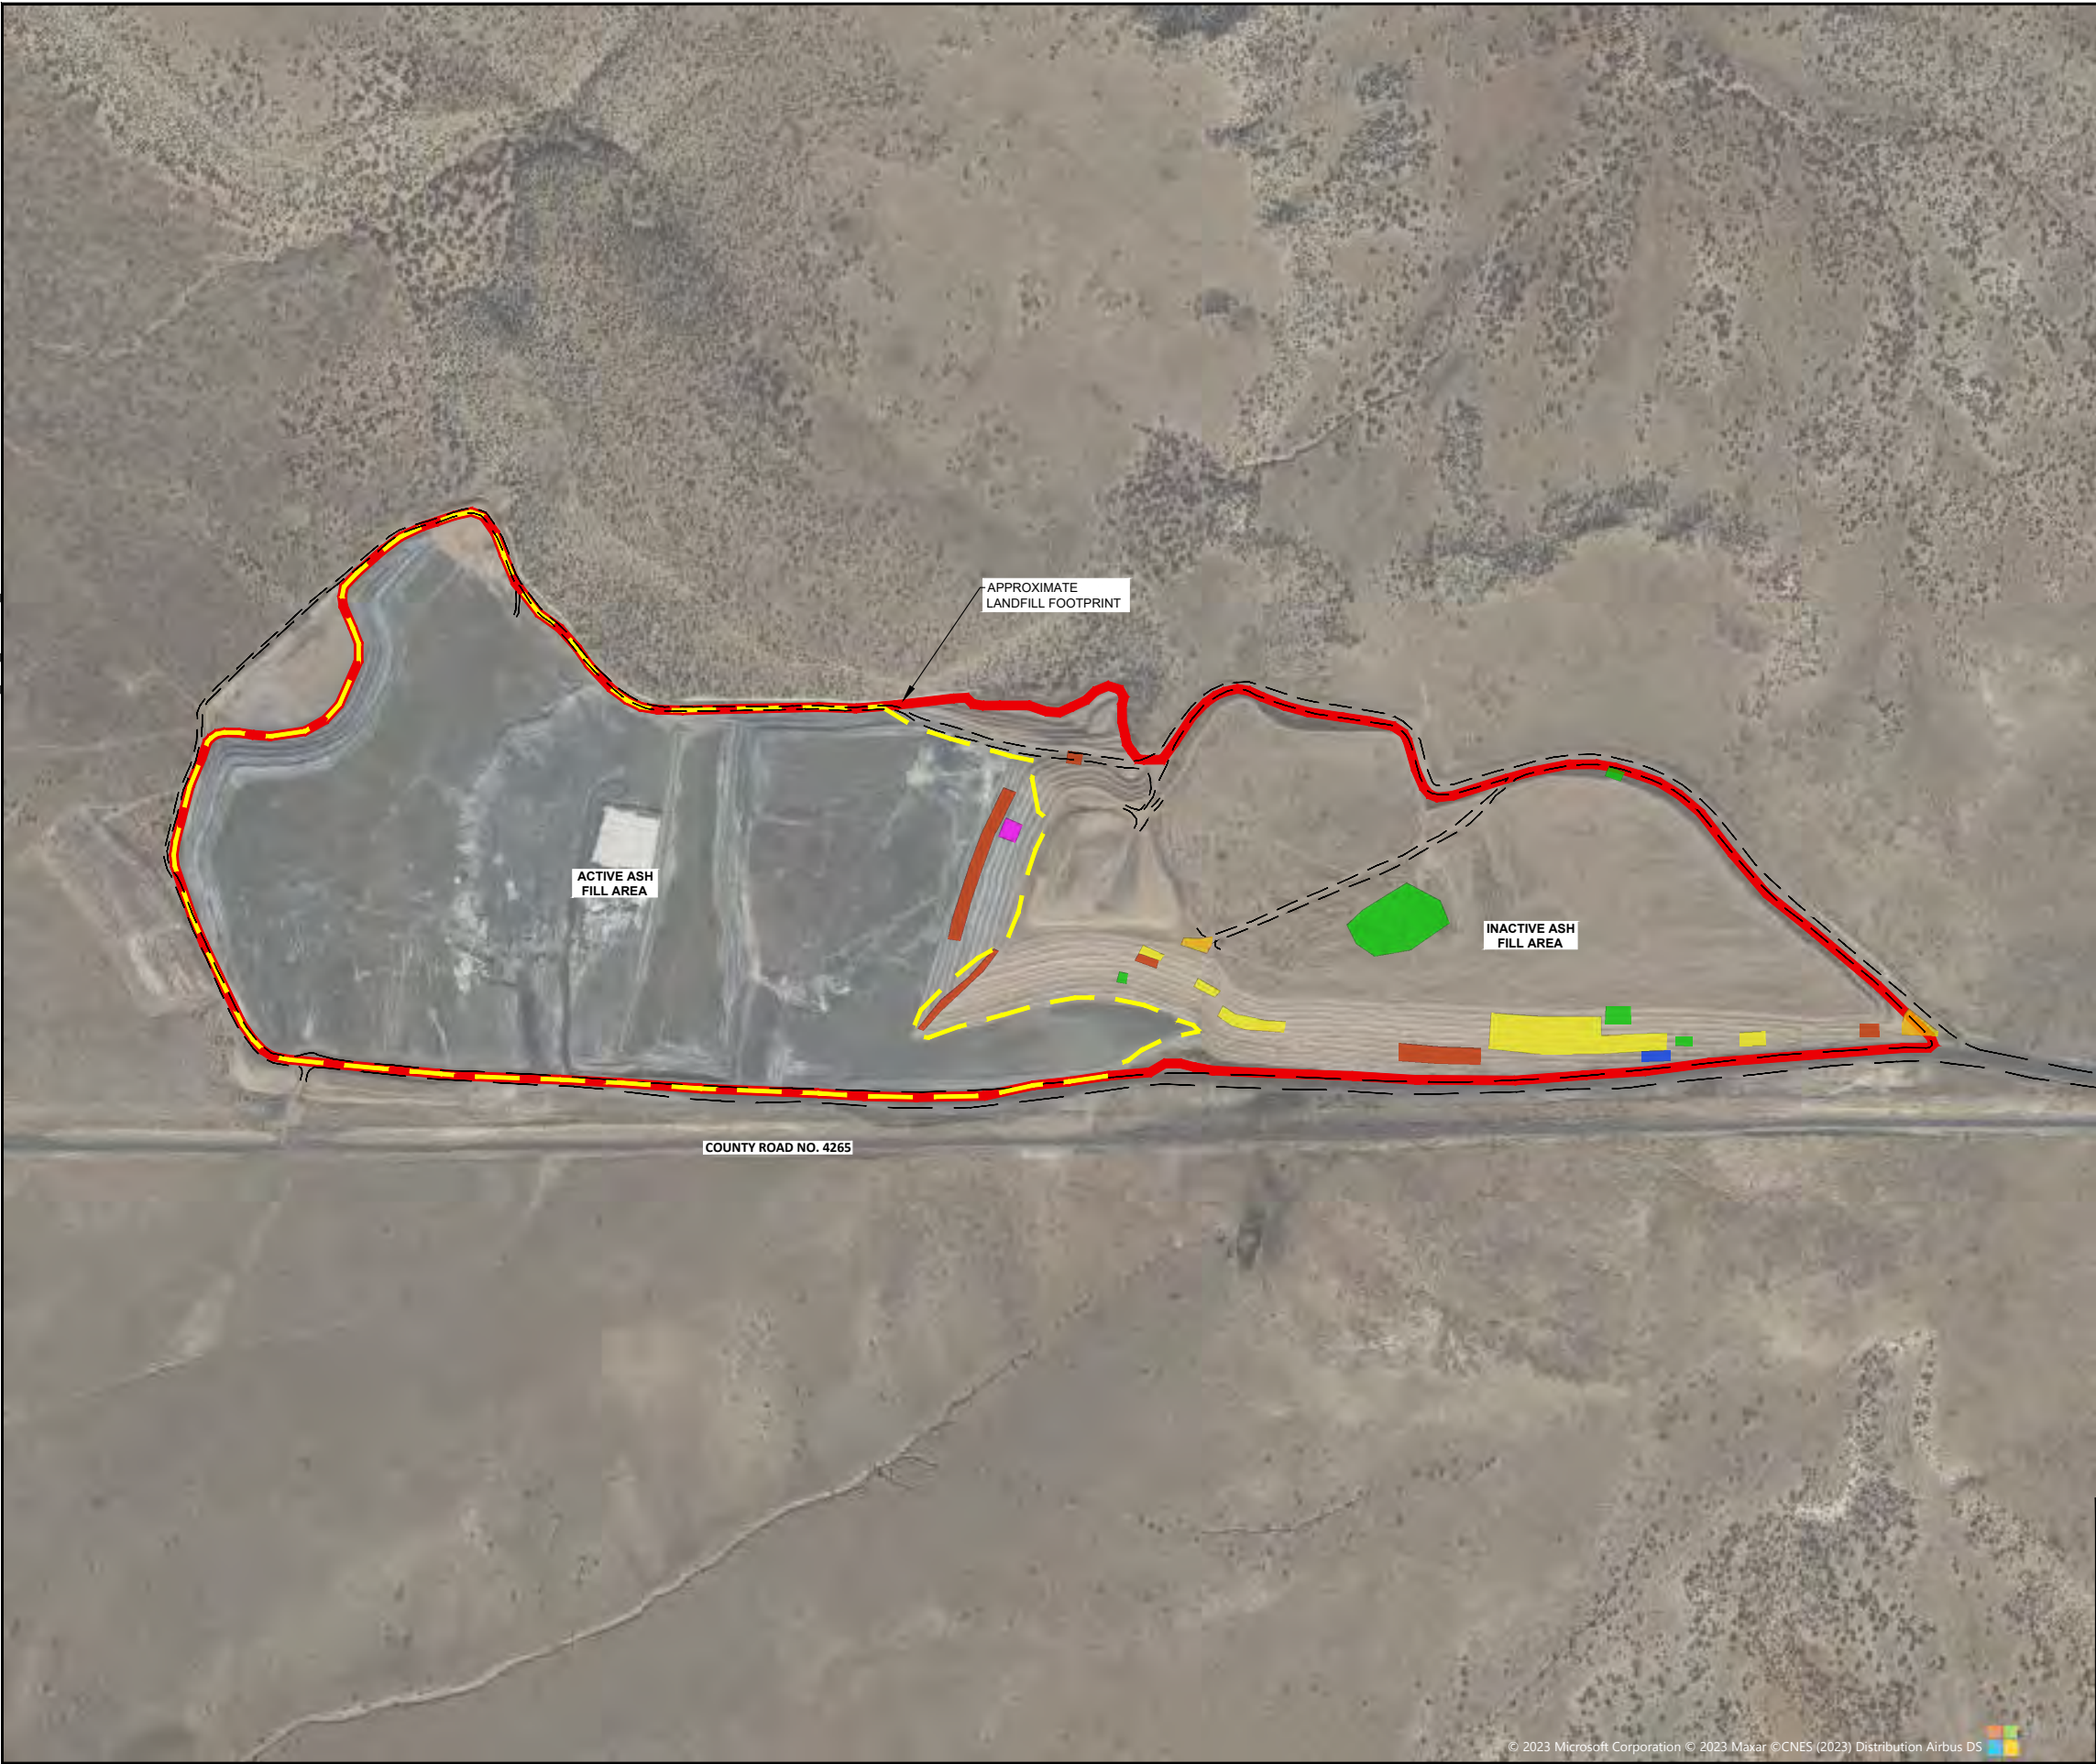
RECOMMENDED MAINTENANCE  
AREAS

Overall, the landfill was observed to be stable and broadly consistent with recognized and generally accepted good engineering standards. No sinkholes or evidence of settlement were observed. Only a few isolated areas of potential sloughing were noted along the exposed western slopes of the inactive portion. Areas of ponding and erosion were observed at locations along the south and southwestern benches of the landfill, as noted in **Section 2.1.1.2** and shown in **Figure 4**.

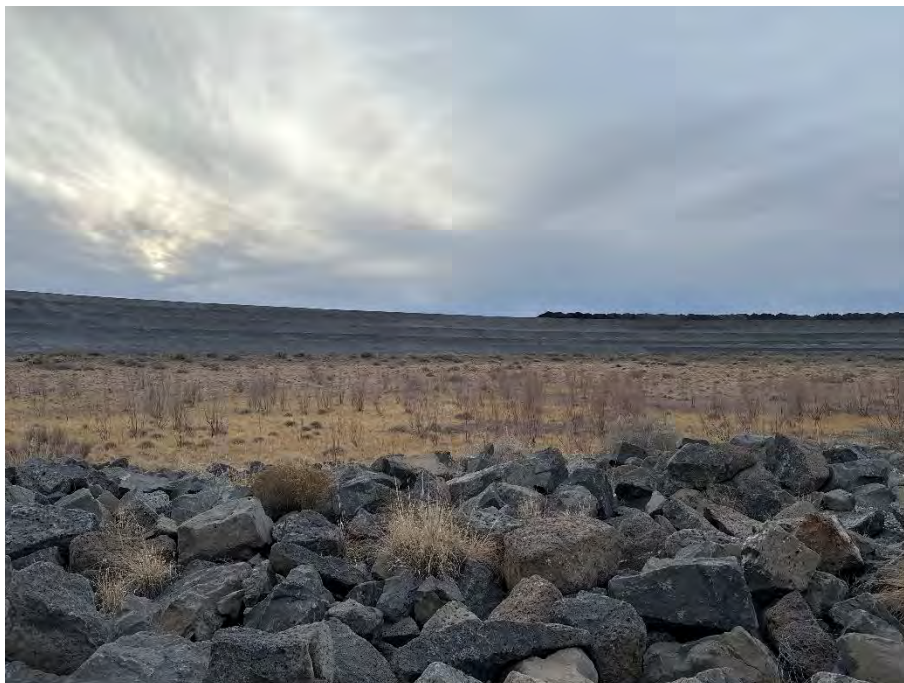
***Photo 1***  
***Retention Structure No. 3 and spillway***

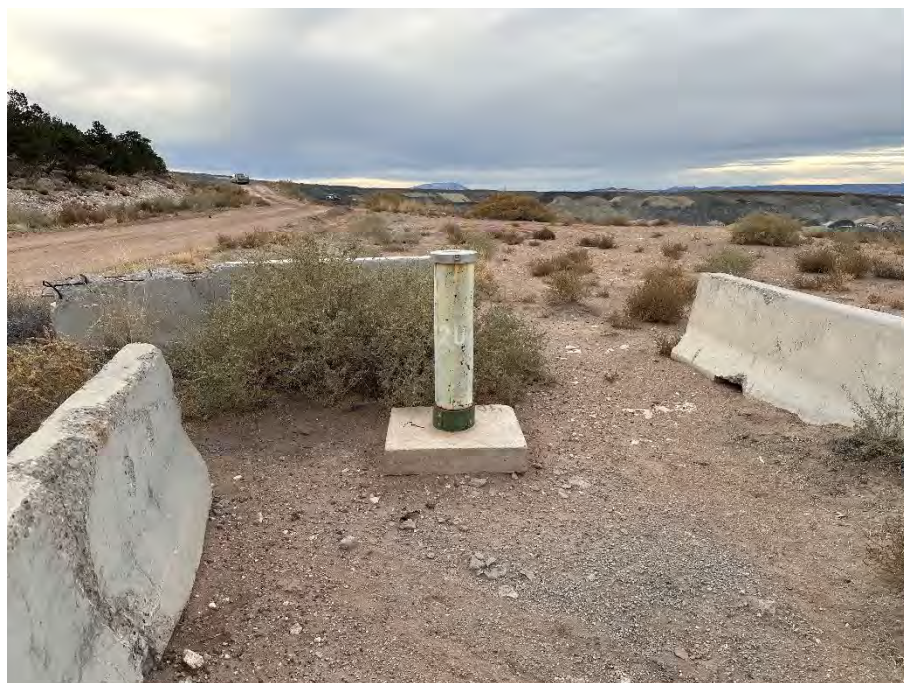
***Photo 2***  
***Condition of Groundwater Monitoring Well, CCR-2U***

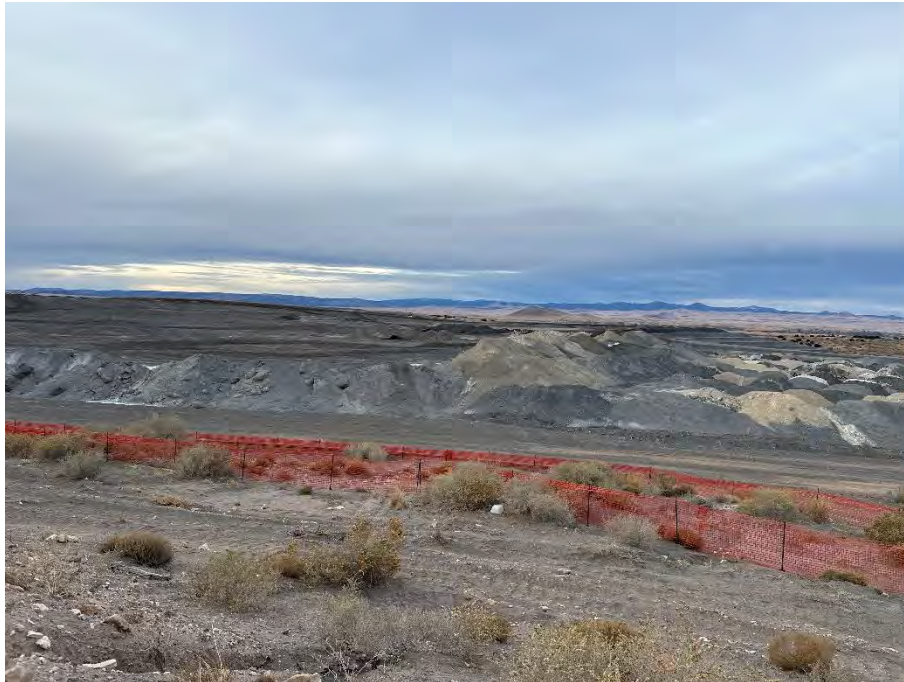
**Photo 3**  
***CCR material stockpiles deposited in Active Fill Area***

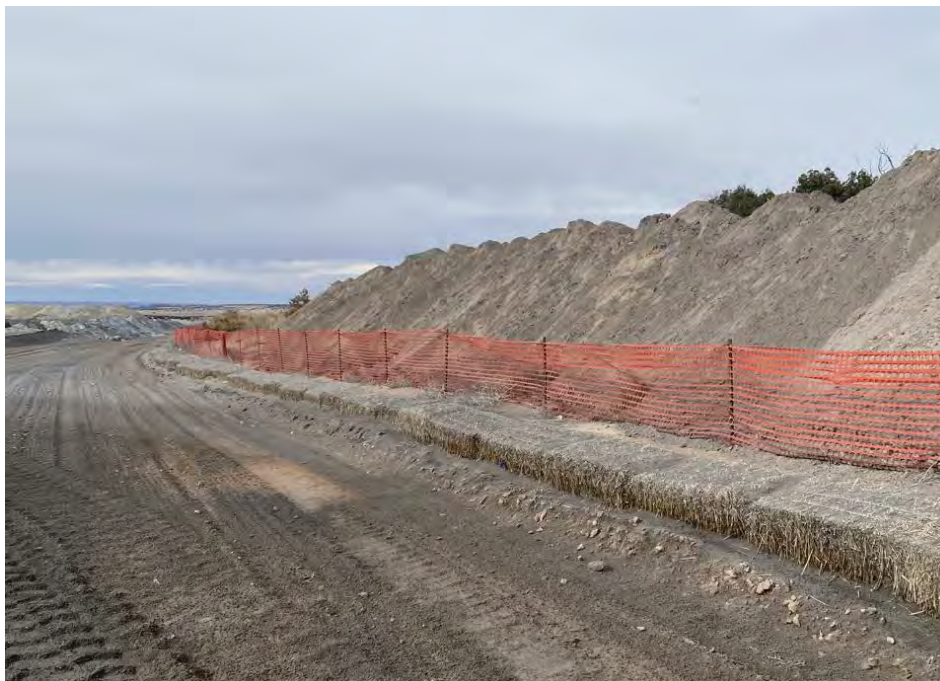
**Photo 4**  
***Erosion and sediment controls (e.g., orange construction fence and hay bales) along perimeter road***

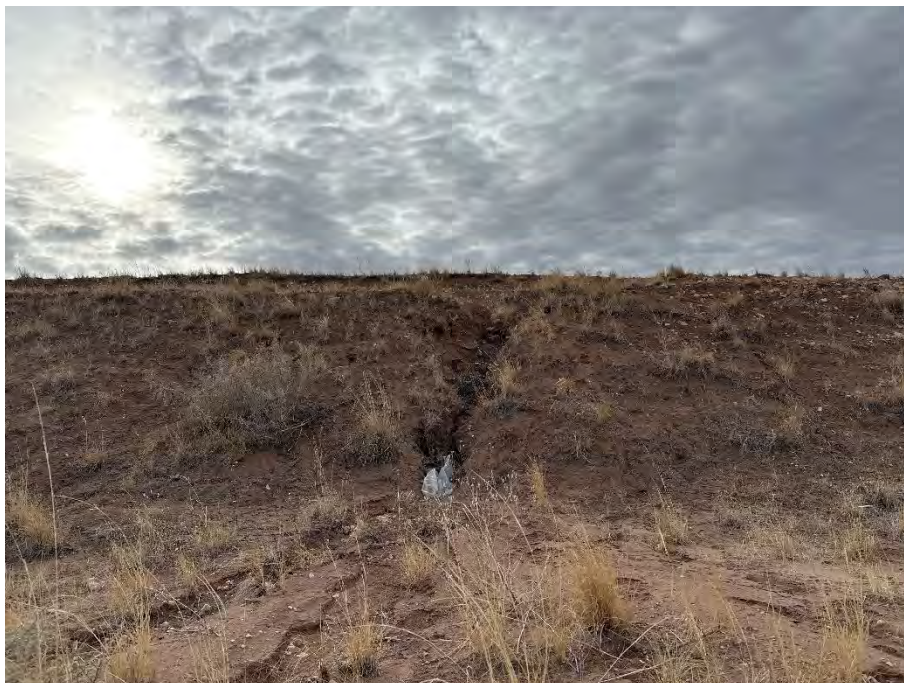
***Photo 9***  
***Erosion gully on north side of Inactive Fill Area***

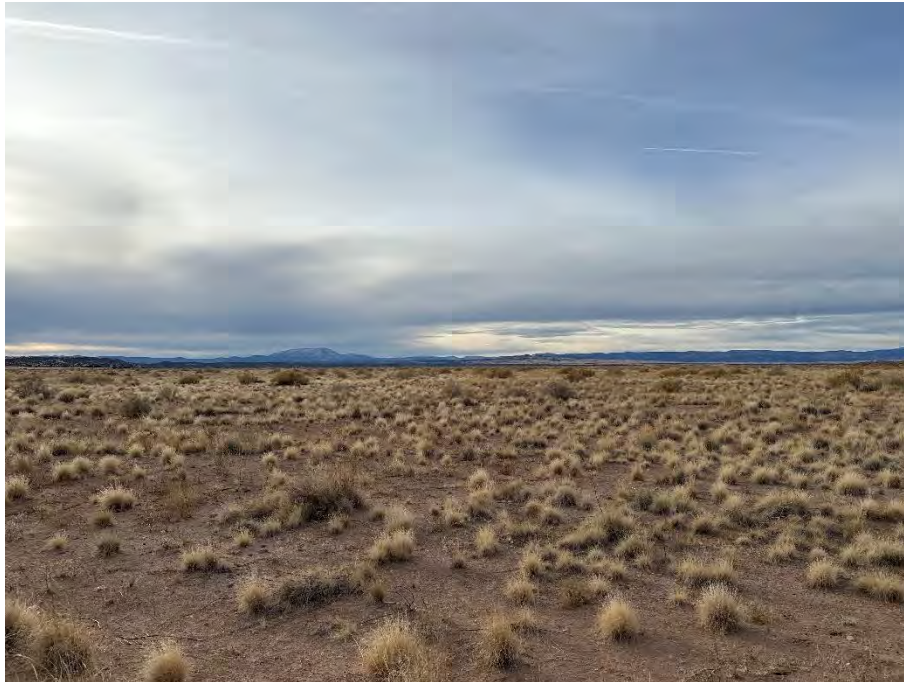
**Photo 15**  
***Typical conditions of vegetation on top deck of Inactive Fill Area***

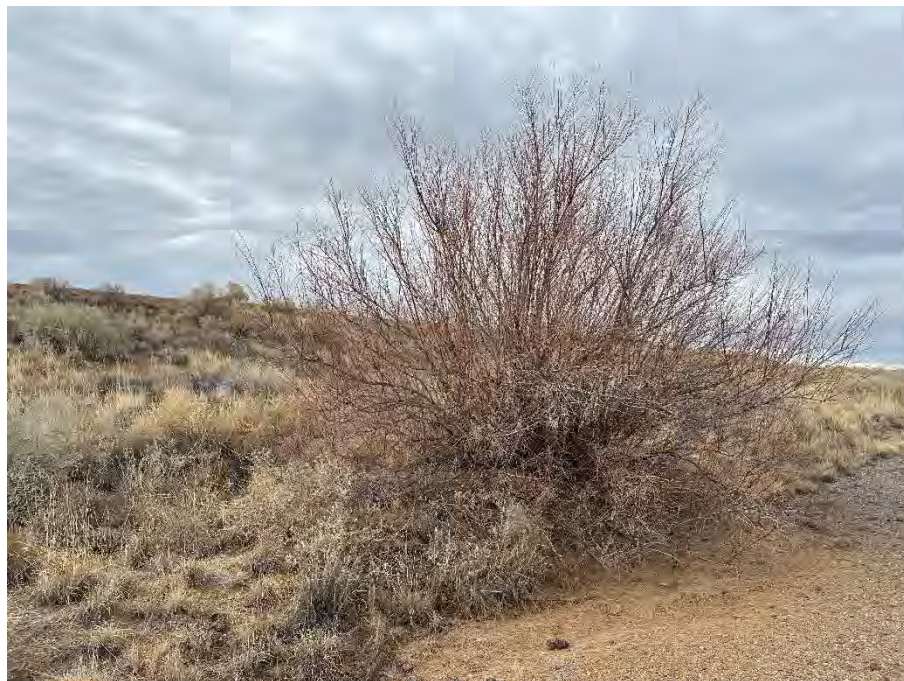
Woody vegetation, primarily salt cedar (noted as an invasive species by the U.S. Department of Agriculture), was present along the top deck, as well as the southern benches and slopes and was observed to range up to 6 feet in height.

**Photo 16**  
***Woody vegetation present near perimeter road on Inactive Fill Area***

- Monitor erosion of the southern and southwestern slopes and implement repairs of rills and gullies that exceed 12 inches in depth.
- Monitor the north and south drainage channels for excessive erosion and/or sedimentation, and repair and regrade to the original design.
- Monitor animal burrows and backfill, as needed, to prevent development of future erosion and/or stability issues.
- Monitor growth of tall, woody, and invasive vegetation and remove by hand-cutting and/or use of light equipment.

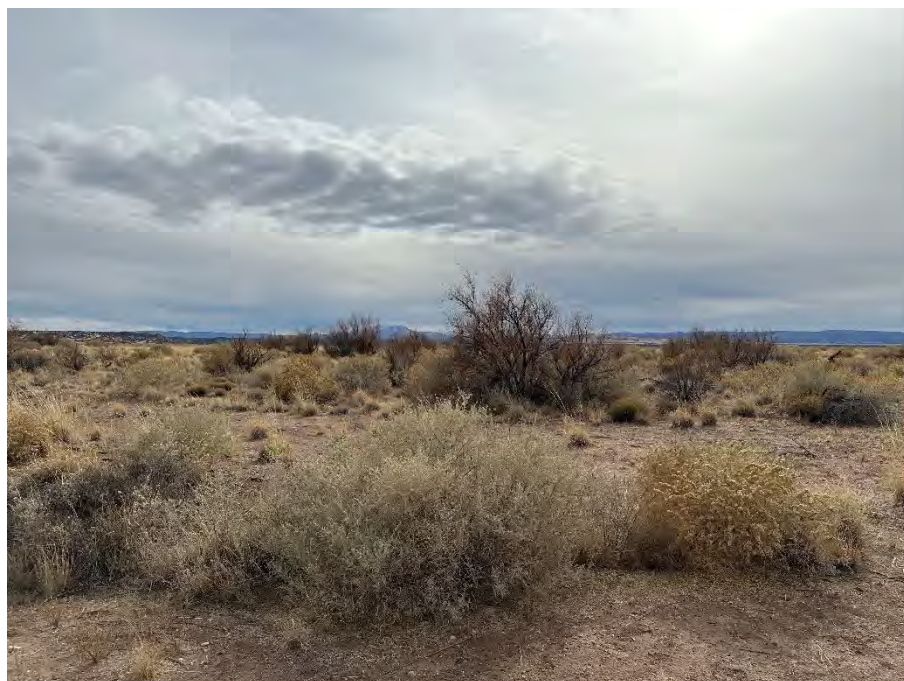
**Photo 18**  
***Tall and woody vegetation present on top deck of landfill***

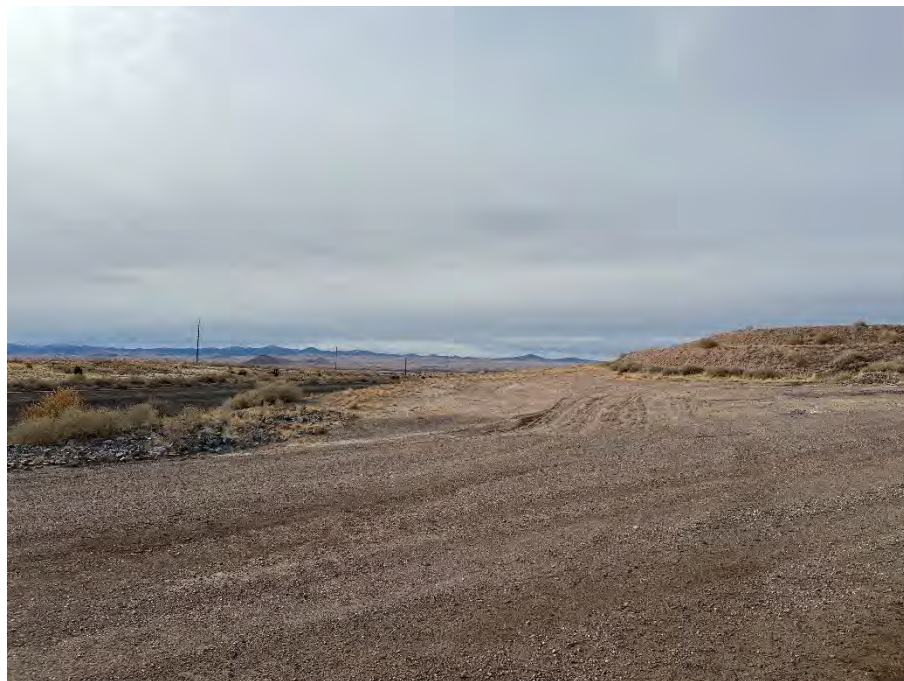
**Photo 5**

***Photo 20***  
***Low area in existing grades near vehicle turnaround***

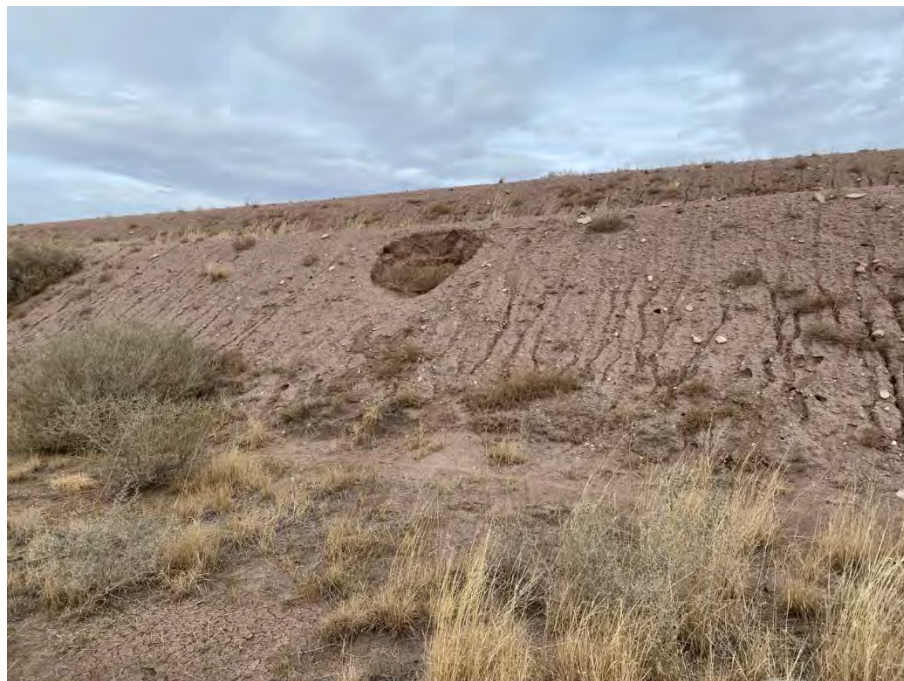
**Photo 22**

Animal burrows and small holes were observed along the outer edges of the southern benches, with small washouts beginning to form in select areas. Relatively shallow erosion rills were observed along outer slopes, except at the southwestern corner, where deeper erosion rills were documented and ash material was exposed, as well as an area along the south-central side that had a deeper washout.

***Typical erosion rills with larger washout on downhill side of bench***

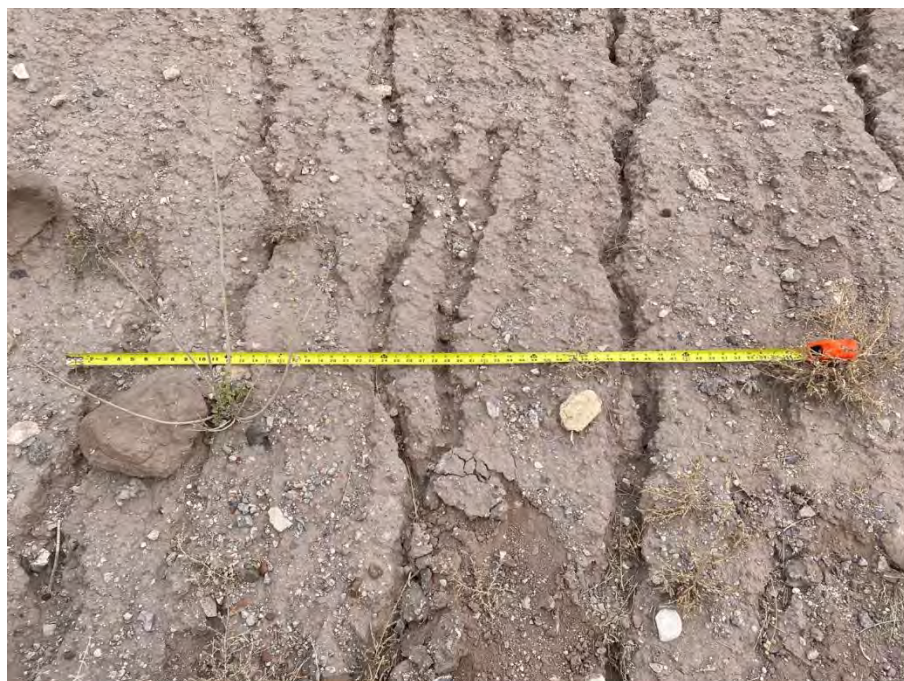
**Photo 24**  
***Closeup and scale of typical erosion rills along downhill side of bench***

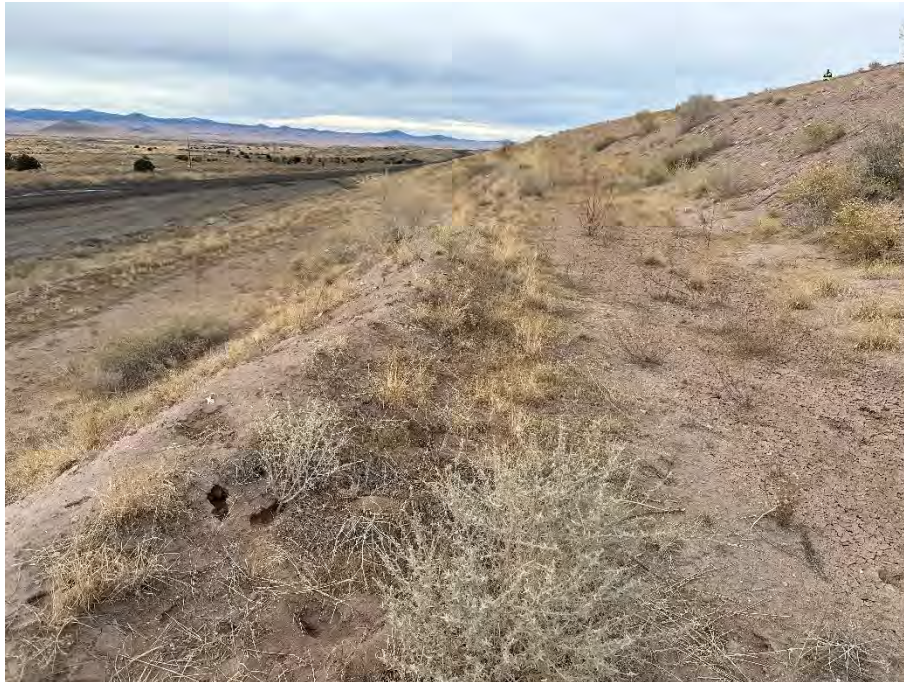
**Photo 25**  
***Animal burrows present along elevated lip on outer edge of bench***

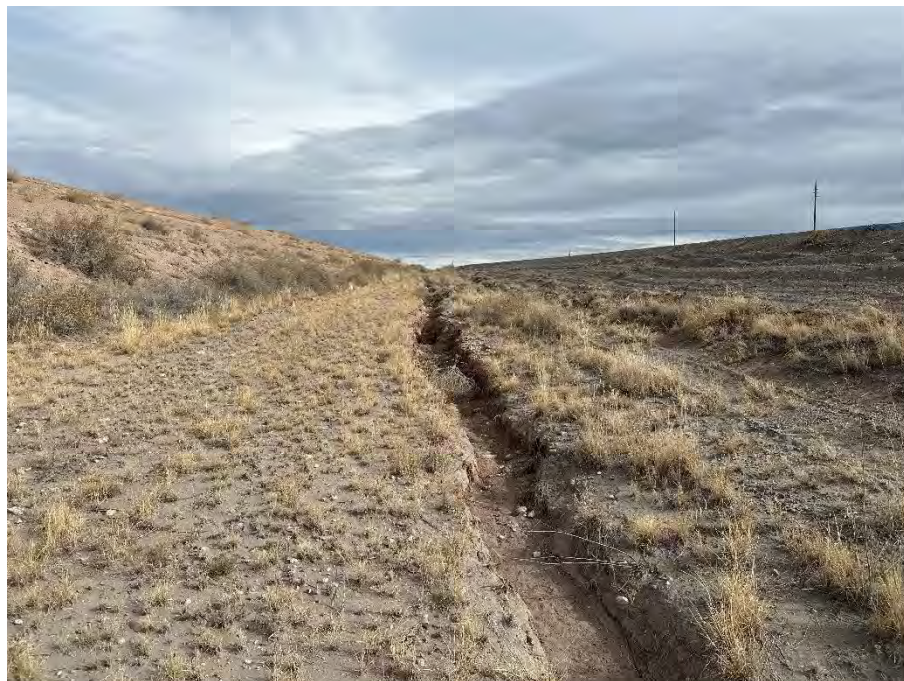
A drainage channel along the southern side of the inactive ash fill area appears to have incised from erosion, creating an irregular width and depth throughout. This southern channel discharges to a south retention area, located to the north of the water truck refill station. A small, constant stream of water was observed to flow from the station into this retention area. TEP personnel noted that the valve on the refill station was left incrementally open to minimize the potential for freezing during winter months.

**Photo 26**  
***Incised/ eroded drainage channel at toe of south embankment and adjacent Ash Haul Road***

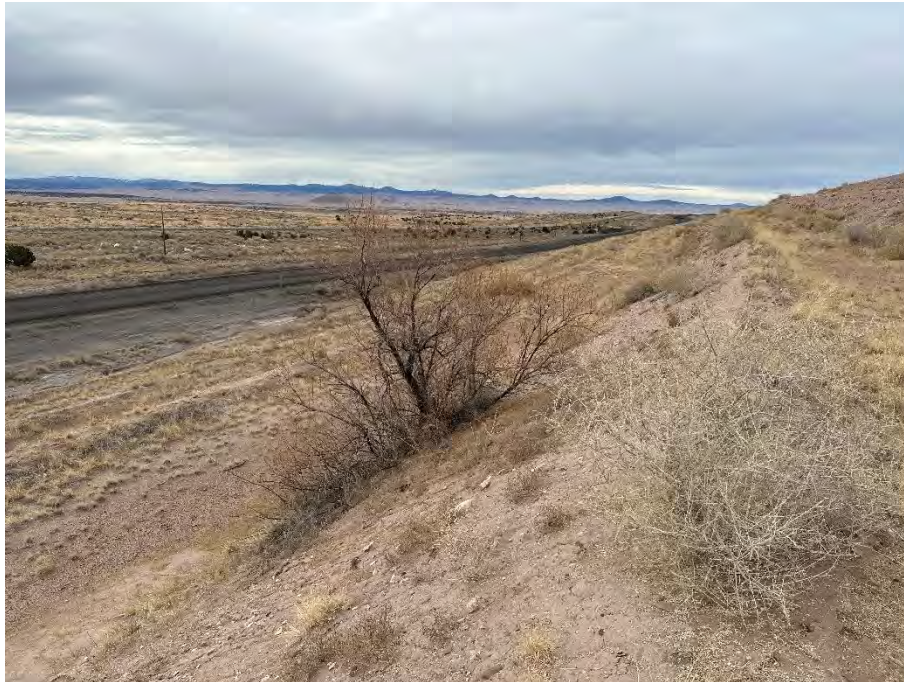
**Photo 27**  
***Woody vegetation on downhill side of bench***

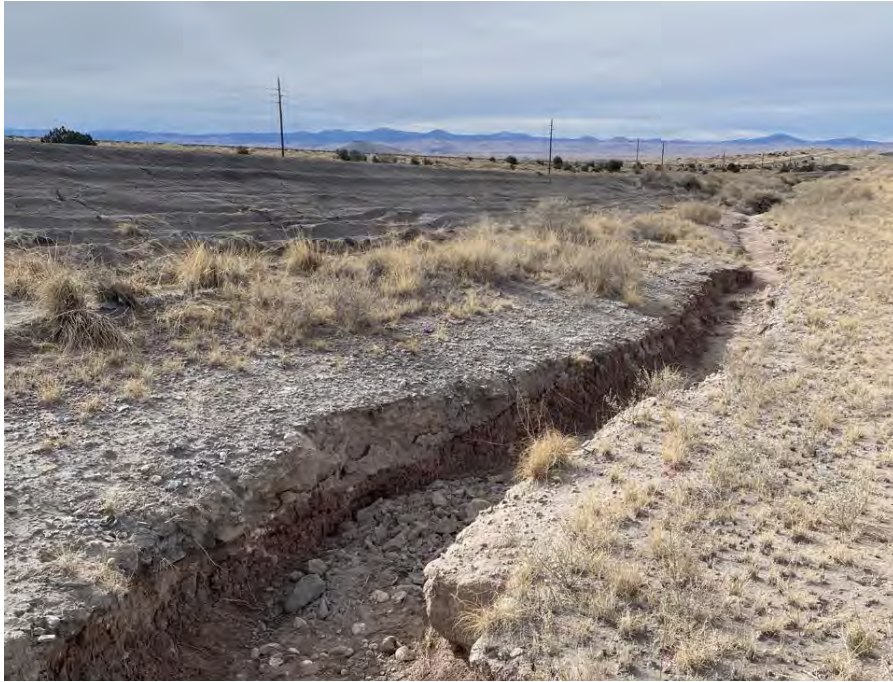
**Photo 29**

***Incised/ eroded drainage channel directing water toward retention area***

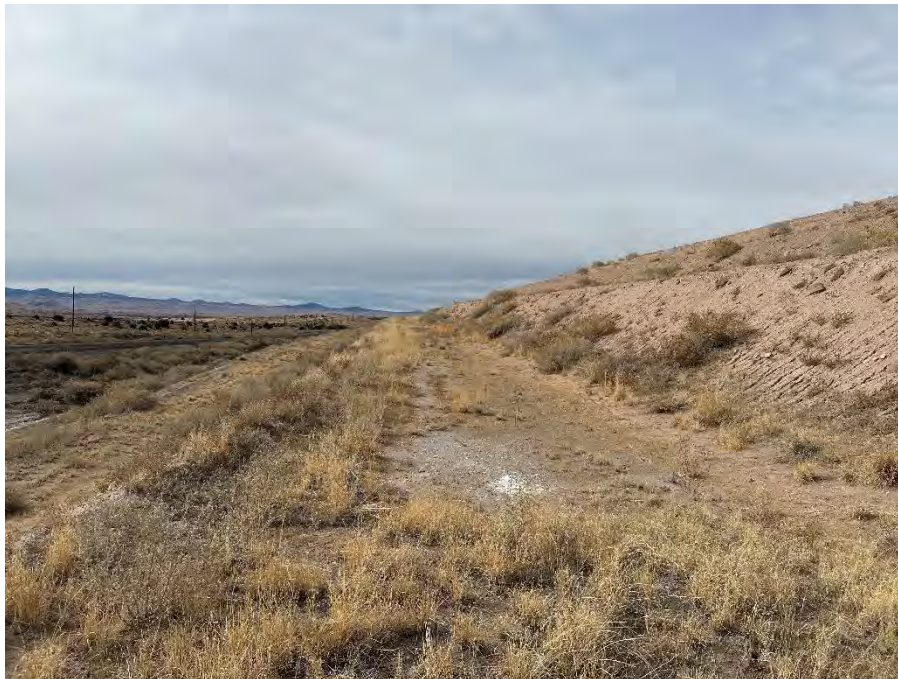
**Photo 30**

***Exposed ash along bench on south side of Inactive Fill Area***

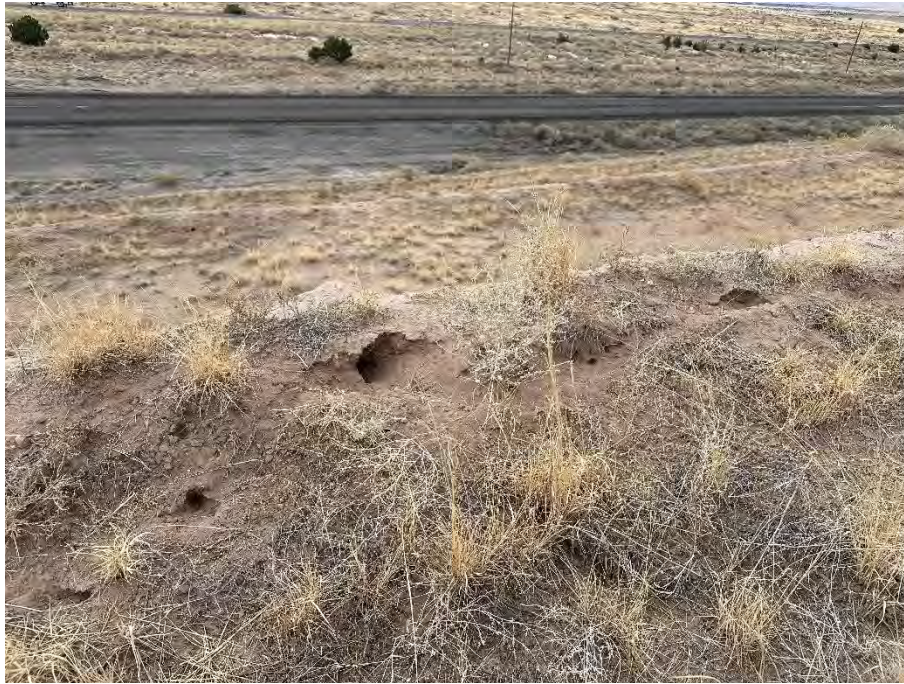
**Photo 31**

***Animal burrows present along elevated lip on outer edge of bench***

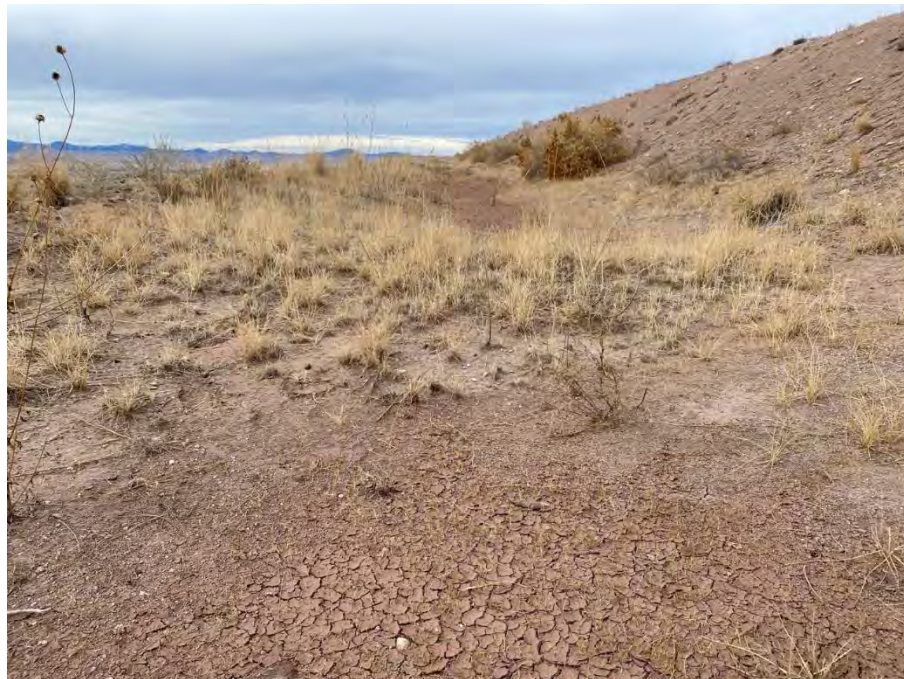
**Photo 32**

***Desiccation of soil cover and typical lateral confining berms on bench***

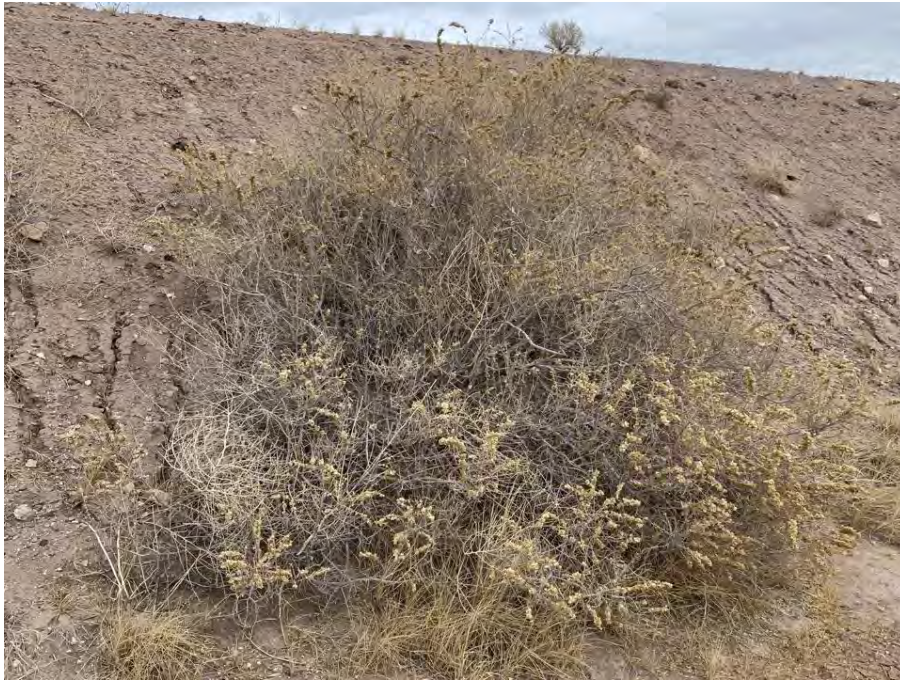
**Photo 33**  
***Woody vegetation present at toe of side slope***

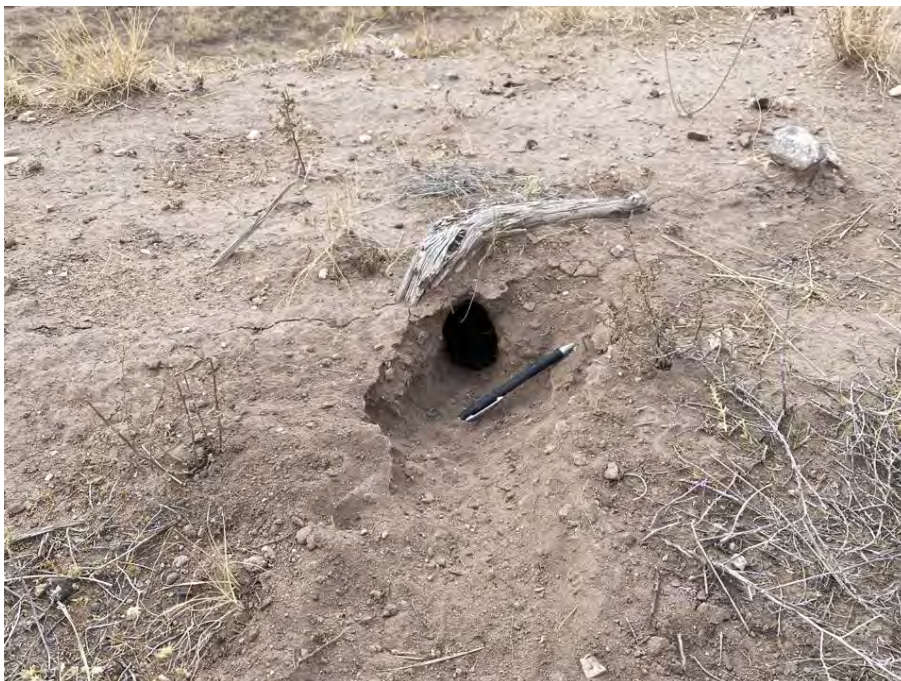
**Photo 34**  
***Closeup and scale of typical animal burrow present on outer edge of bench***

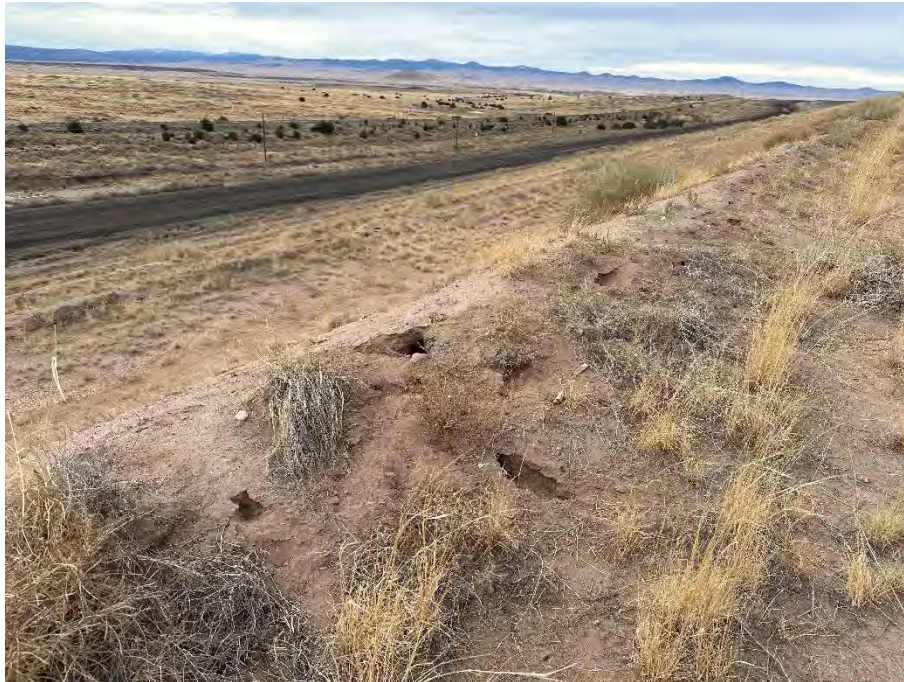
**Photo 35**  
***Animal burrows present on outer edge of bench***

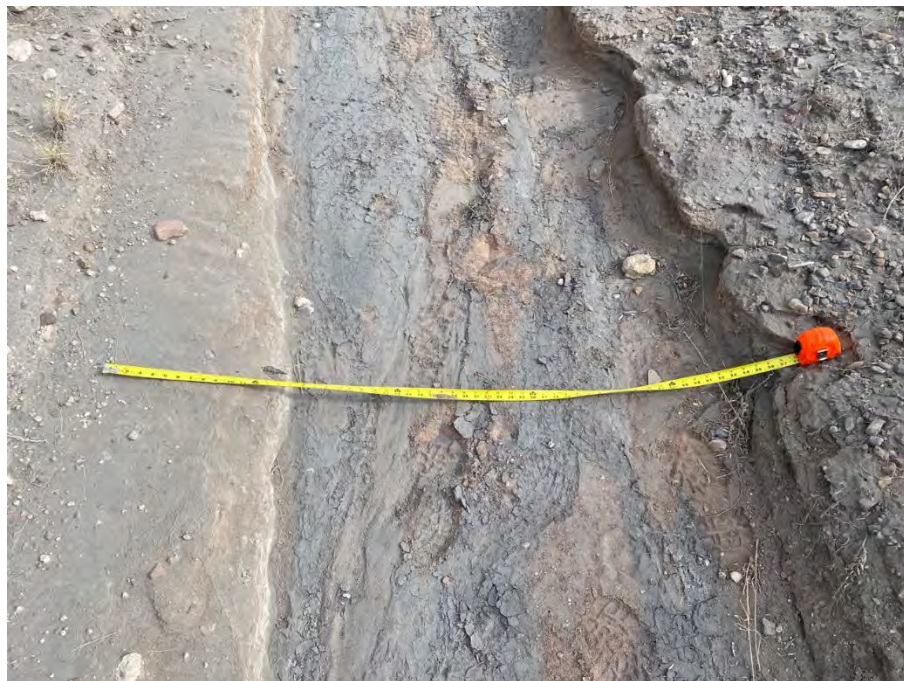
**Photo 36**  
***Typical width of incised/ eroded drainage channel at toe of south embankment***

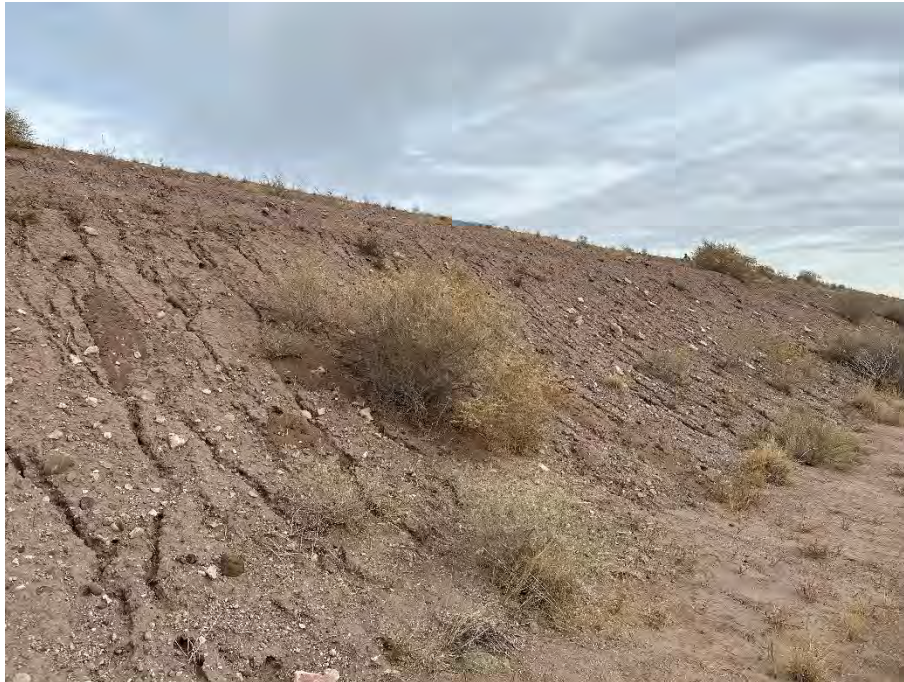
**Photo 37**  
***Typical erosion rills and vegetation along benches***

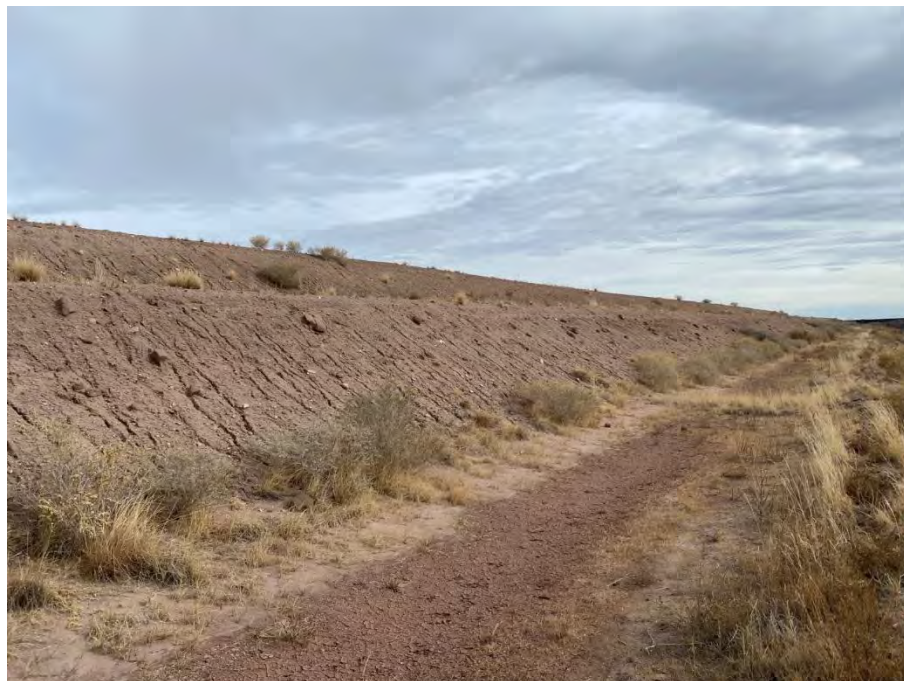
- Ponding on benches and other areas noted along toe of slope that could cause weakening of in-situ materials, piping along preferential pathways, and potentially leading to leachate generation;

**Photo 38**  
***Pooling area between lateral confining berms on bench***

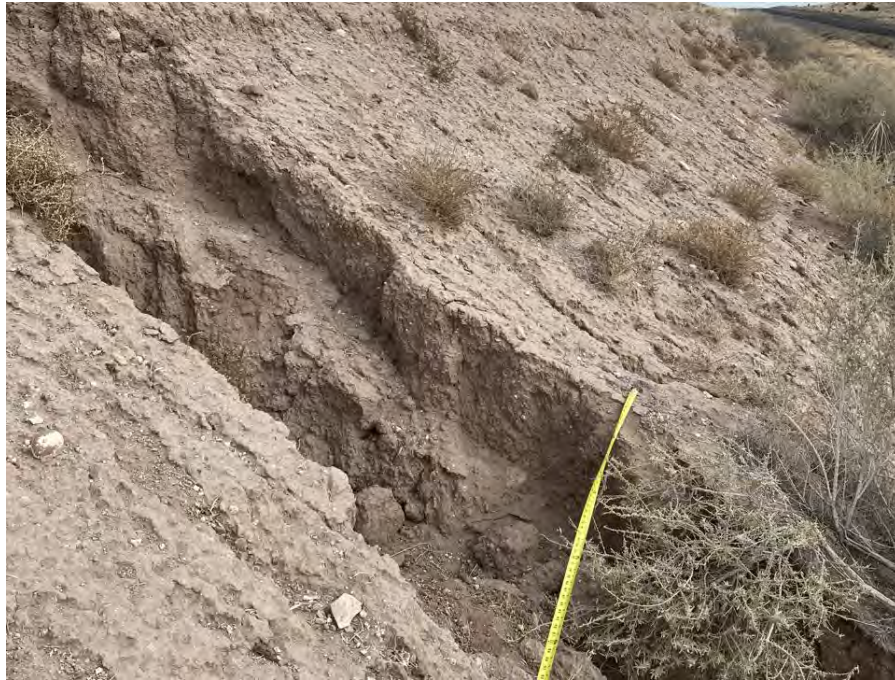
**Photo 39**  
***Closeup and scale of deep erosion gully on downhill side of bench***

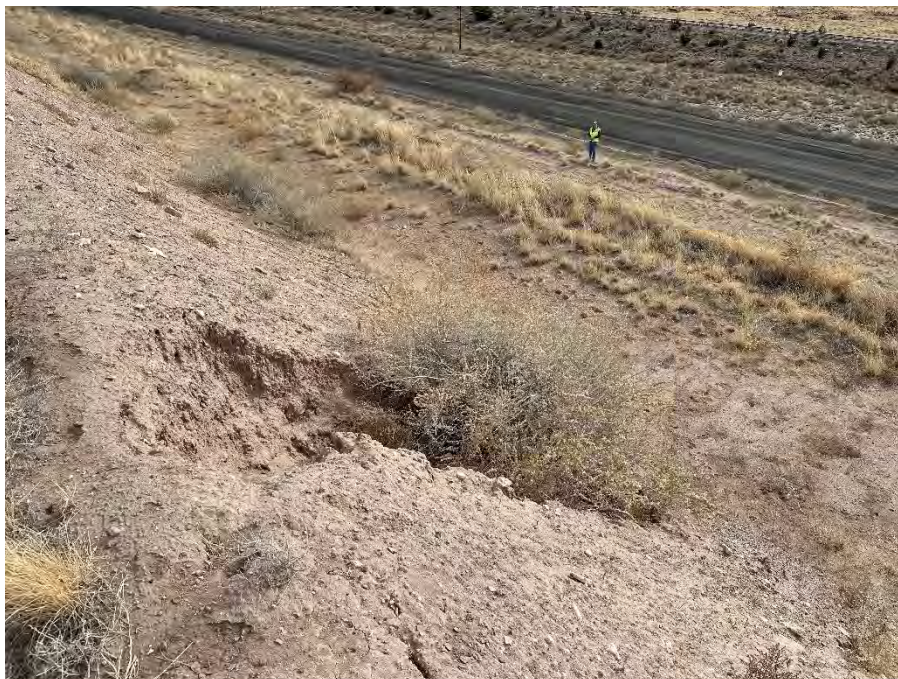
**Photo 40**  
***Deep erosion gully on downhill side of bench***

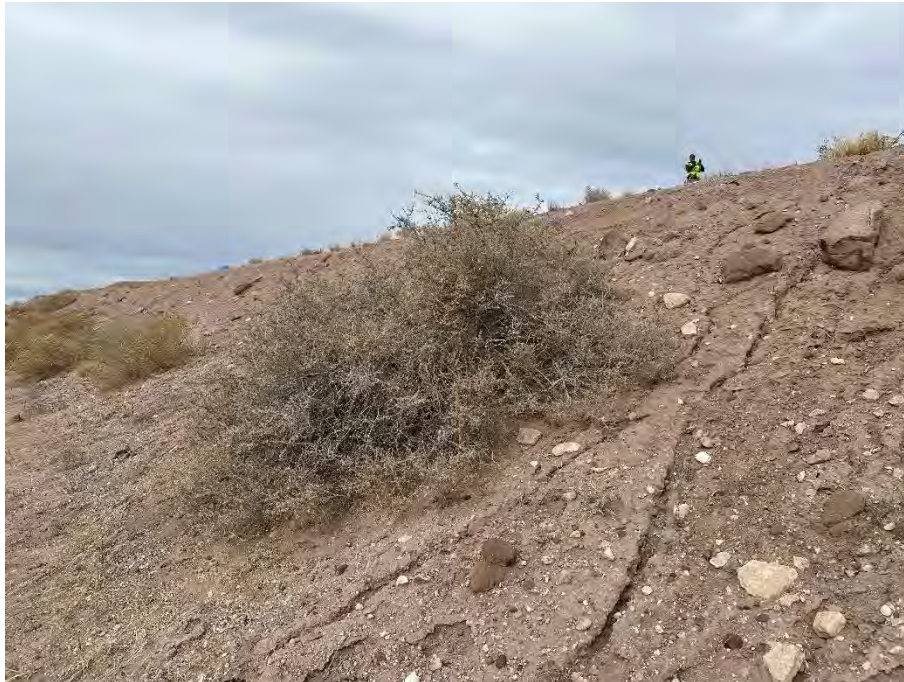
**Photo 41**

***Typical vegetation and erosion rills on downhill side of bench***

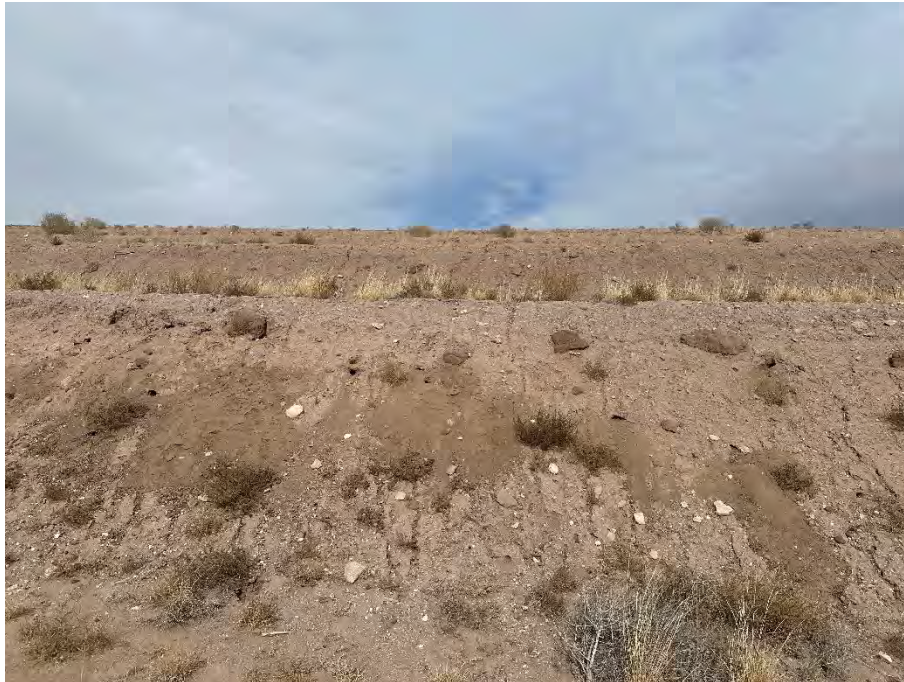
**Photo 43**

***Apparent irregularity in soil cover conditions along downhill side of bench***

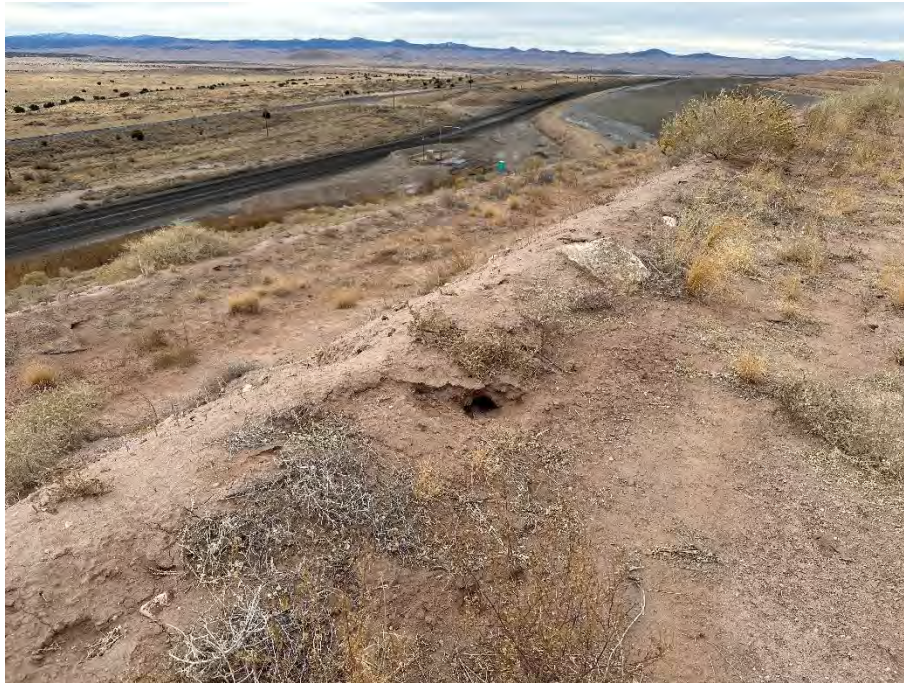
**Photo 45**  
***Animal burrows present on outer edge of bench***
