Subject: 2023 Annual Inspection by a Qualified Professional Engineer  
Ash Landfill  
Springerville Generating Station  
Springerville, Arizona

**REPORT ON**  
**2023 ANNUAL INSPECTION BY A QUALIFIED PROFESSIONAL**  
**ENGINEER**  
**ASH LANDFILL**  
**SPRINGVILLE GENERATING STATION**  
**SPRINGVILLE, ARIZONA**

File No. 0208568-001  
January 2024

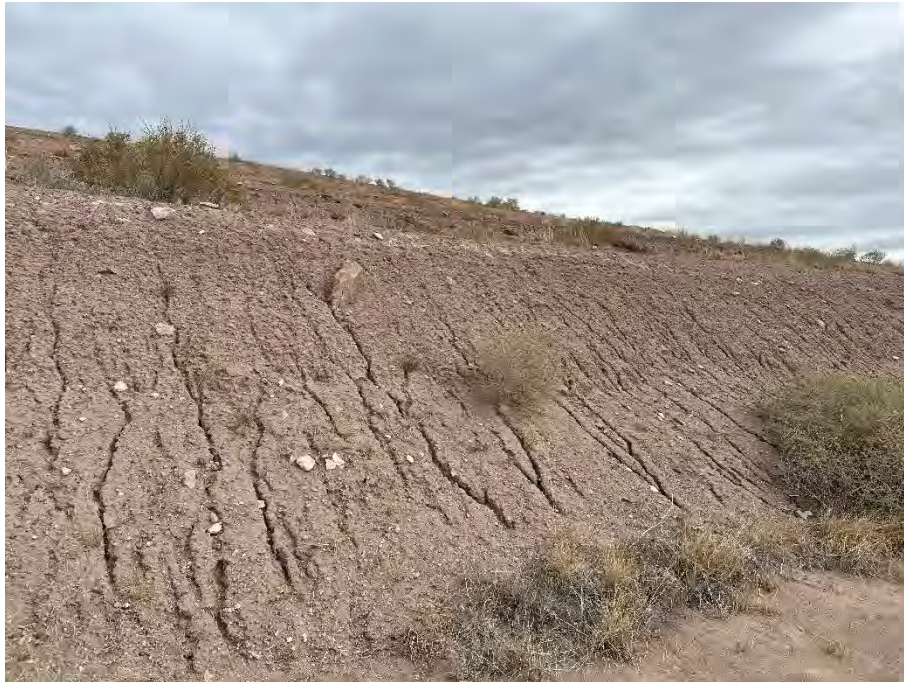
**Photo 47**  
***Typical erosion rills on downhill side of bench***

- Monitor erosion of the southern and southwestern slopes and implement repairs of rills and gullies that exceed 12 inches in depth.
- Monitor the north and south drainage channels for excessive erosion and/or sedimentation, and repair and regrade to the original design.
- Monitor animal burrows and backfill, as needed, to prevent development of future erosion and/or stability issues.
- Monitor growth of tall, woody, and invasive vegetation and remove by hand-cutting and/or use of light equipment.

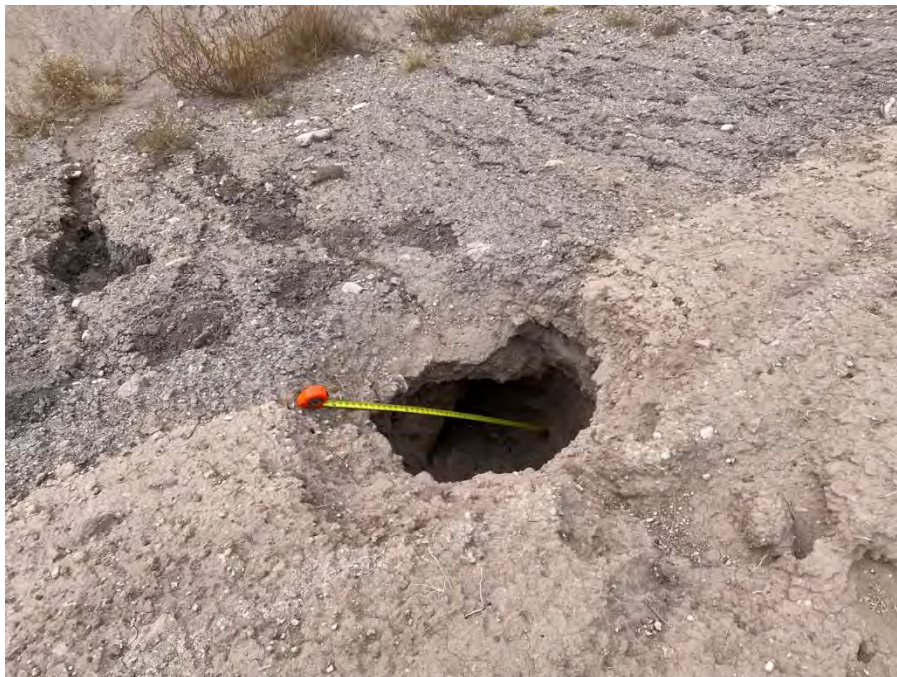
**Photo 48**  
***Small-to-moderate sized hole or cave-in at crest of berm***

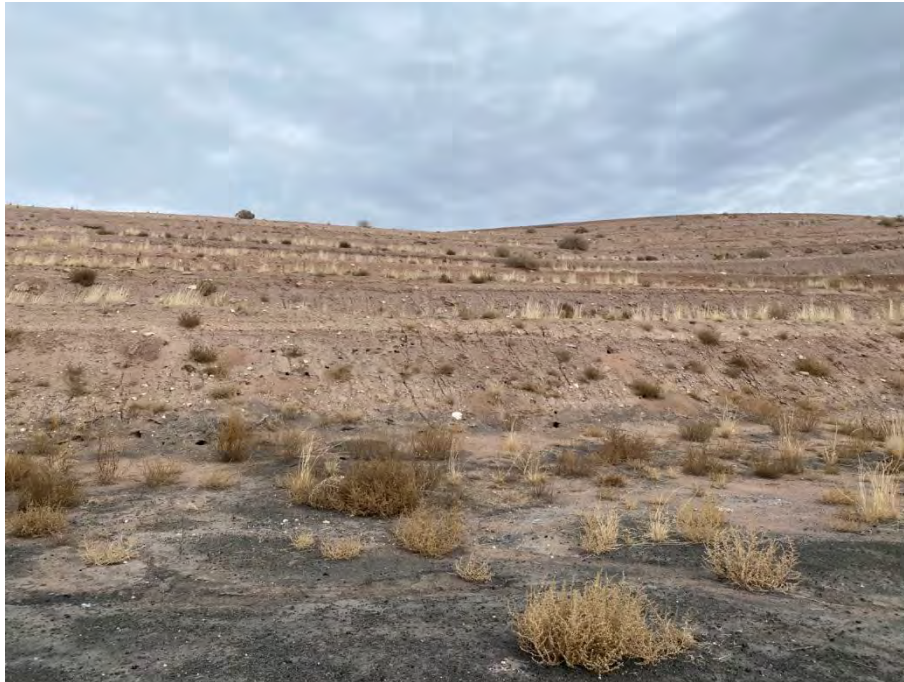
**Photo 49**

***Uncovered ash fill area, looking up toward soil cover on benches and side slopes***

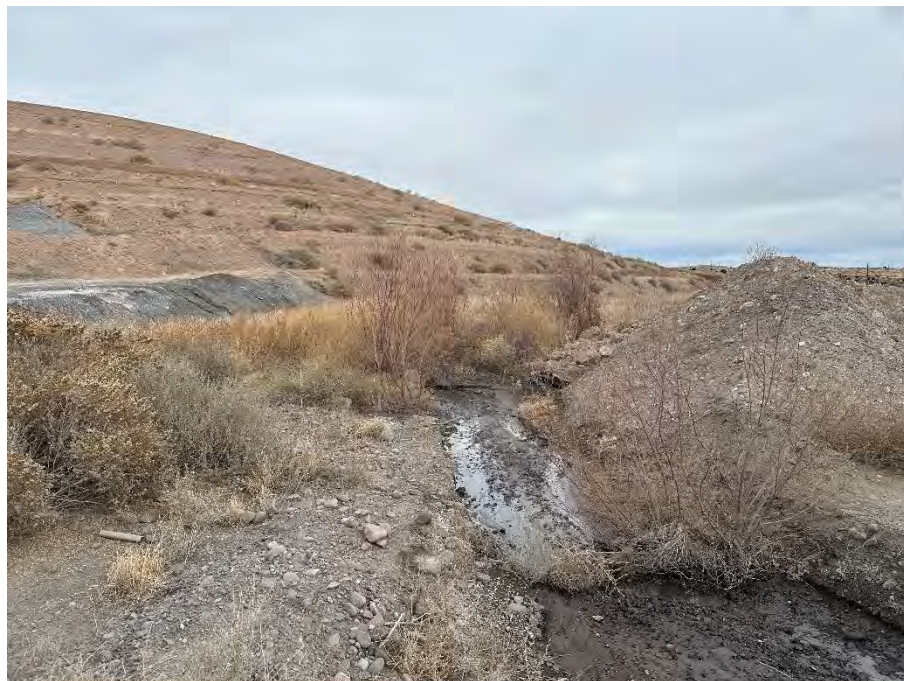
**Photo 50**

***Run-off from Water Truck Refill Station into South Retention Area***

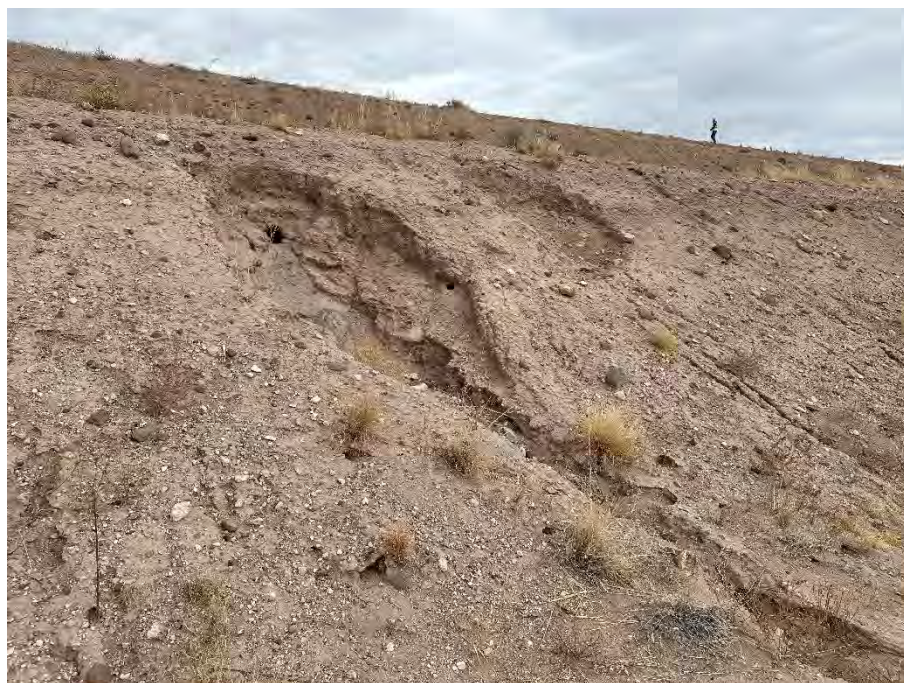
***Photo 52***  
***Erosion washout on downhill side of bench***

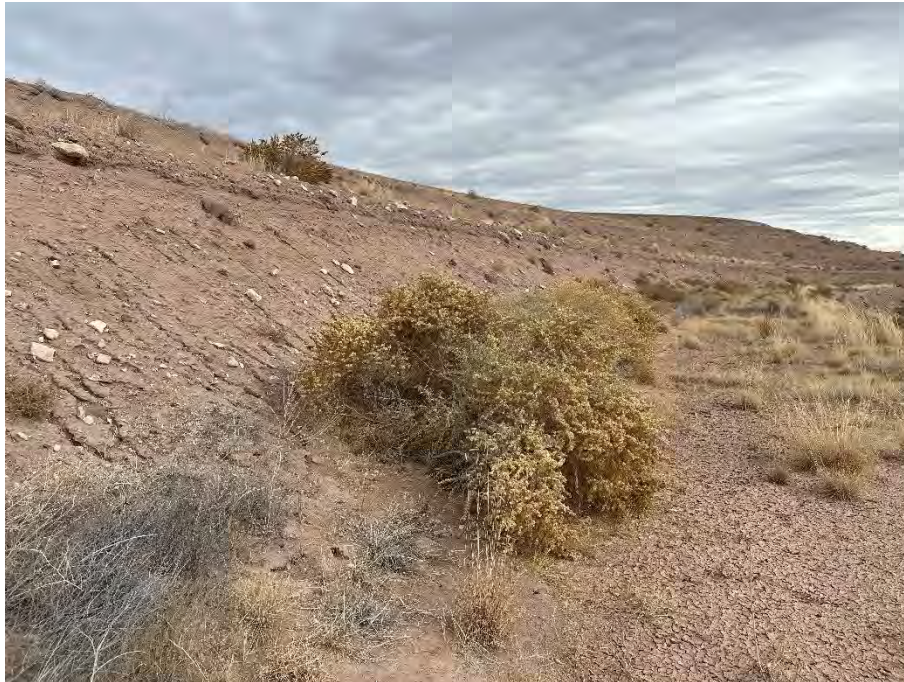
**Photo 53**  
***Woody vegetation on toe of side slope***

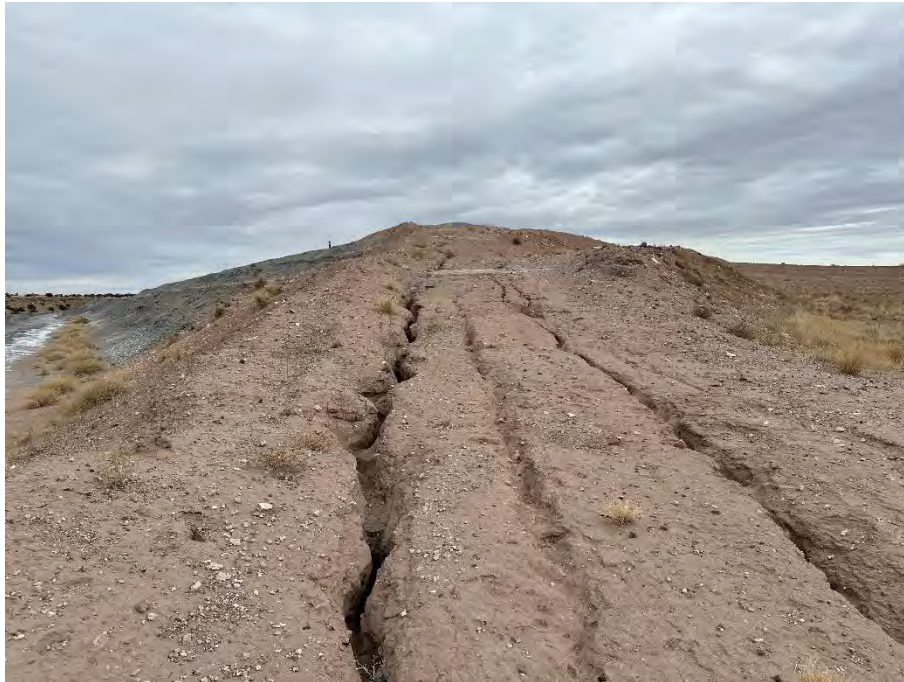
**Photo 55**

***Deep erosion rills/ potential cracking along southwestern corner of Inactive Fill Area***

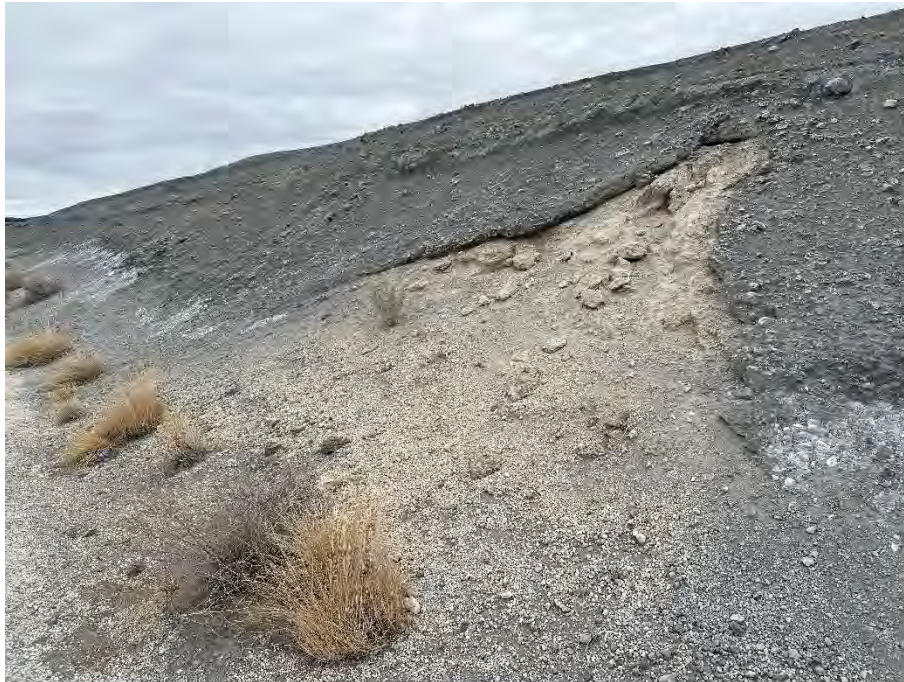
The slopes at the western face of the inactive landfill portions were benched (generally ranging from 10 to 20 feet wide and 10 feet high) and consisted of exposed ash material with no soil cover. Isolated areas with minor sloughing were observed along these relatively flat benches.

- Large active fill area requiring increased efforts to control fugitive dust and stormwater runoff;
- Steep side slopes with localized sloughing that could continue to progress and cause larger mass mobilization;

**Photo 57**  
***Isolated sloughing on downhill side of benches***  
***(light-colored fly ash exposed beneath cover layer of bottom ash)***

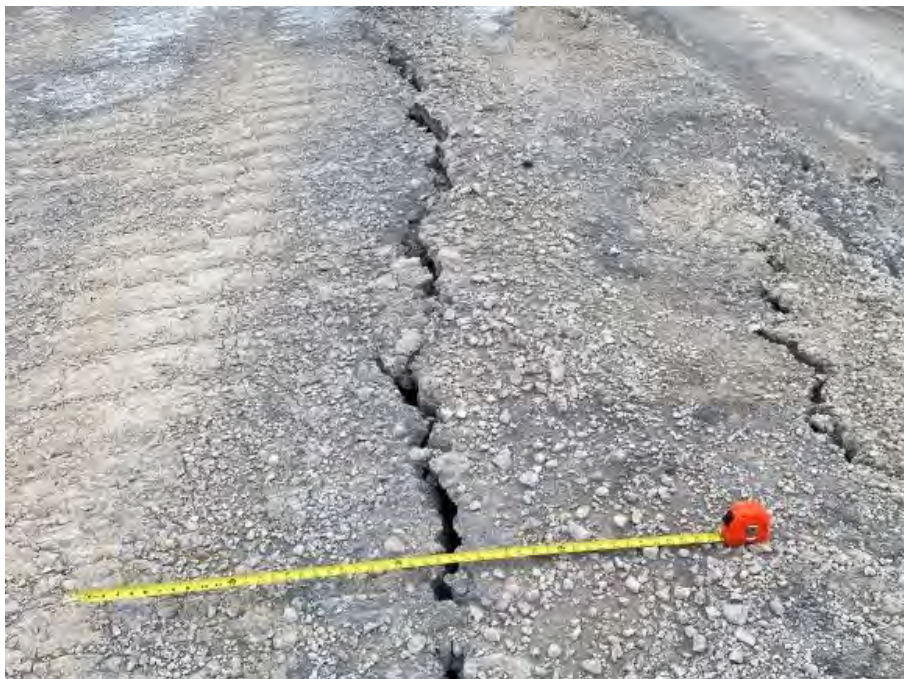
**Photo 58**  
***Tension cracking along crest of western slope in Inactive Fill Area***

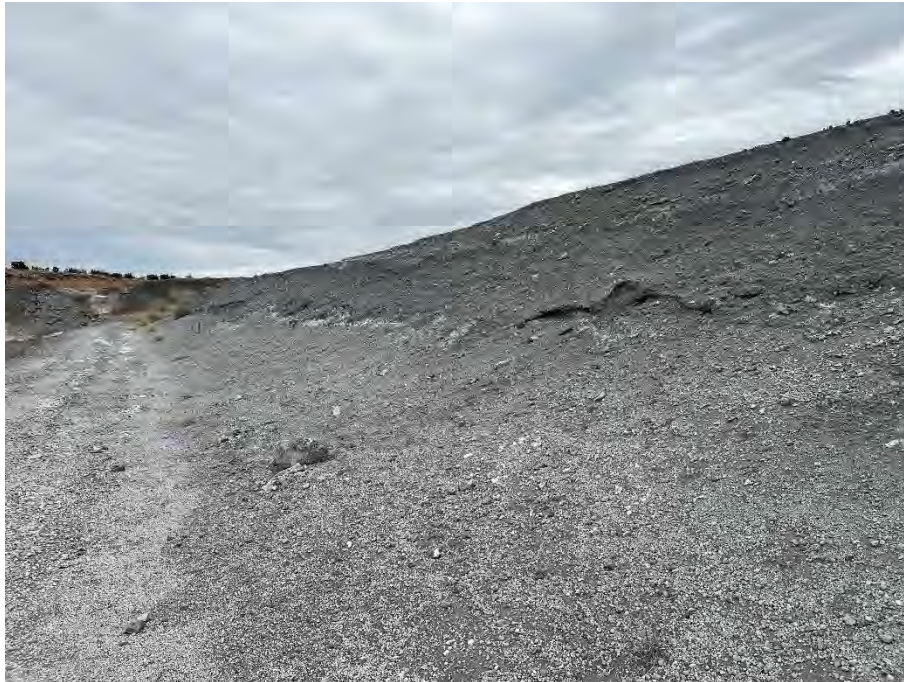
**Photo 59**

***Typical downhill side of bench with minor erosion of uncovered Inactive Fill Area***
