REPORT ON
2024 ANNUAL INSPECTION BY A QUALIFIED PROFESSIONAL
ENGINEER
ASH LANDFILL
SPRINGVILLE GENERATING STATION
SPRINGVILLE, ARIZONA

By
Haley & Aldrich, Inc.
Cleveland, OH

For
Tucson Electric Power
Springerville Generating Station
Springerville, Arizona

File No. 0208568-005
January 2025

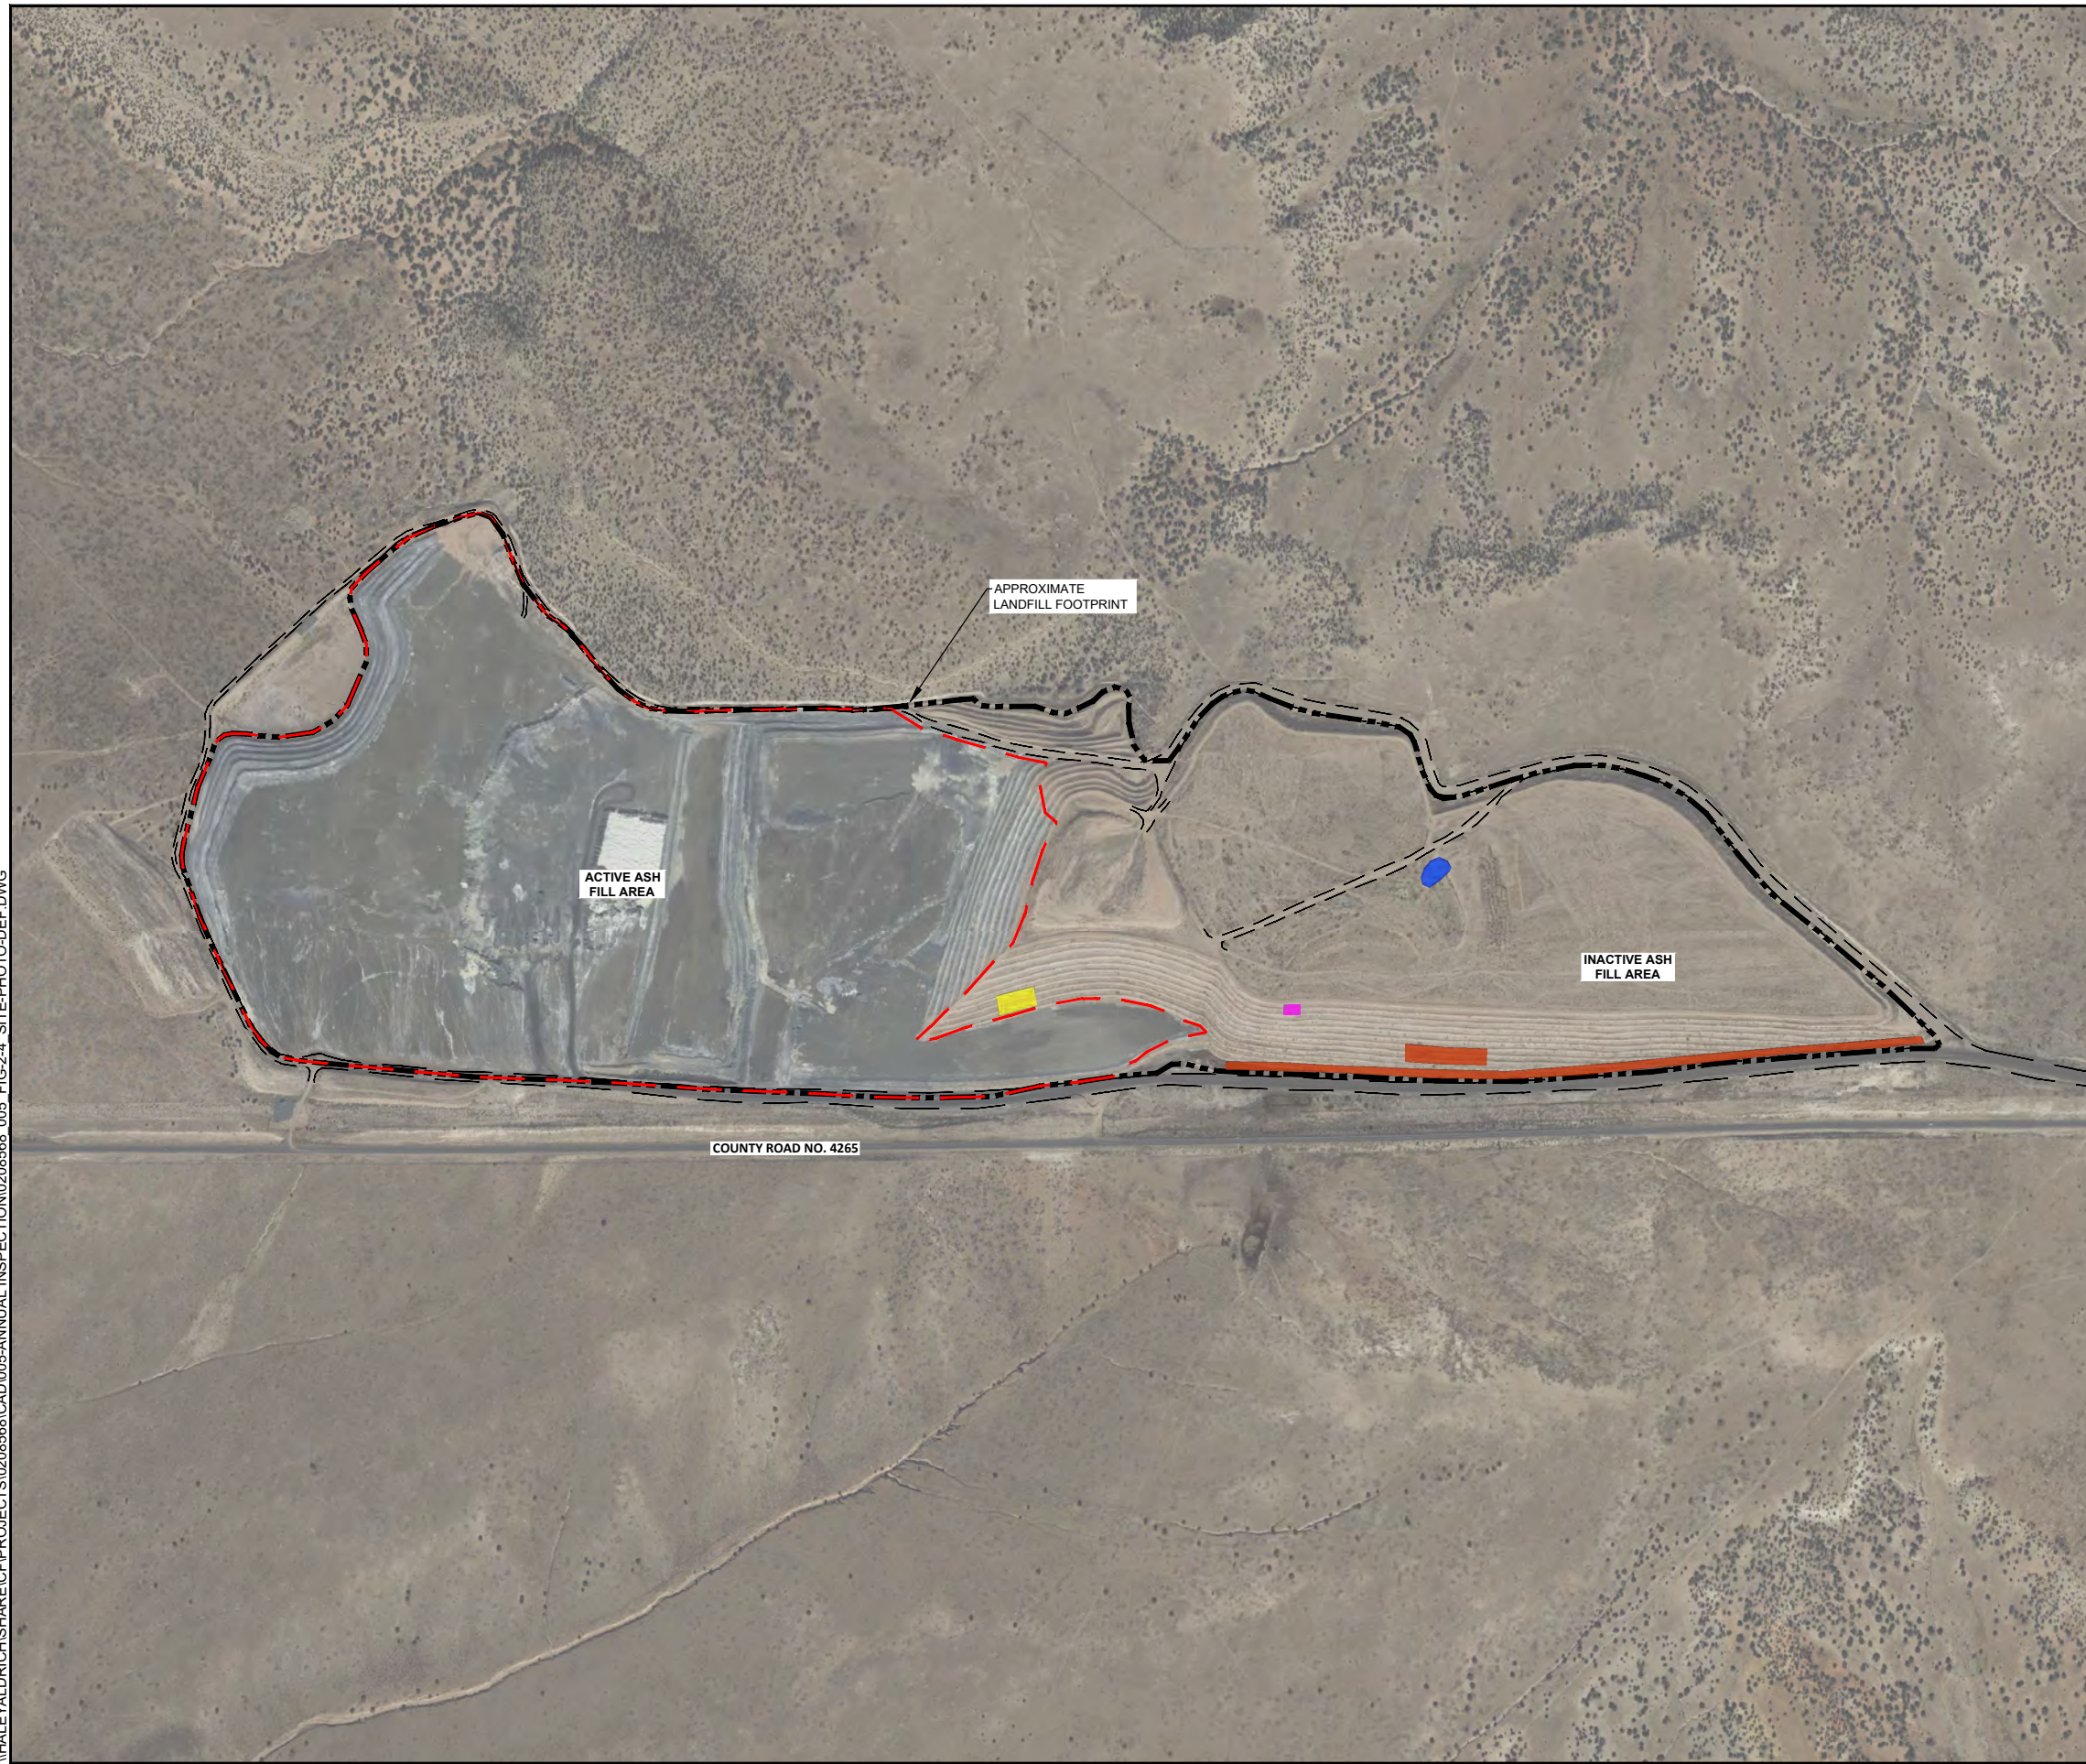
**RECOMMENDED MAINTENANCE
AREAS**

Overall, the landfill was observed to be stable and broadly consistent with recognized and generally accepted good engineering standards. No sinkholes or evidence of settlement were observed. Only one isolated area of potential cracking was noted along an upper bench of the inactive portion along the south face. Areas of minor erosion were observed at locations along the south and southwestern benches of the landfill, as noted in **Section 2.1.1.2** and shown in **Figure 4**.

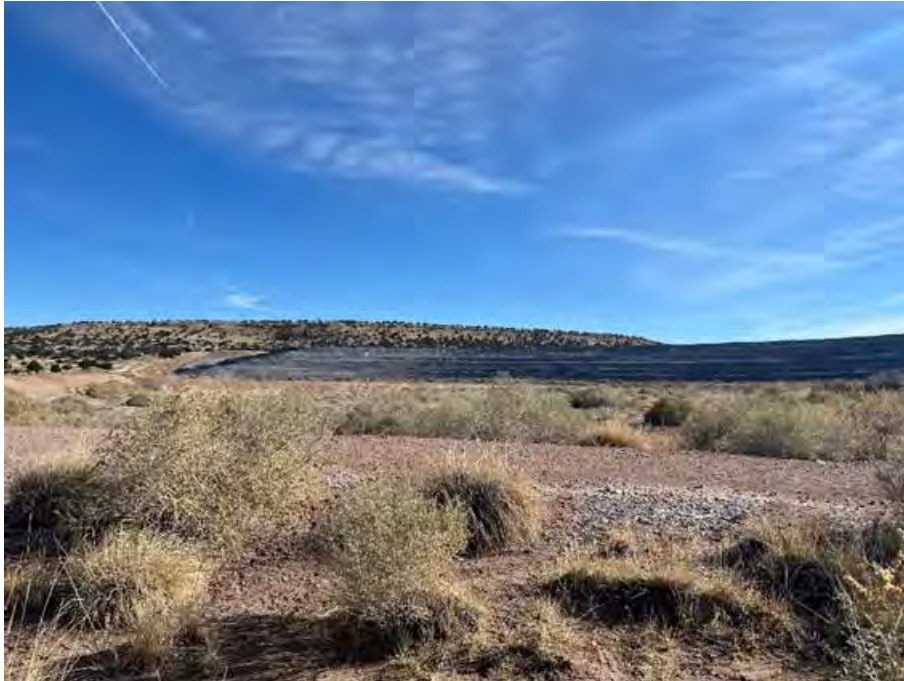
Photo 1

Typical Conditions in Retention Structure No. 3 area and along Active Ash Fill Area benches on the northwest side of the landfill; facing northeast

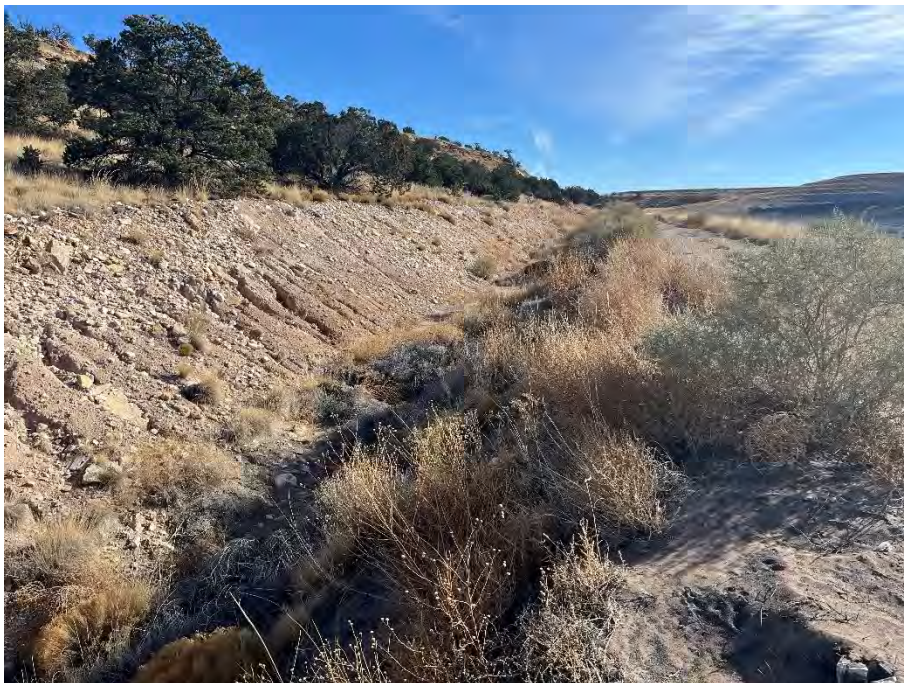
Photo 6

During the site inspection, northern drainage channels were observed to have some minor sediment buildup. It is recommended that this material be removed to restore and maintain full hydraulic capacity of the channel. Rock check dams could be considered as an enhancement along this channel to help retain material.

North perimeter drainage channel, directing run-on stormwater away from active areas; facing east

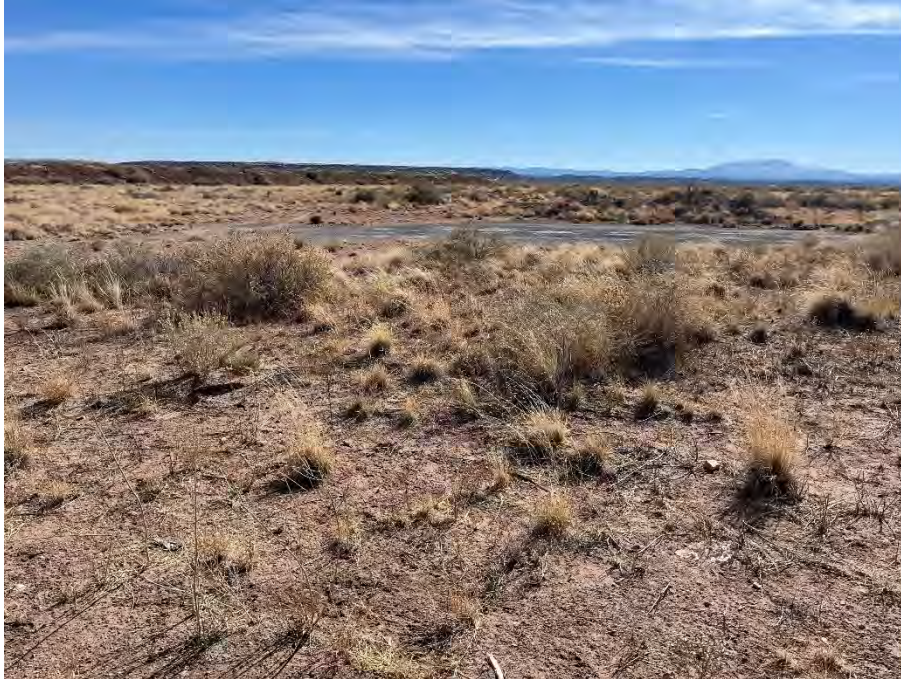
Photo 13
Bare spot on top of the landfill; facing southeast

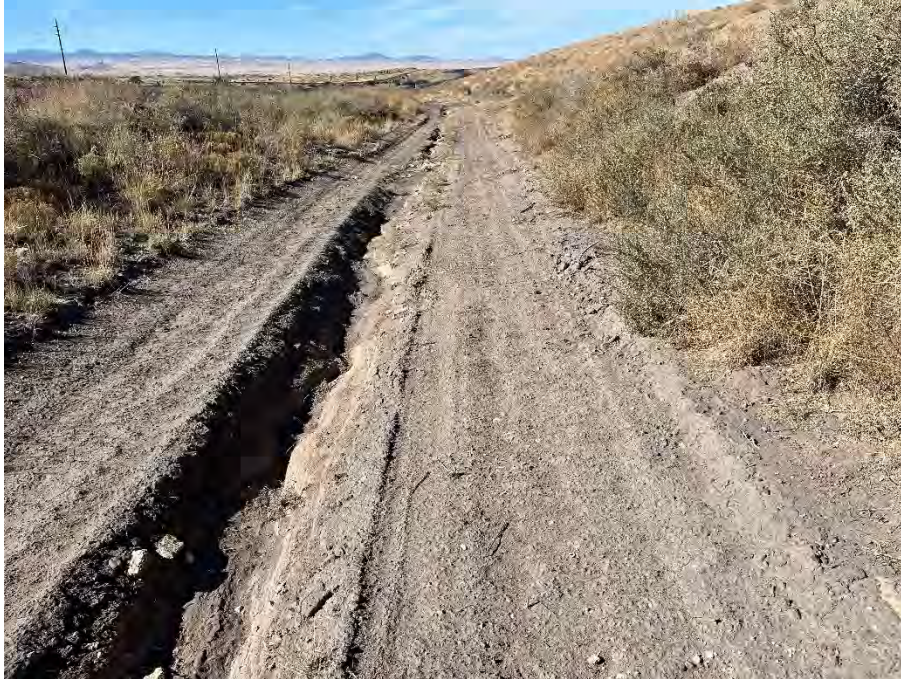
Photo 19

A drainage channel along the southern side of the inactive ash fill area was observed to have a small to moderate amount of erosion, creating an irregular width and depth throughout. This southern channel discharges to a south retention area, located to the north of the water truck refill station.

Erosion along south drainage channel adjacent to the Ash Haul Road; facing west

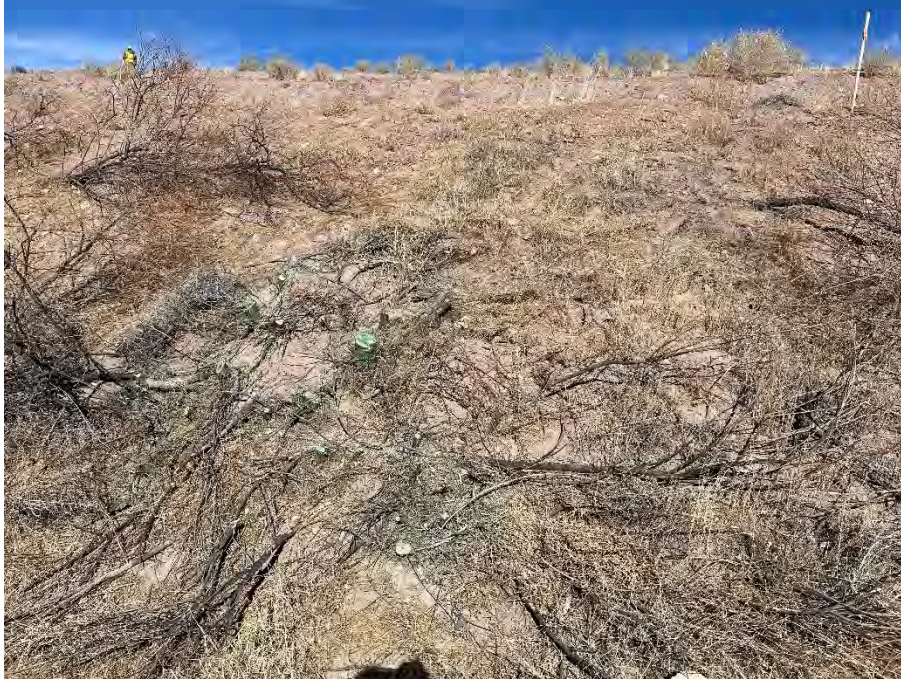
Woody vegetation, previously observed to be present along the top deck, southern benches and slopes, was observed to have been cut and removed.

Photo 23
Removed woody vegetation on south slope of Inactive Fill Area; facing north

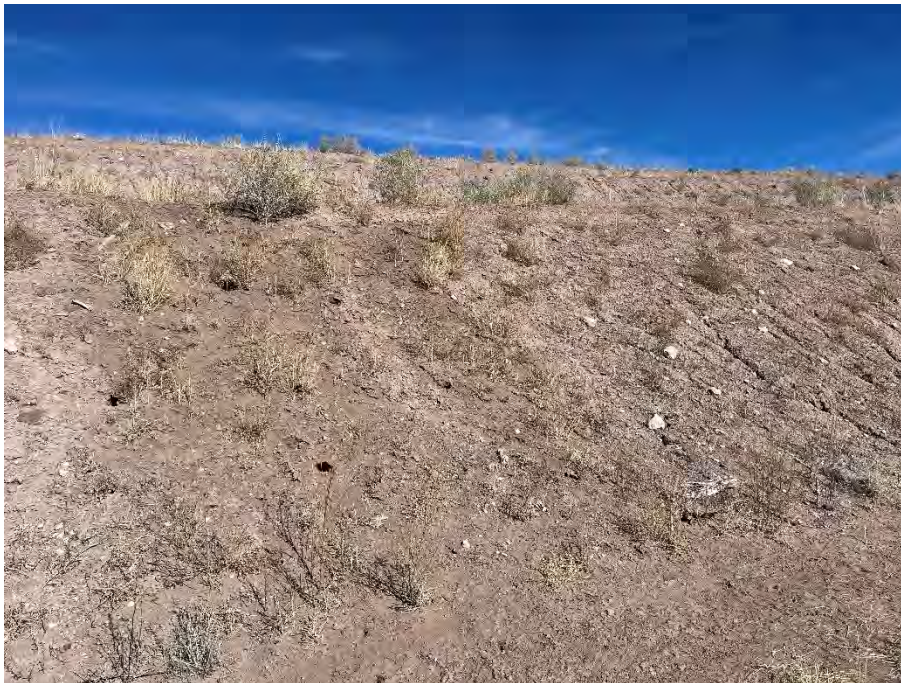
Animal burrows and small holes were observed along the outer edges of the southern benches. TEP personnel indicated these were caused by striped ground squirrels, of which TEP is in the process of having removed. Relatively shallow erosion rills were observed along outer slopes, while areas with deeper erosion rills noted in the previous report were observed to have been repaired.

Photo 24
Animal burrows and minor erosion rills present on side slope; facing north

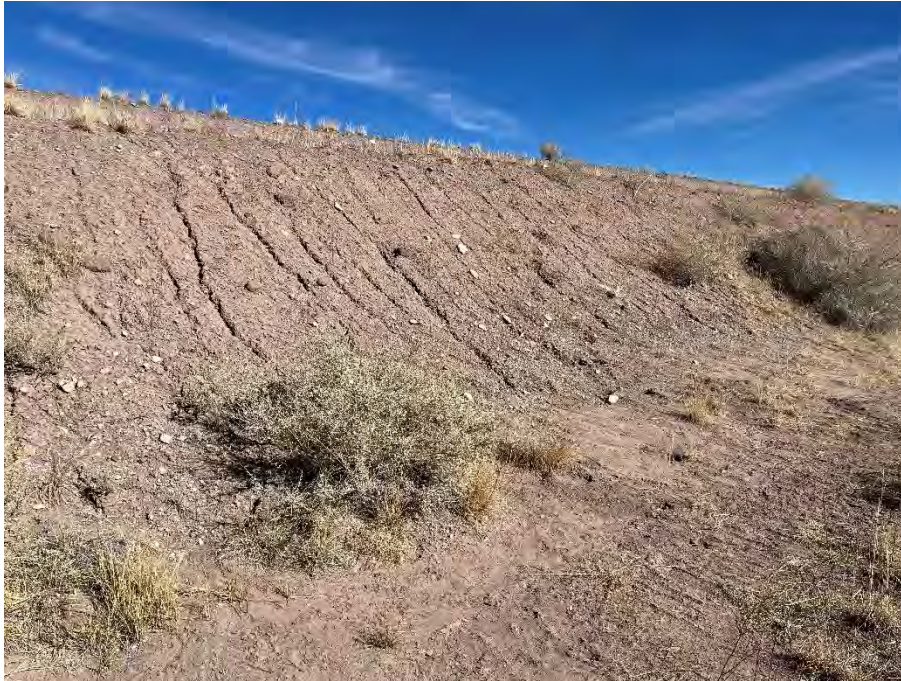
Photo 25

Animal burrows present along elevated lip on outer edge of bench; facing northeast

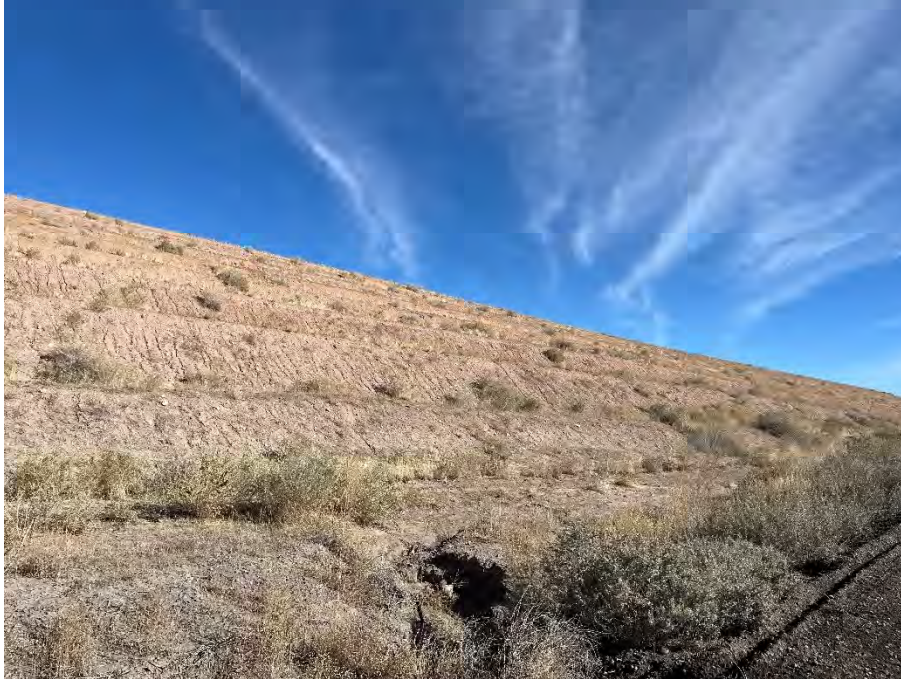
Photo 29

Minor erosion rills along side slopes and erosion in south drainage channel; facing northeast

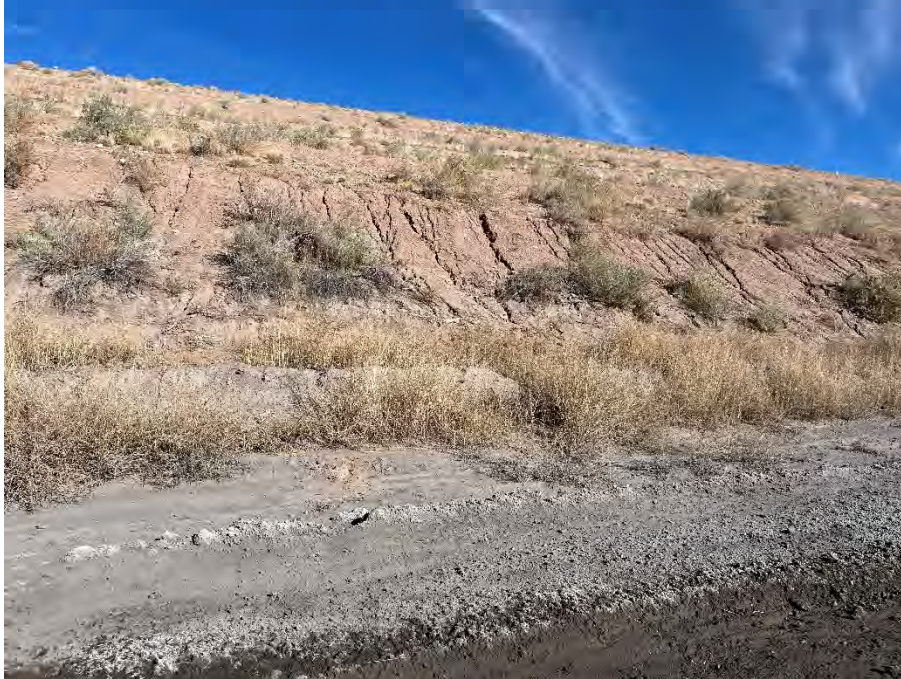
Photo 35
Erosion rills along south slope near the Ash Haul Road; facing north

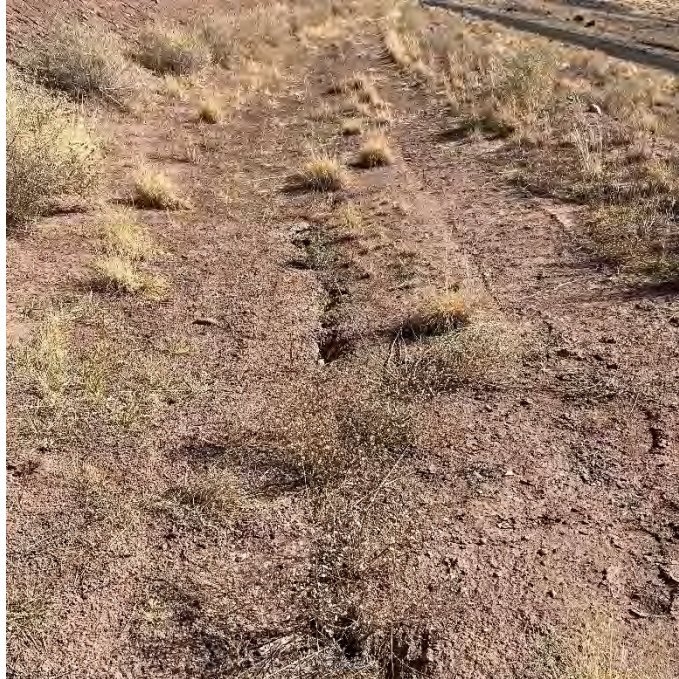
Overall, little to no erosion rills were observed along the eastern and northern slopes of the landfill, which were noted to consist of shorter and more uniform slopes with denser vegetation. No signs of major slope instability or stress (e.g., misalignments, depressions, or bulging) were observed along any portion of the top deck or side slopes of the landfill. One location along an upper bench of the southern face appeared to have potential signs of minor cracking. It is recommended that this location be monitored for any change of condition in the future.

Photo 39
Cracks on the second bench from top; facing east

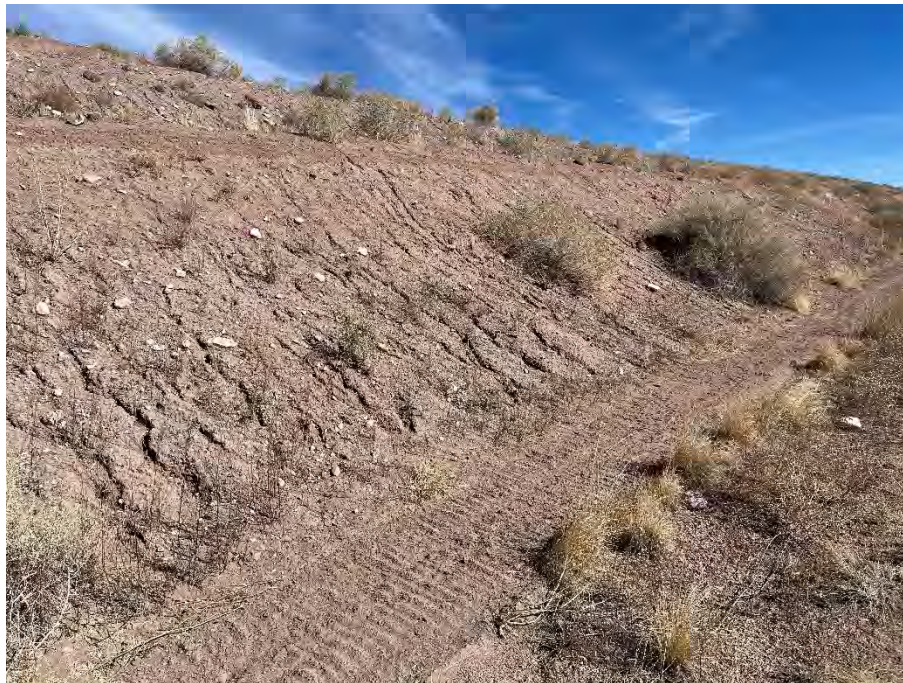
Photo 40
Erosion rills on side slopes; facing northeast

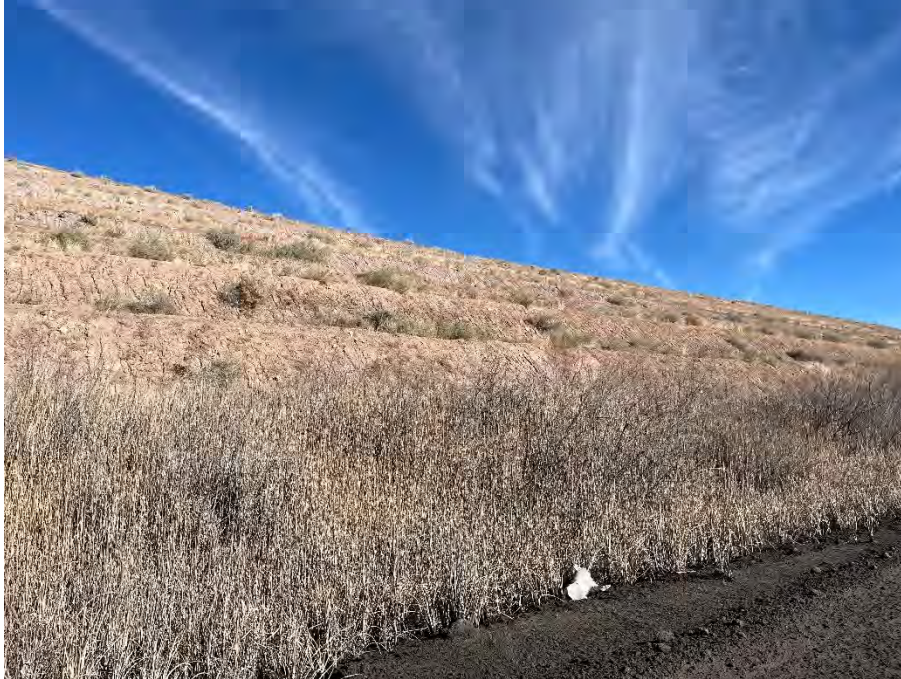
Photo 41

Taller vegetation at the toe of the slope along Ash Haul Road; facing northeast

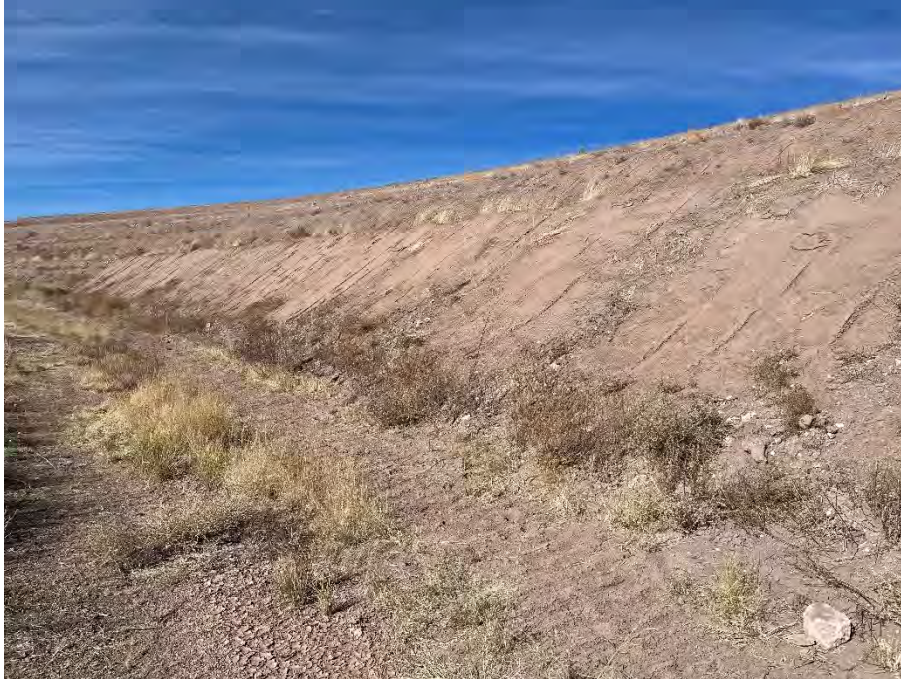
Photo 47
Repaired erosion rills on side slope of Inactive Fill Area; facing northwest

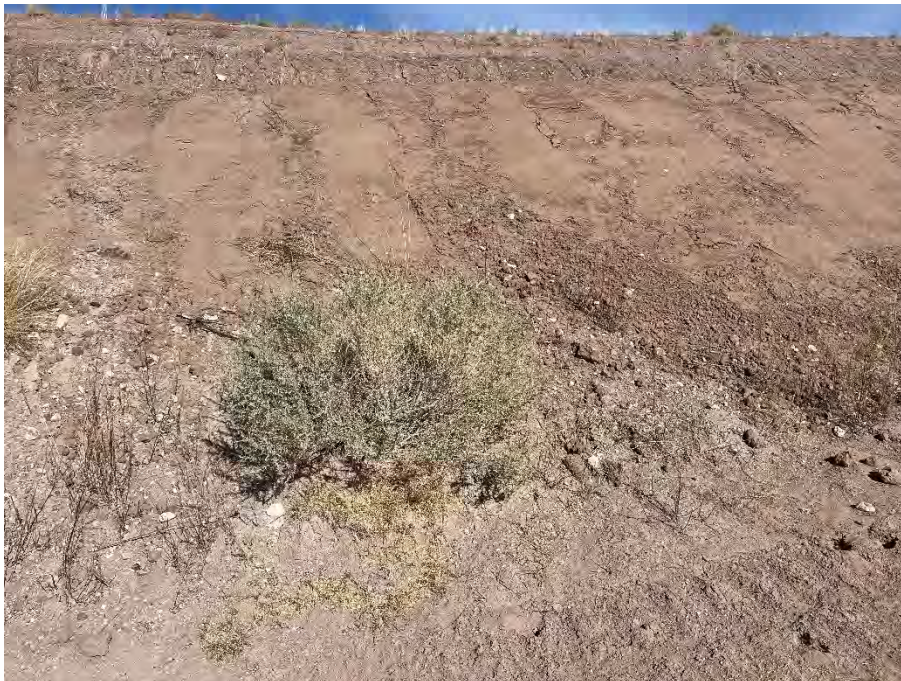
Photo 48
Repaired erosion on downhill side of bench; facing northeast

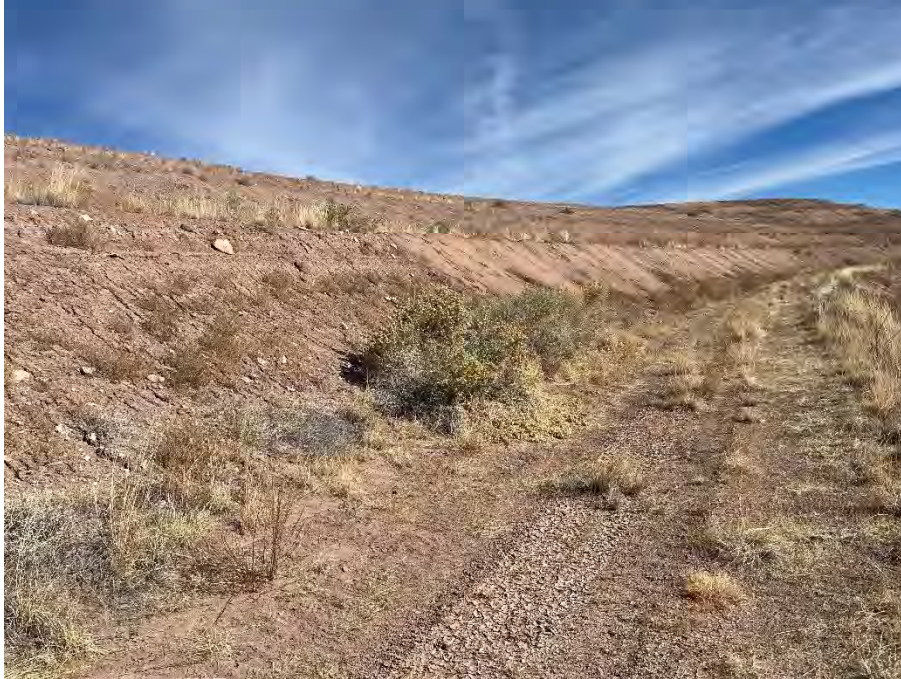
Photo 49
Typical conditions and repaired erosion on side slope; facing east

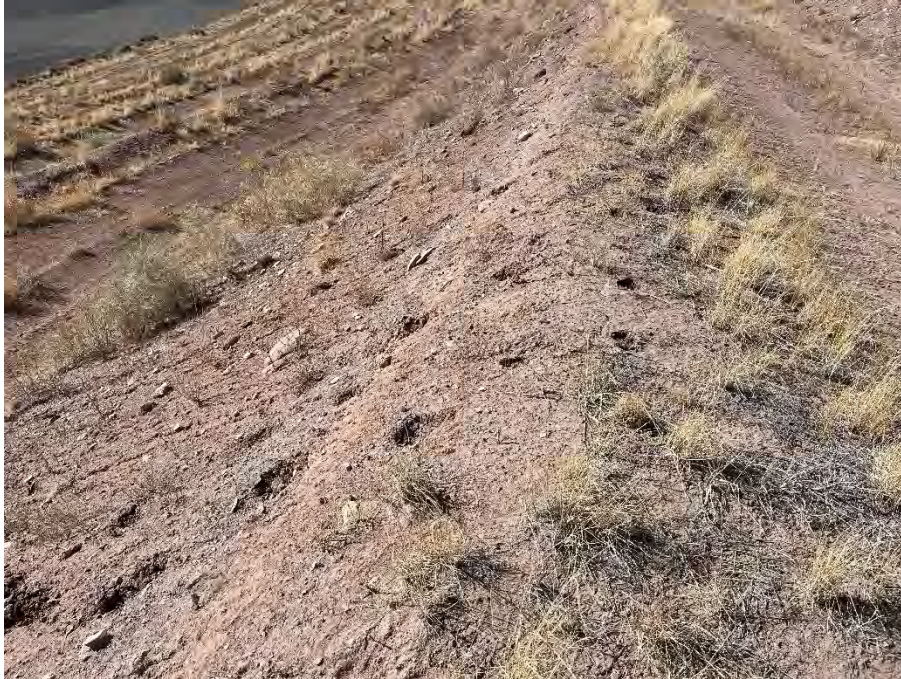
Photo 51
Animal foraging holes on side slope; facing southwest

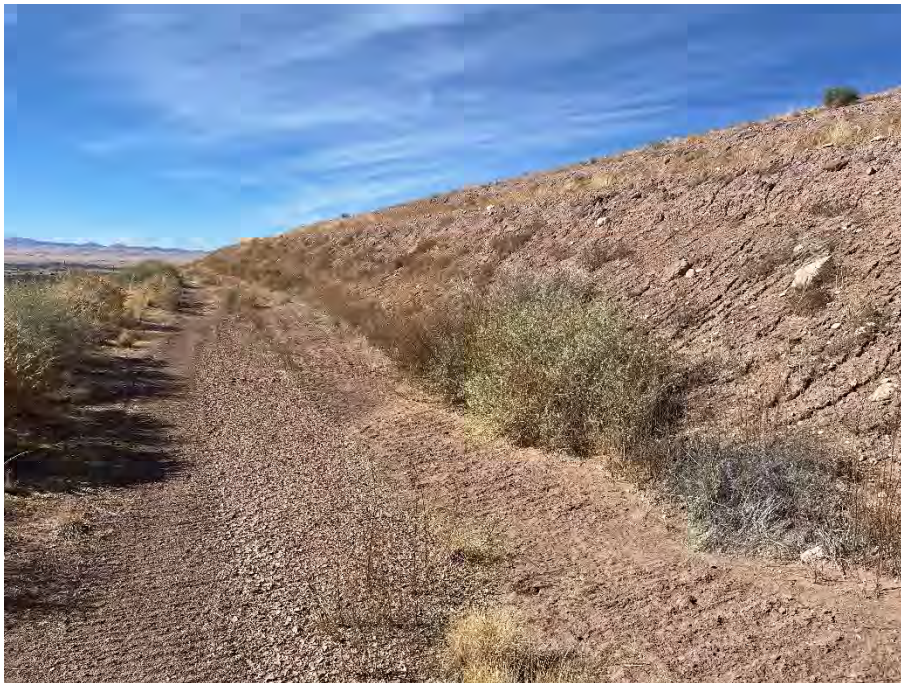
Photo 52
Erosion rills on the slope; facing west

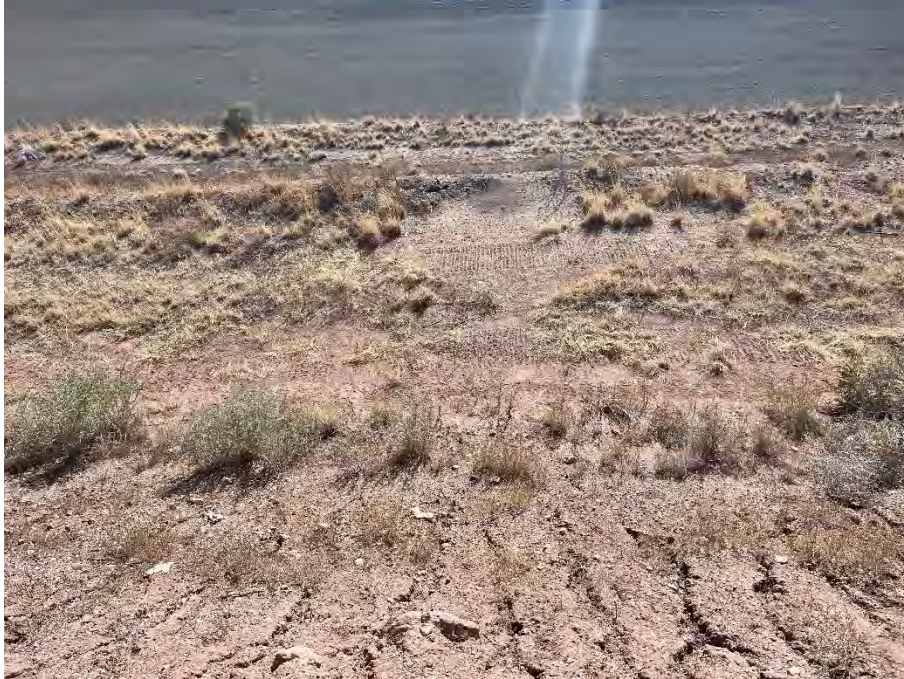
Photo 53
Small animal burrow near lateral confining berm along bench; facing south

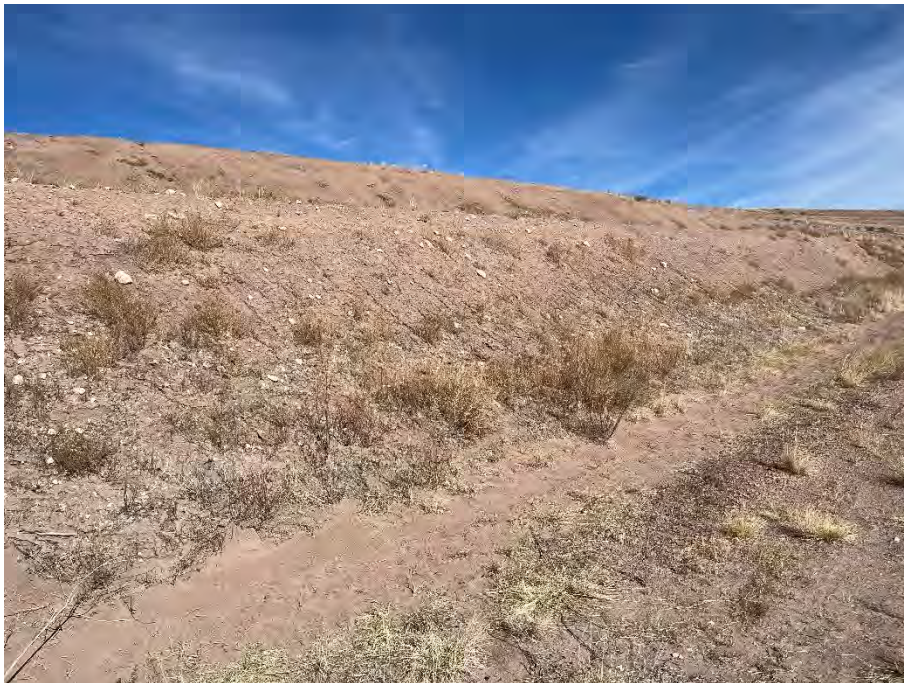
Photo 54
Repaired slopes along upper bench; facing northeast

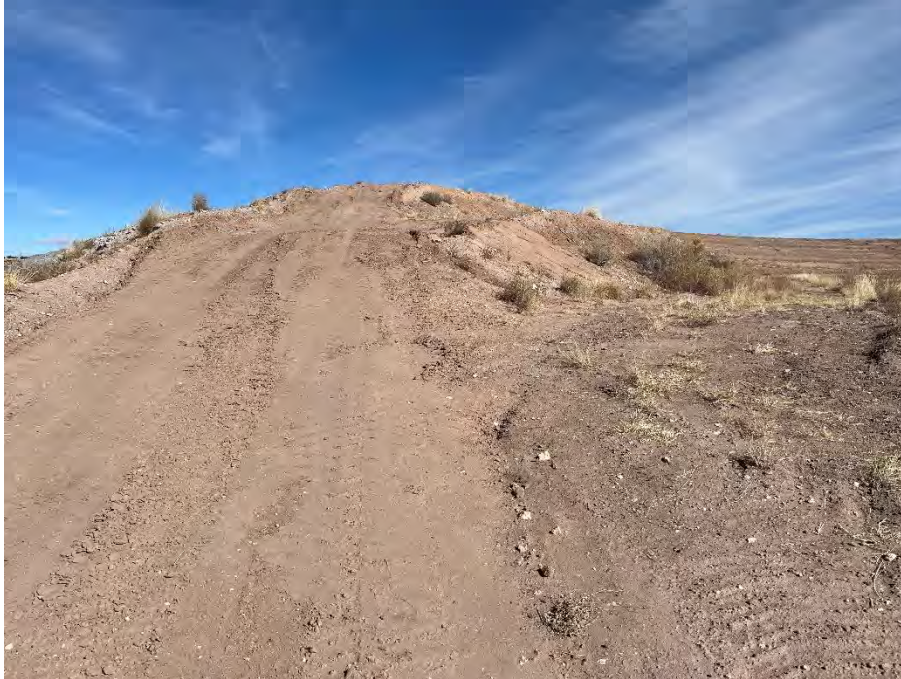
Photo 55

Repaired deep erosion rills along southwestern corner of Inactive Fill Area; facing northeast
