Subject: 2025 Annual Inspection by a Qualified Professional Engineer
Ash Landfill, Springerville Generating Station
Springerville, Arizona

REPORT ON
2025 ANNUAL INSPECTION BY A QUALIFIED PROFESSIONAL
ENGINEER
ASH LANDFILL
SPRINGERVILLE GENERATING STATION
SPRINGERVILLE, ARIZONA

File No. 0213269
January 2026

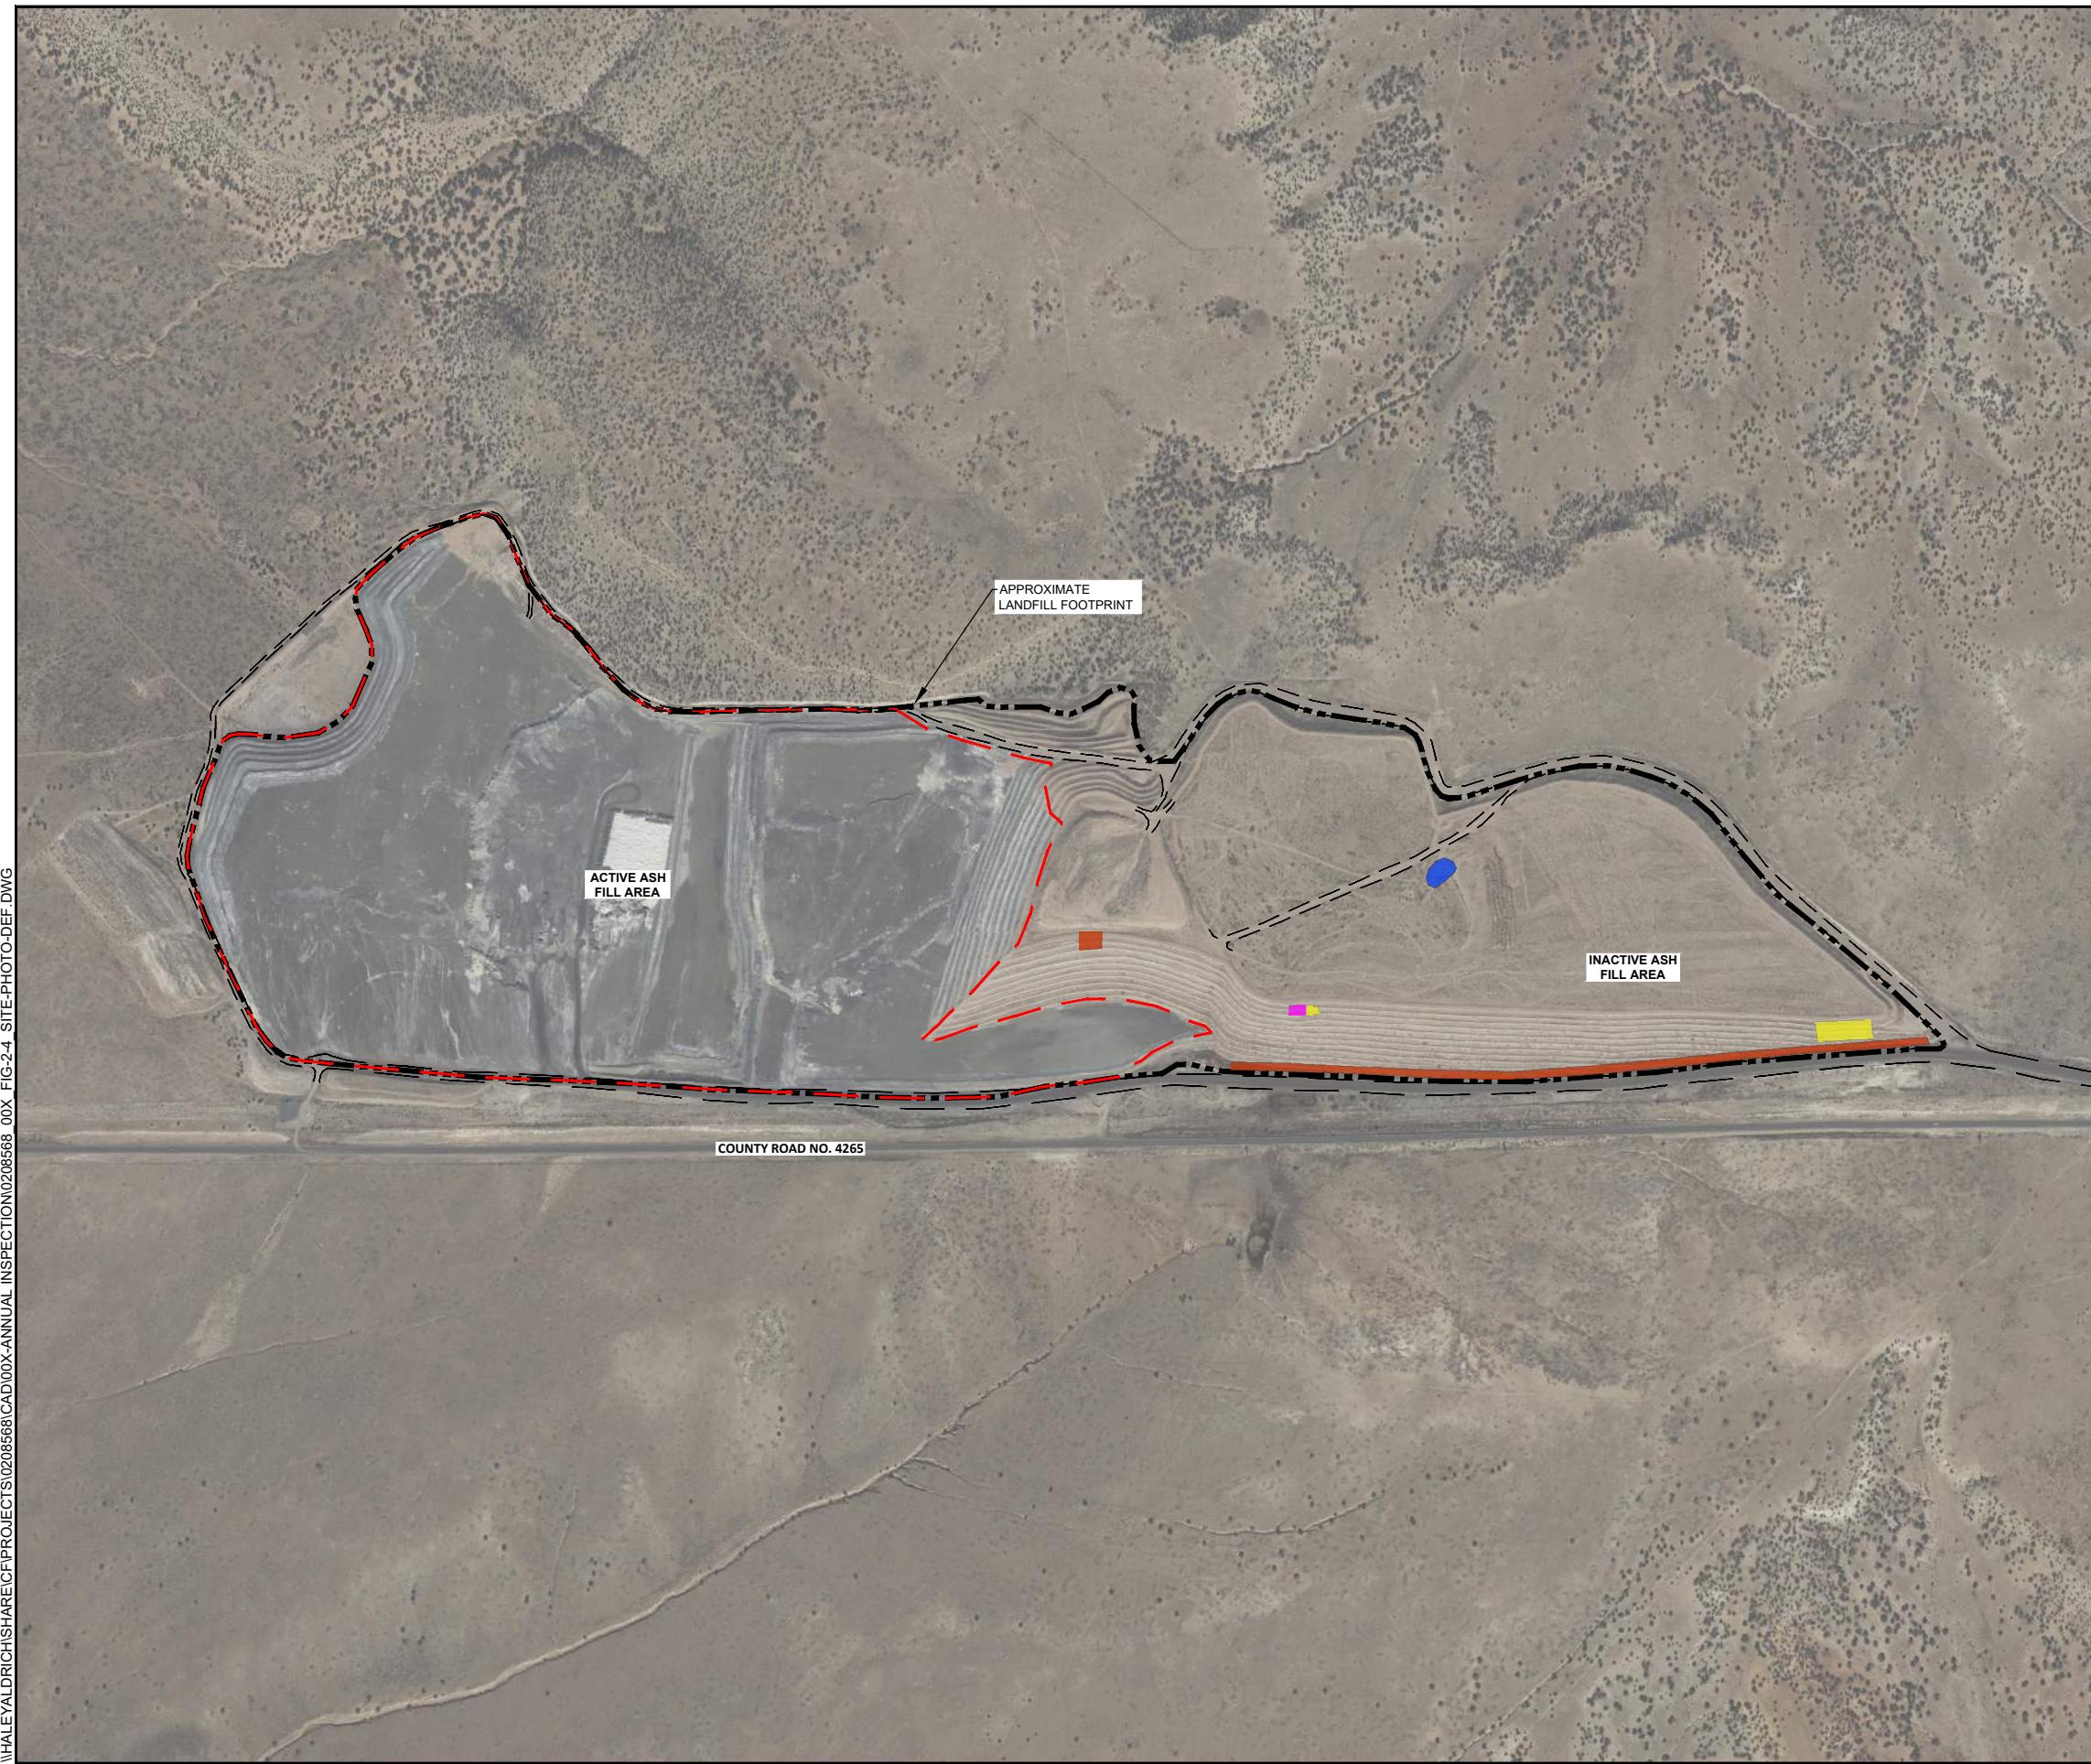
FIGURE 4

Animal burrows and small holes were observed along the outer edges of the southern benches. In a few areas, larger burrows were identified, but upon closer review the burrow did not reach the underlying CCR. Relatively shallow erosion rills were observed along outer slopes, while areas with deeper erosion rills noted in previous reports were observed to have been repaired. Several erosion rills were noted as being repaired by TEP prior to our on-site inspection.

Overall, little to no erosion rills were observed along the eastern and northern slopes of the landfill, which were noted to consist of shorter and more uniform slopes with denser vegetation. No signs of major slope instability or stress (e.g., misalignments, depressions, or bulging) were observed along any portion of the top deck or side slopes of the landfill. One location along an upper bench of the southern face appeared to have potential signs of minor cracking in the 2024 inspection. That same area was observed as part of the 2025 inspection, noting no identifiable change in conditions having occurred over the course of 2025. It is recommended that this location continue to be monitored for any change of condition in the future.

Overall, the landfill was observed to be stable and broadly consistent with recognized and generally accepted good engineering standards. No sinkholes or evidence of settlement were observed. We recommend continued observation of the identified isolated area of potential cracking along the south face upper bench of the inactive portion. Areas of minor erosion were observed at locations along the south and southwestern benches of the landfill, as noted in **Section 2.1.1.2** and shown in **Figure 4**.

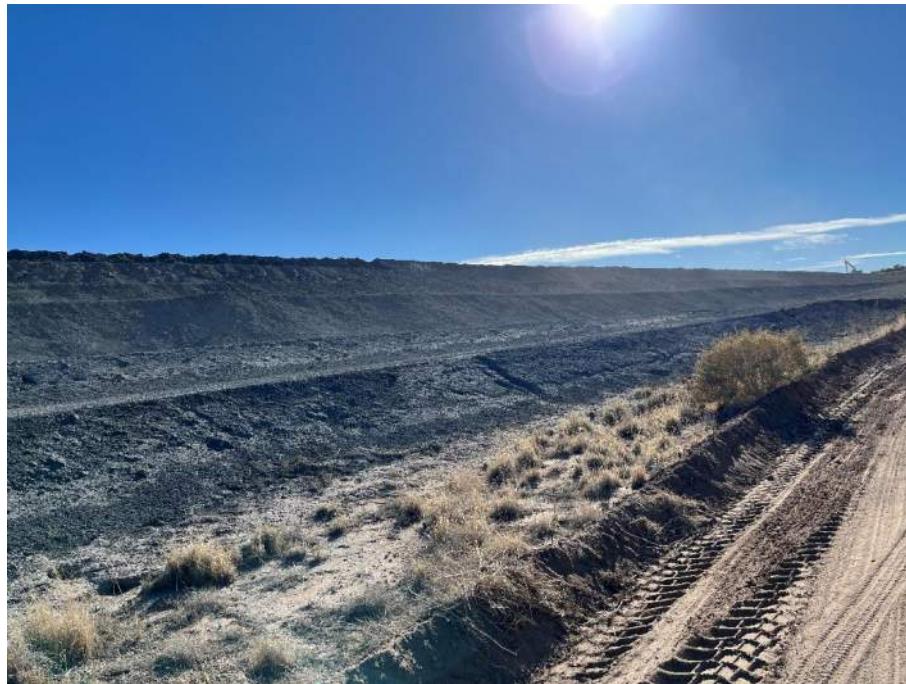
Photo 1

West face of the Active Ash Fill Area on the west side of the landfill; facing southeast

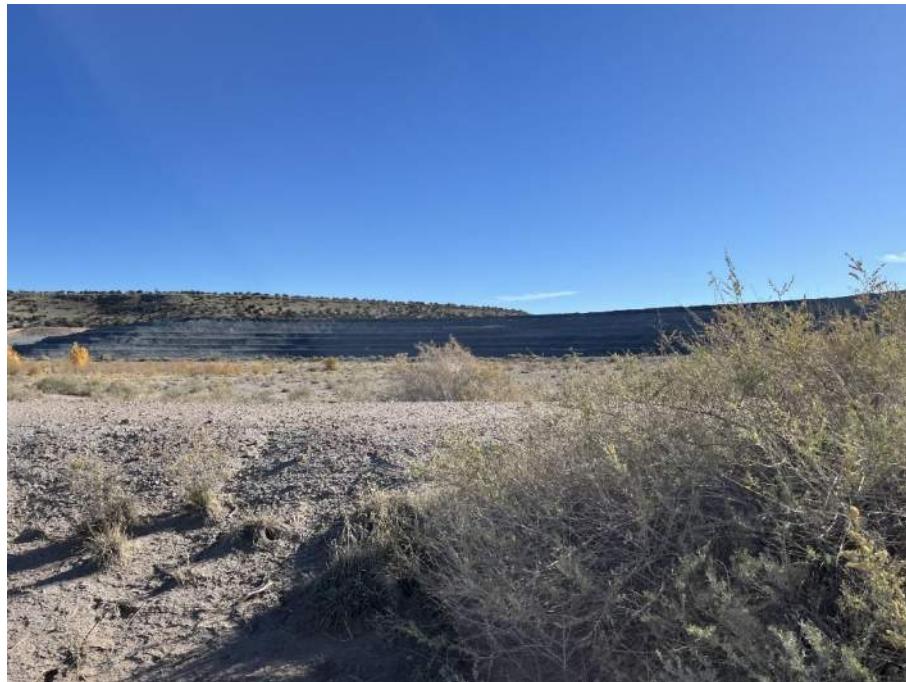
Photo 2

Typical Conditions in Retention Structure No. 3 area and along Active Ash Fill Area benches on the northwest side of the landfill; facing northeast

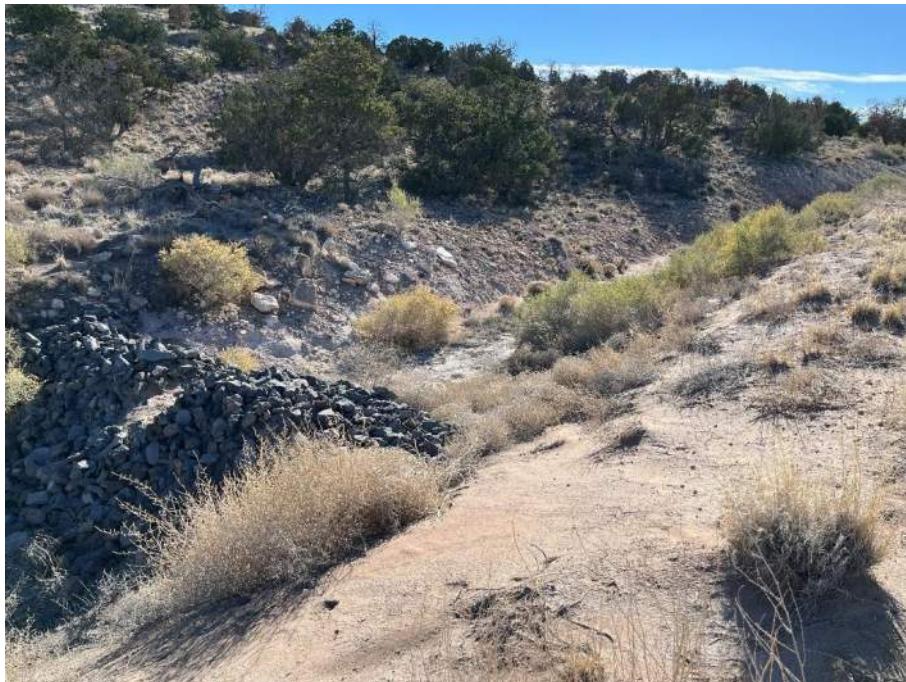
Photo 3

During the site inspection, northern drainage channels were observed also focusing on inspection observations from the 2024 annual inspection. Haley & Aldrich observed the regrading of the channels and installation of rock check dams to control any sediment. These structures were intact and appeared to be functioning as intended.

Rock check dam in the north perimeter drainage ditch; facing southwest

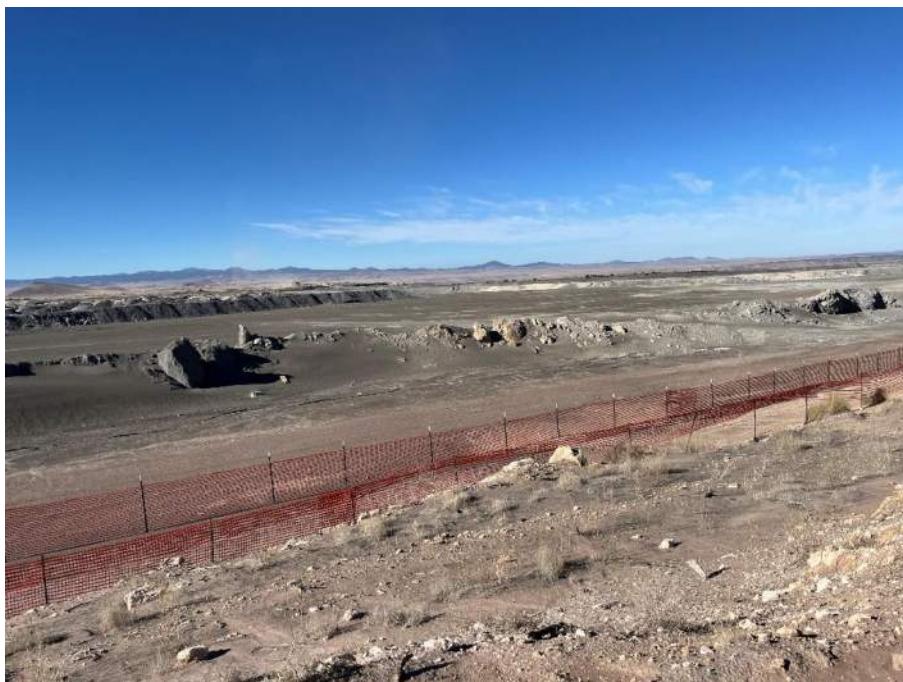
Photo 4

Typical condition of Active Ash Fill Area and erosion and sediment controls (e.g., orange construction fence); facing west

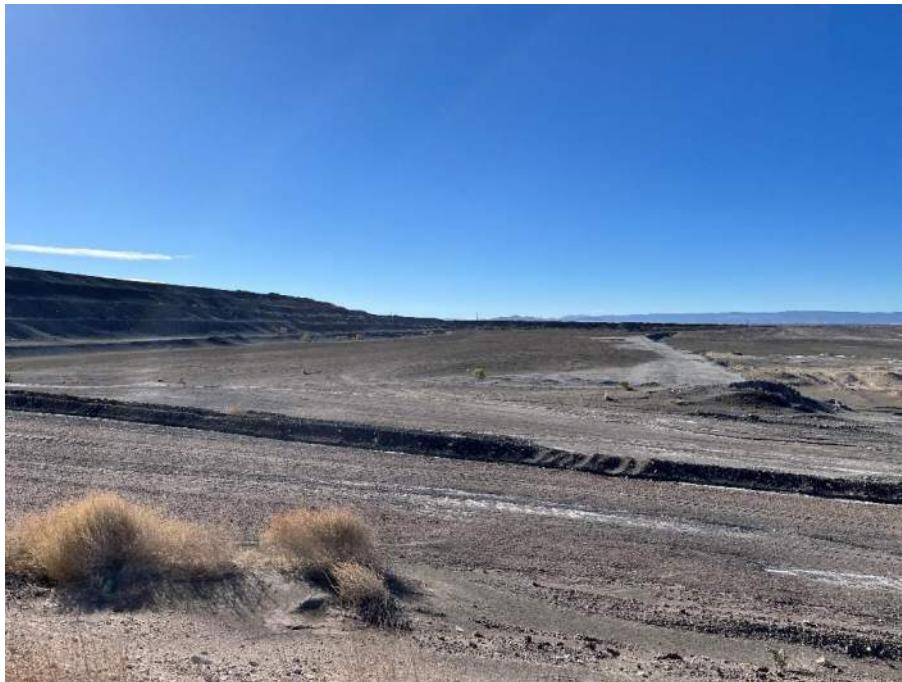
Photo 5
Typical conditions of Active Ash Fill Area; facing southeast

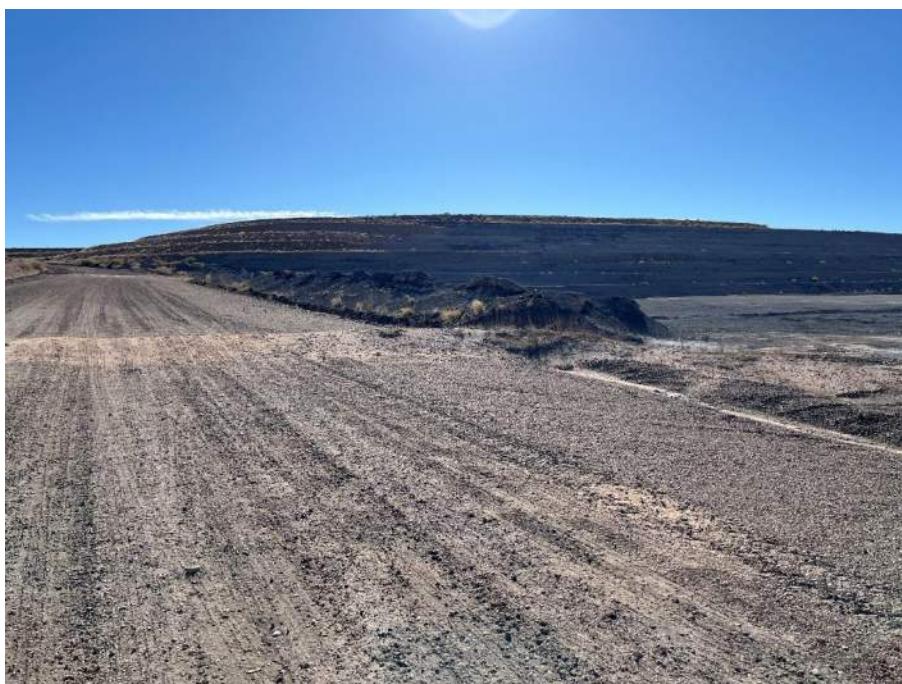
Photo 6
Water bars along perimeter haul road, directing stormwater onto Active Fill Area; facing east

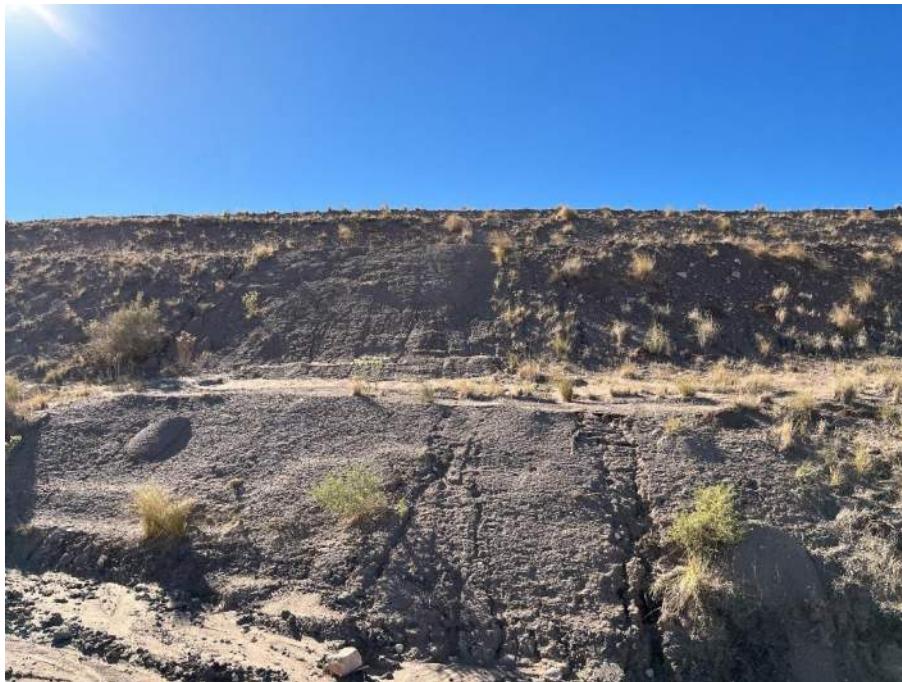
Photo 7

Repaired erosion gully on north side of Inactive Fill Area; facing south

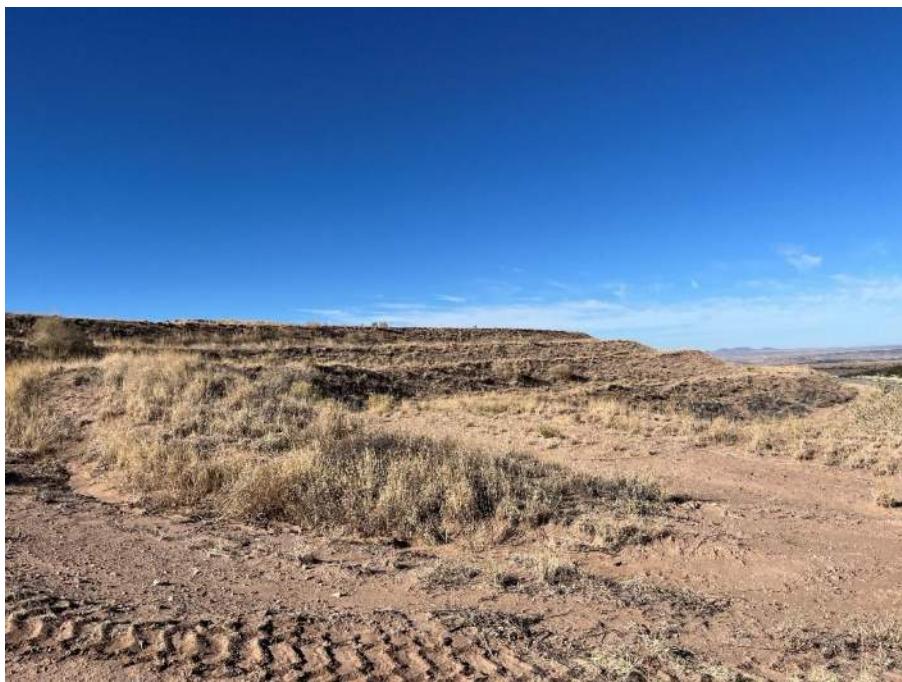
Photo 8

Typical condition of Inactive Fill Area benches; facing southwest

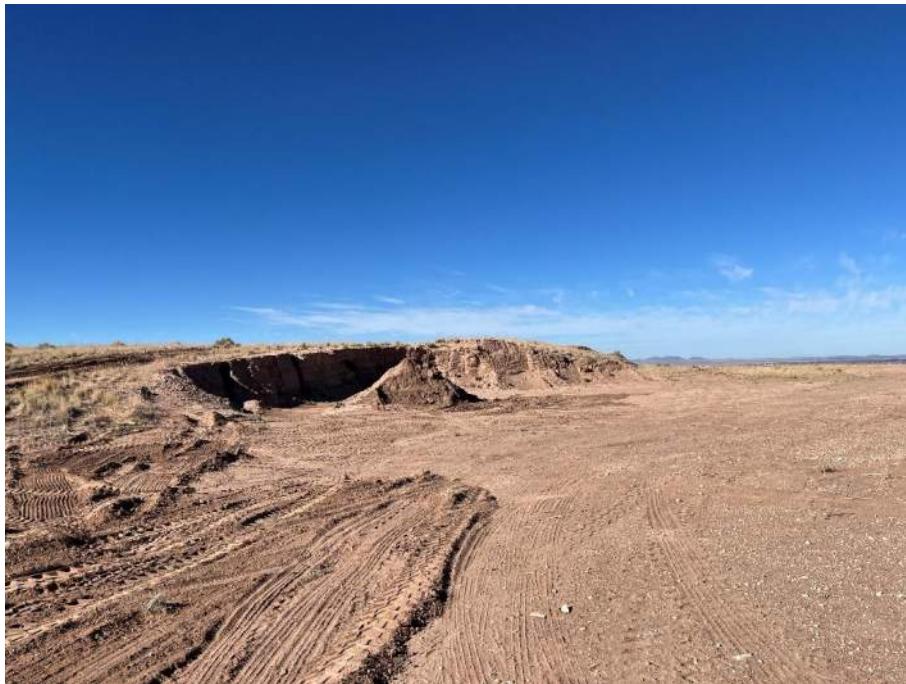
*Photo 9
Topsoil stockpile in western end of Inactive Fill Area; facing south*

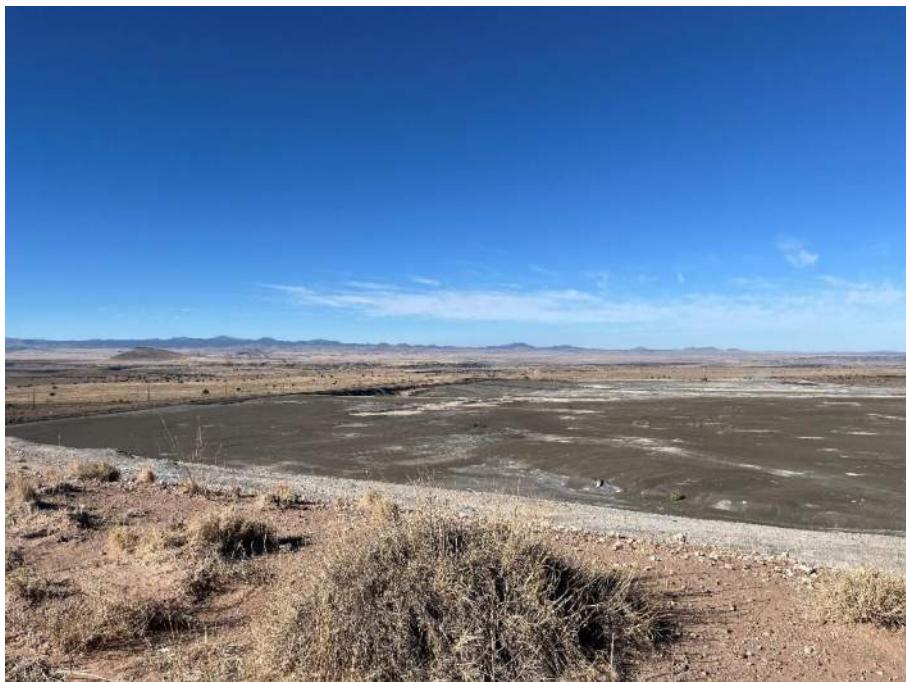
*Photo 10
View of the Active Fill Area from the top bench of the landfill; facing west*

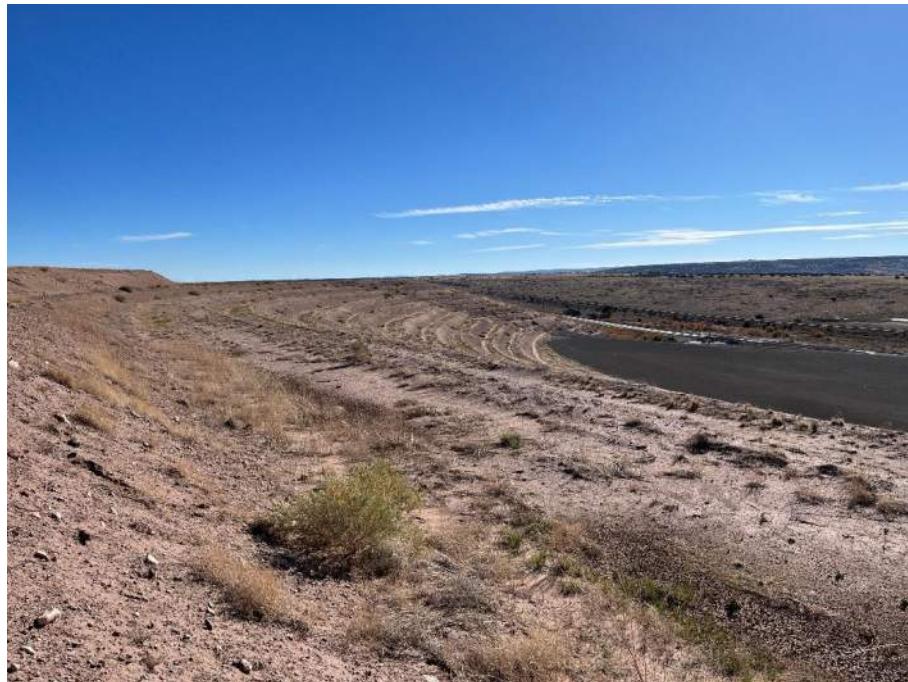
Photo 11
Typical condition of benches and side slopes of Inactive Fill Area; facing west

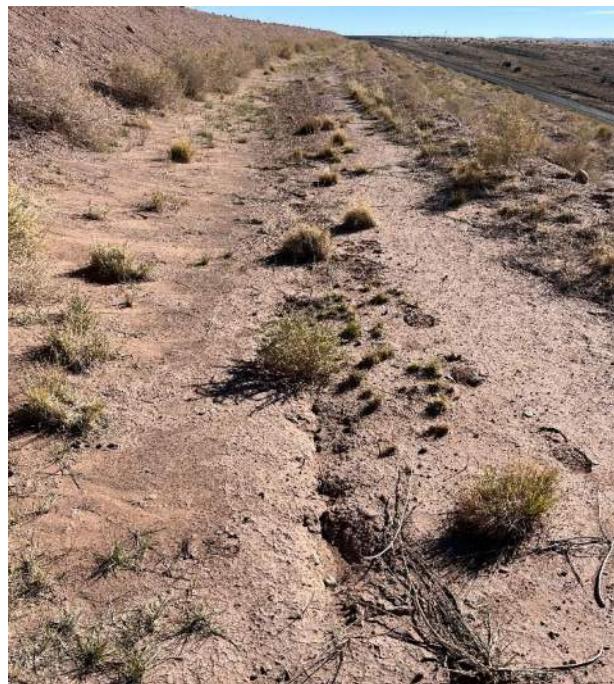
- Large active fill area requiring increased efforts to control fugitive dust and stormwater runoff;
 - One area of minor cracking along an upper bench that could be a sign of instability if observed to increase in length, width, or depth over time;

Photo 12
Cracks on the second bench from top; facing east

| <u>Landfill Inspection - Structural Stability</u> | | | | |
|---|---|---|---|---|
| Is there evidence of surface cracking at top of ash fill or along any slope benches? | Evidence of localized, minor surface cracking exists at upper bench along south face of Inactive Ash Fill Area. Monitor and repair if changes observed. | | X | |

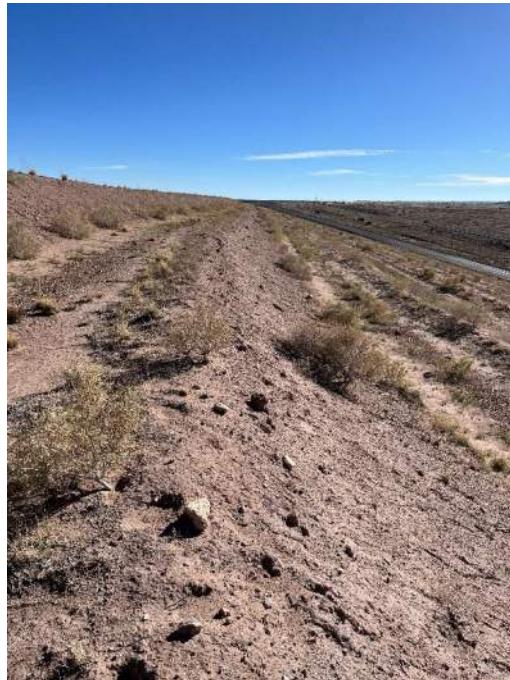
*Photo 13
Animal burrows on the slopes; facing east*

| <u>Landfill Inspection - Structural Stability</u> | | | | |
|---|---|---|---|---|
| Is there evidence of sinkholes or animal burrows? | Evidence of small animal burrows at crests of benches along soil cover of southern slopes. Monitor and repair, as needed. | | X | |

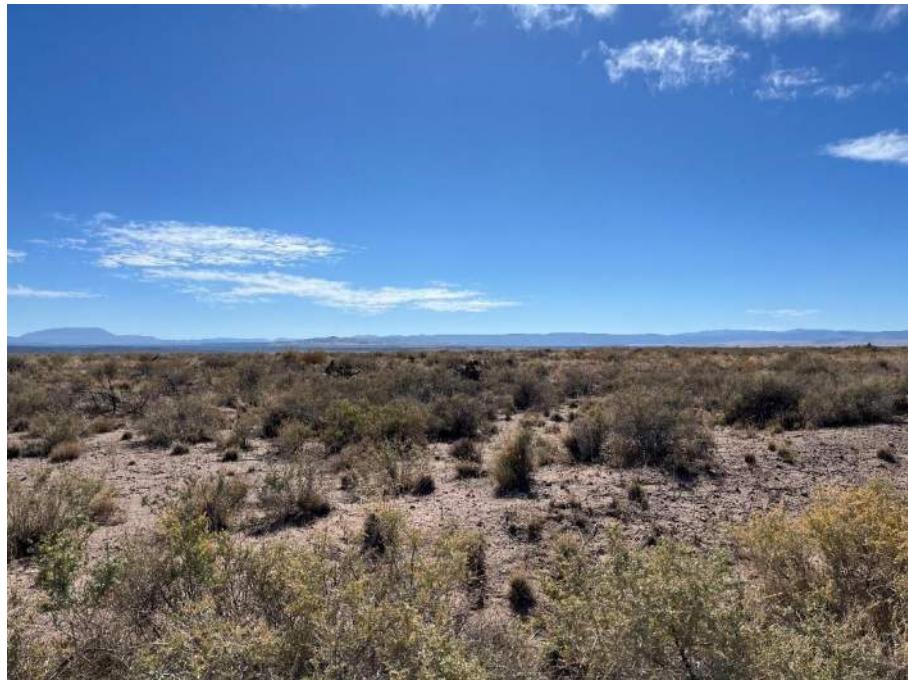
*Photo 14
Typical conditions on top deck of landfill; facing south*

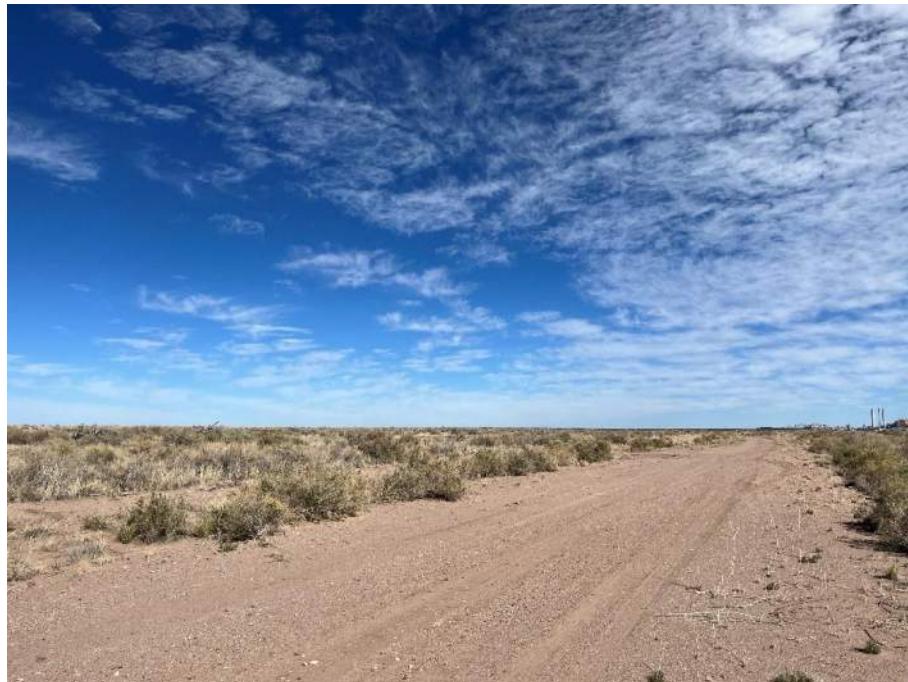
Photo 15
Typical condition of access road on top of the landfill; facing northeast

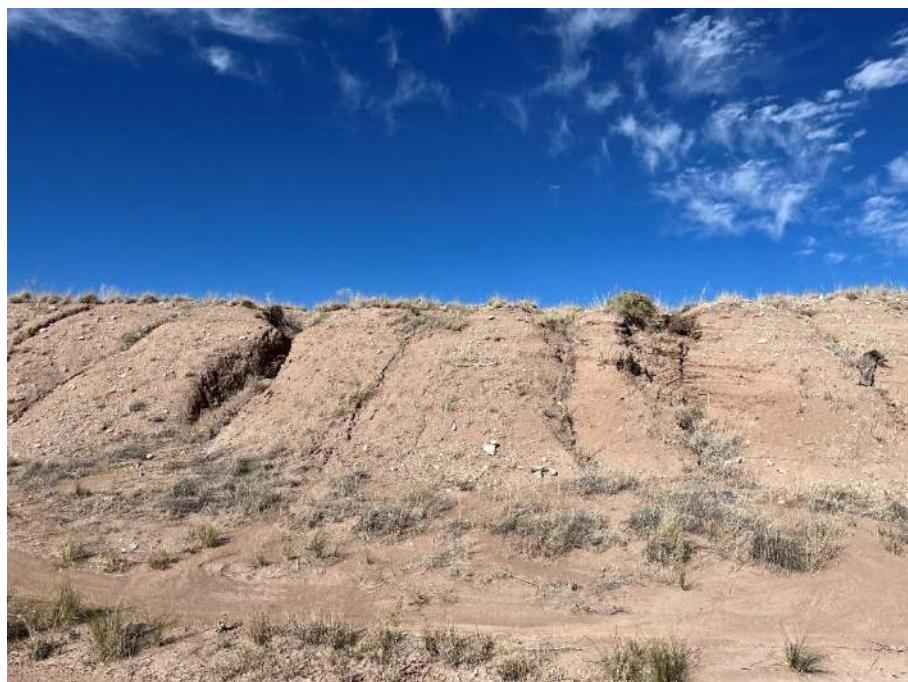
Photo 16
Deep erosion gullies on the slope; facing north

| <u>Landfill Inspection - Structural Stability</u> | | | | |
|---|---|---|---|---|
| Is there evidence of erosion on fill slopes or inactive landfill areas? | Only minor erosion rills observed in Inactive Fill Area. | | X | |

- Re-evaluate landfill operations for potential improvements associated with the ongoing CCR placement activities and long-term closure planning, with considerations such as, but not limited to:
 - reduced active footprint with exposed CCR materials,
 - modified side slopes and benching configuration for increased stability of interim and future final cover systems, and
 - reduced potential for stormwater ponding within the landfill waste boundary.
- Monitor surface cracking (e.g., along southern upper bench of the Inactive Fill Area) for any changes in size, shape, or extent. If cracking significantly changes or worsens, consult qualified geotechnical engineer for further assessment of landfill structural stability and conditions.
- Continue to monitor erosion of the southern slopes and implement repairs of rills and gullies that exceed 12 inches in depth.

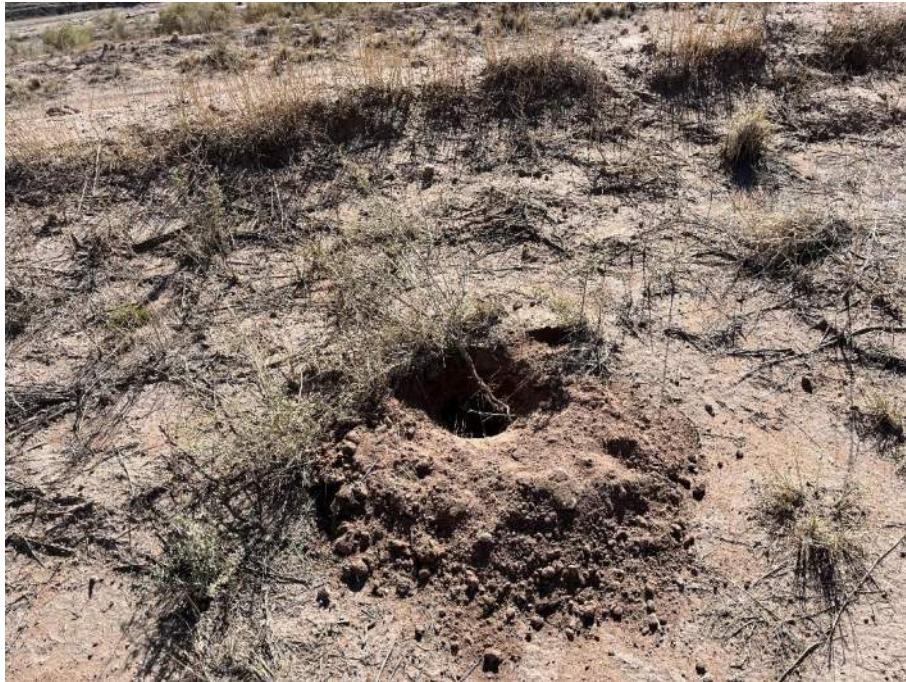
*Photo 17
Animal burrows in the Inactive Fill Area; looking down*

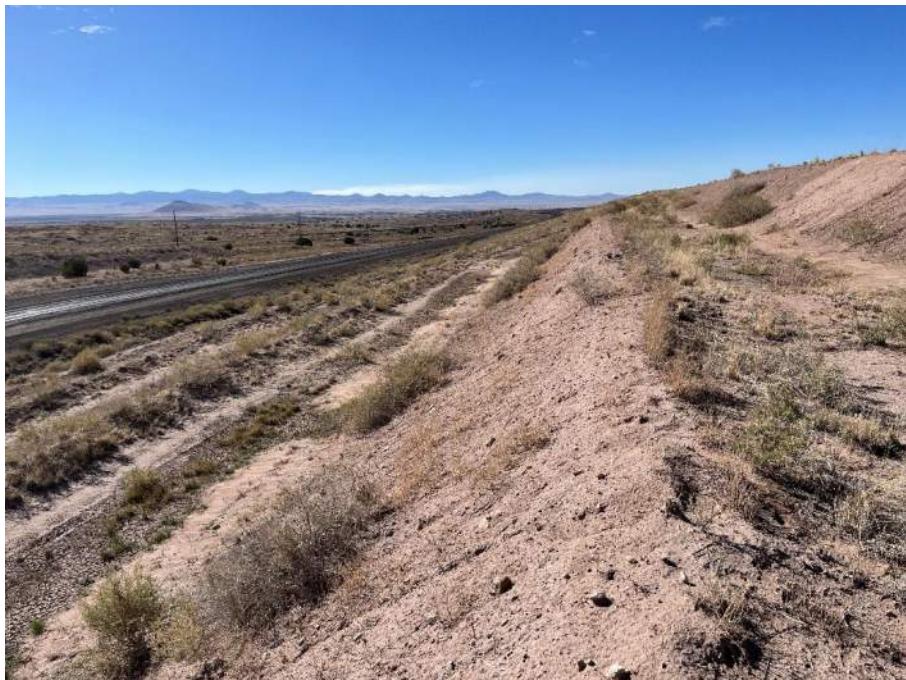
*Photo 18
Typical conditions of bench and south slope of Inactive Fill Area; facing west*

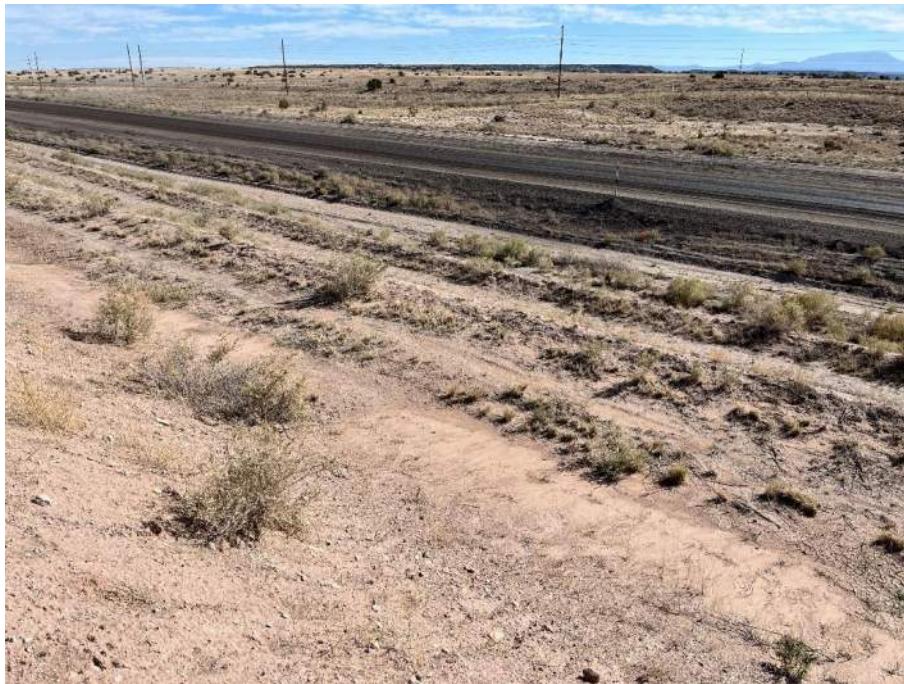
*Photo 19
Typical conditions of bench and slopes along the Ash Haul Road; facing south*

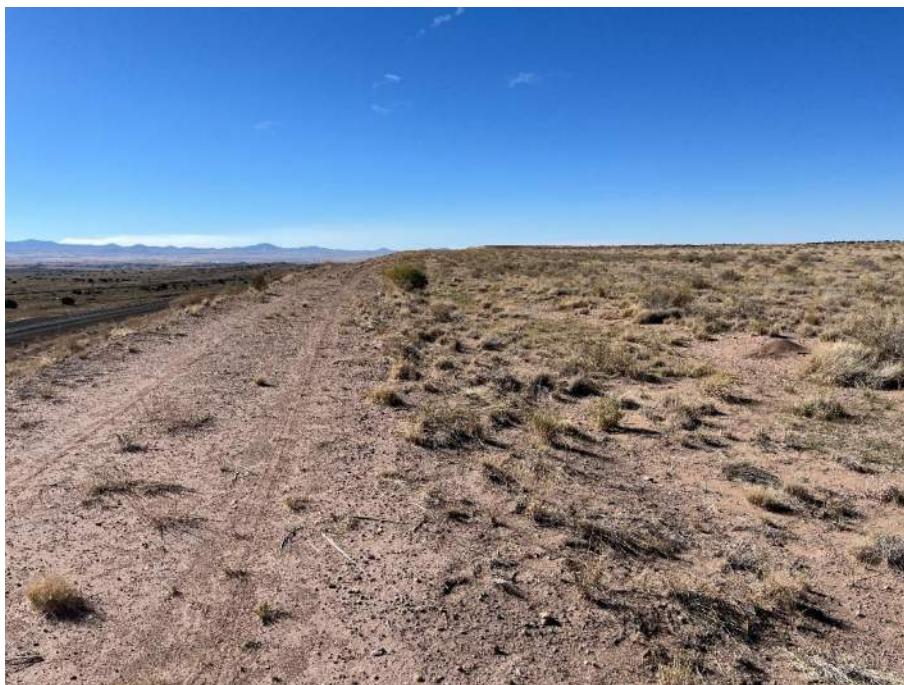
*Photo 20
Typical conditions along outer edge of the top bench of the landfill; facing west*

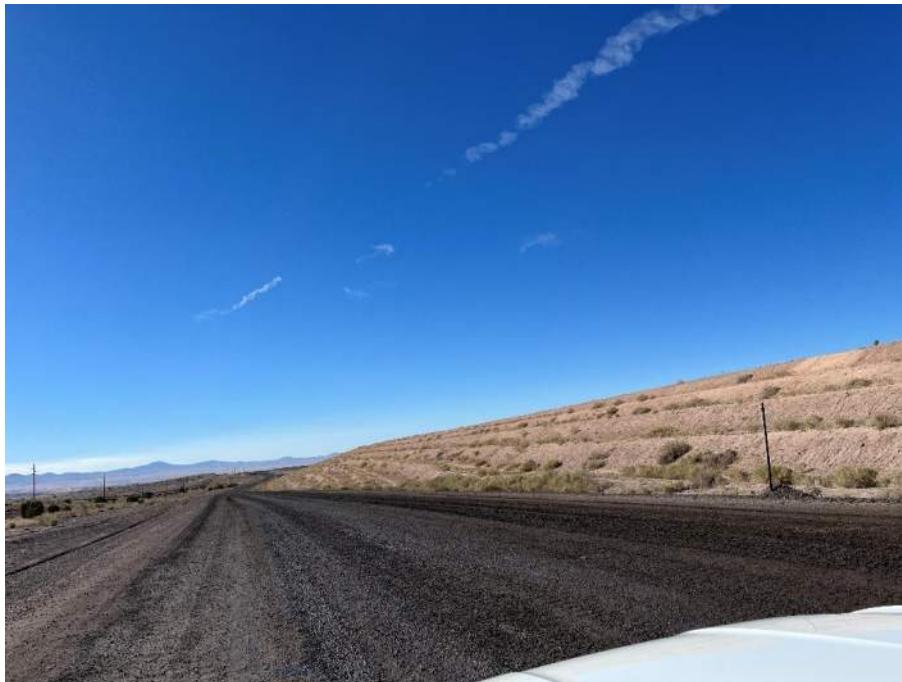
*Photo 21
Typical condition of Ash Haul Road; facing west*

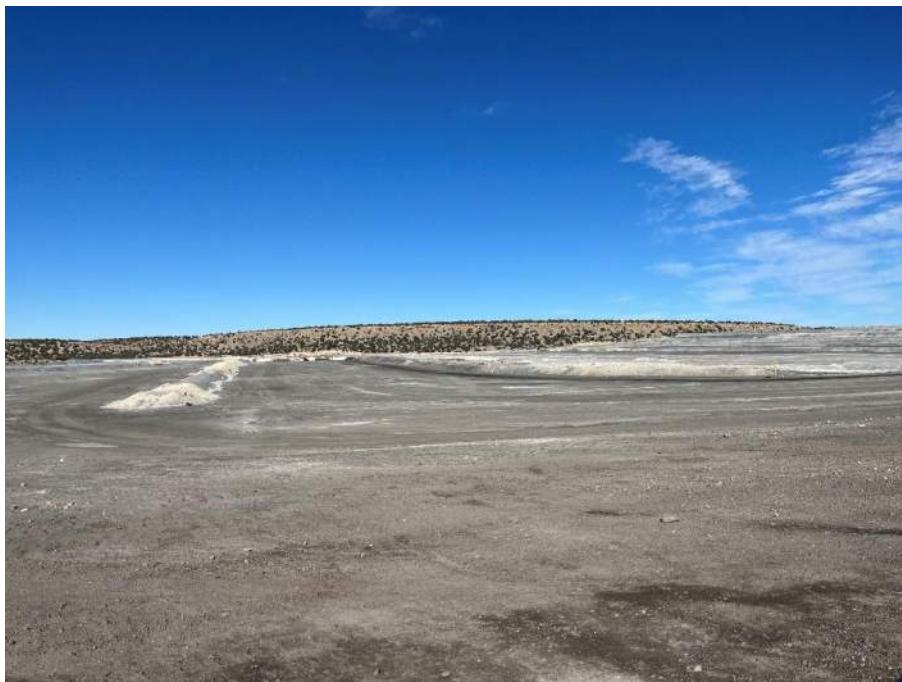
*Photo 22
Typical condition of the Active Fill Area; facing north*

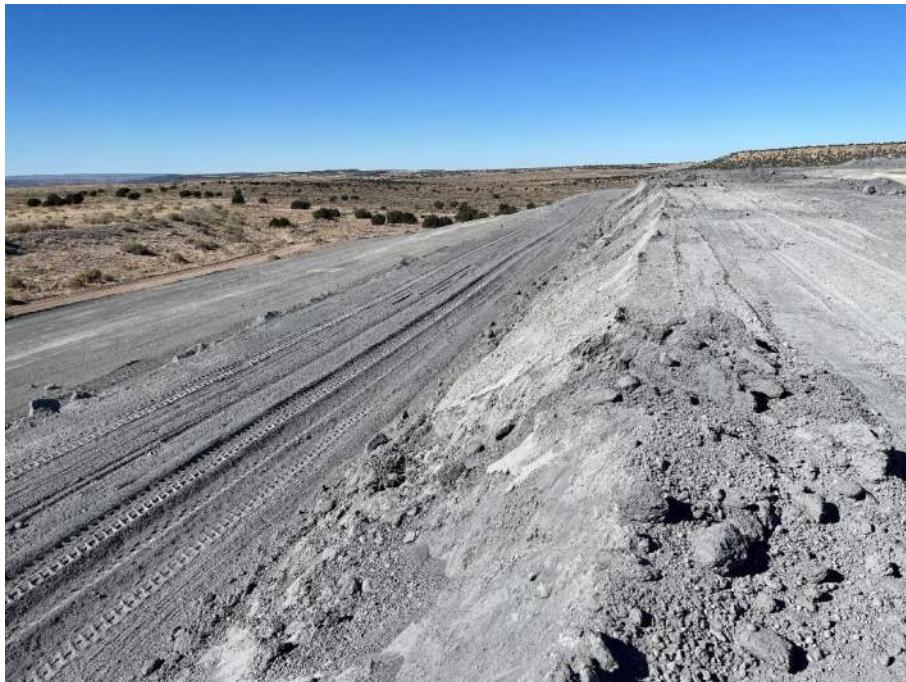
*Photo 23
Outer edge of the Active Ash Fill Area; facing north*

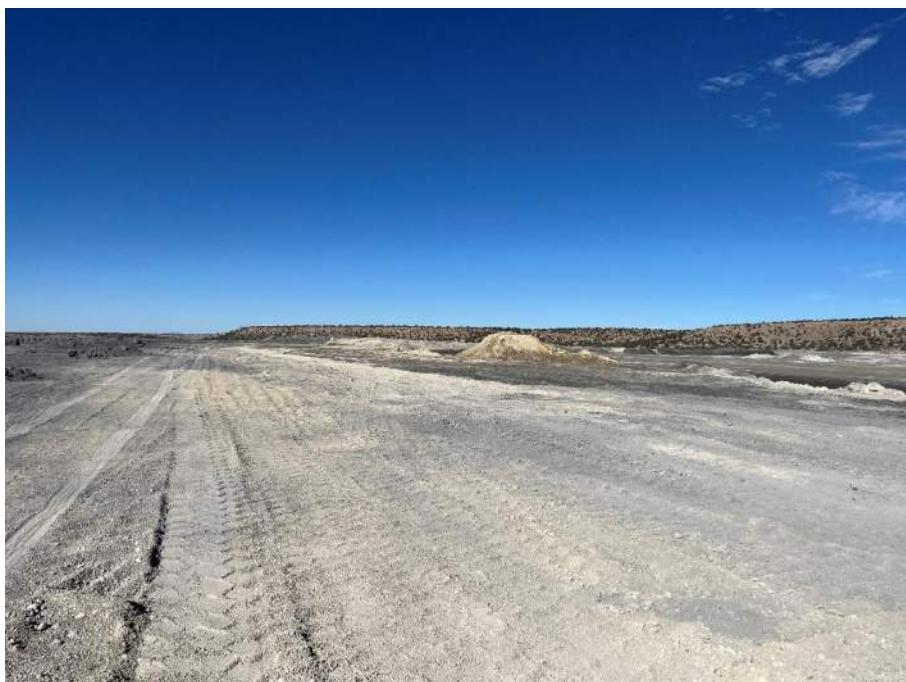
*Photo 24
Typical condition of Active Ash Fill Area on the southwest portion of the landfill; facing north*
