INITIAL INSPECTION REPORT
ASH LANDFILL AREA
SPRINGERVILLE GENERATING STATION
SPRINGERVILLE, ARIZONA

Prepared for
Tucson Electric Power Company

January 19, 2016

**Initial Annual Inspection Report
Ash Landfill Area
Springerville Generating Station
Springerville, Arizona**

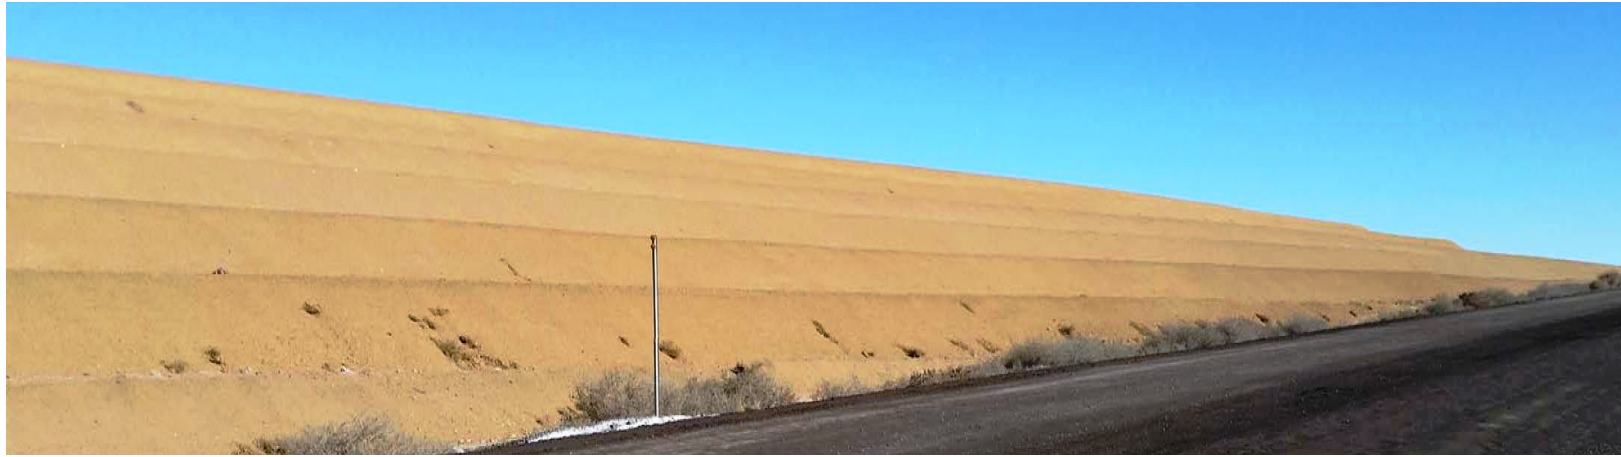
PHOTOGRAPH 1.

Ash Landfill with soil cover and hydroseeded soil cover on slopes. View looking Southwest to Northeast.

TEP has applied a soil cover over the inactive areas of the landfill that is at least 2 feet in thickness. This soil cover has been hydroseeded to accommodate the growth of native plants/species that will assist in erosion control. Site photographs depicting the soil cover at the site are presented in **Appendix A**.

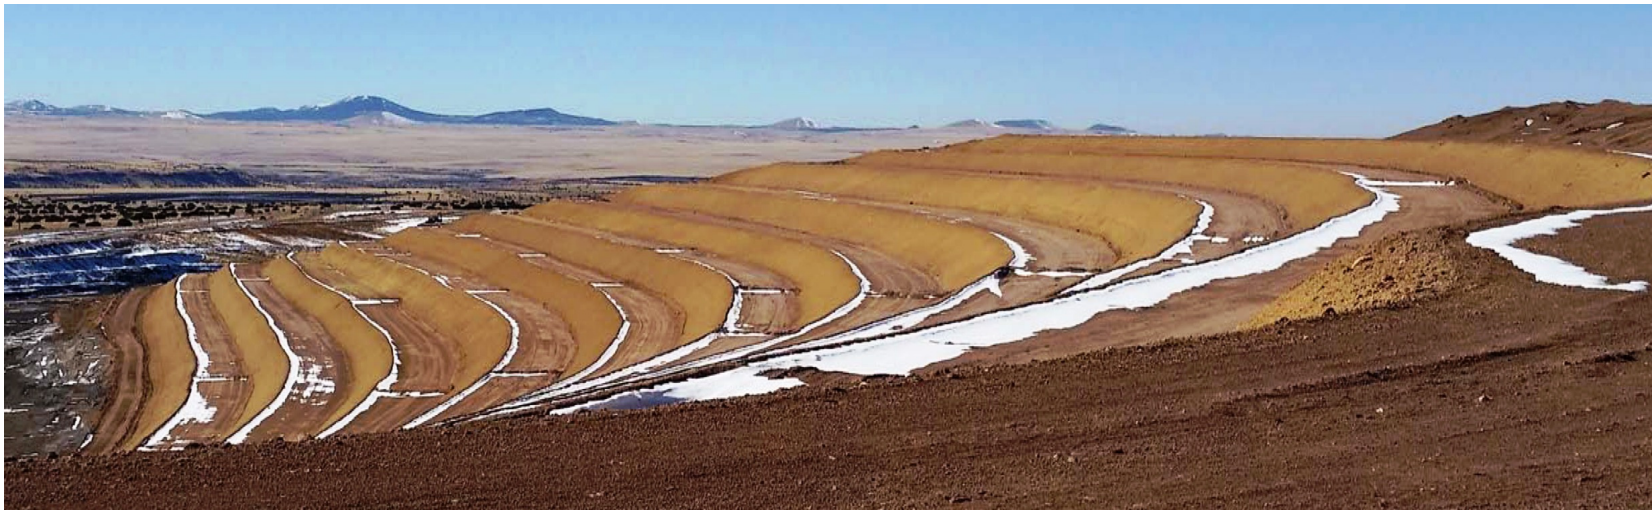
PHOTOGRAPH 2.

Ash Landfill with soil cover and hydroseeded soil cover on slopes. View looking East to West.
