ANNUAL INSPECTION REPORT
ASH LANDFILL AREA
SPRINGERVILLE GENERATING STATION
SPRINGERVILLE, ARIZONA

Prepared for
Tucson Electric Power Company

January 18, 2017

Project No. 1004.06

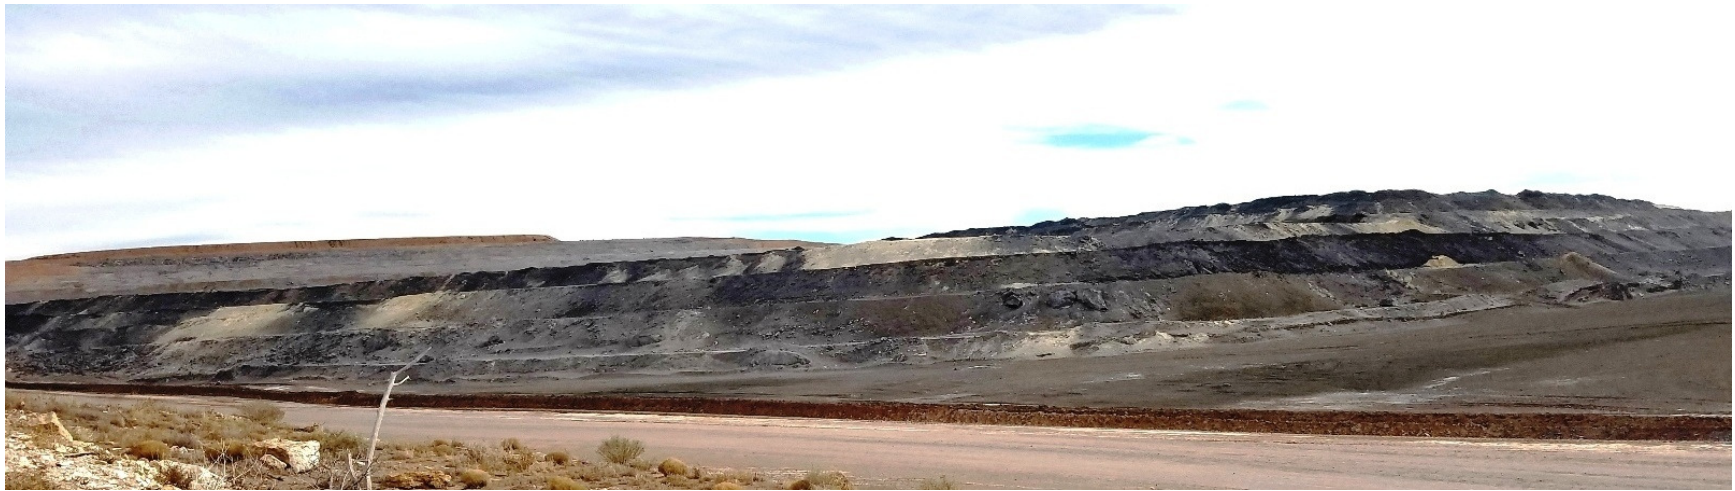
PHOTOGRAPH 1.

Ash Landfill working face showing ash/waste benches. View looking from Northwest to Southeast.

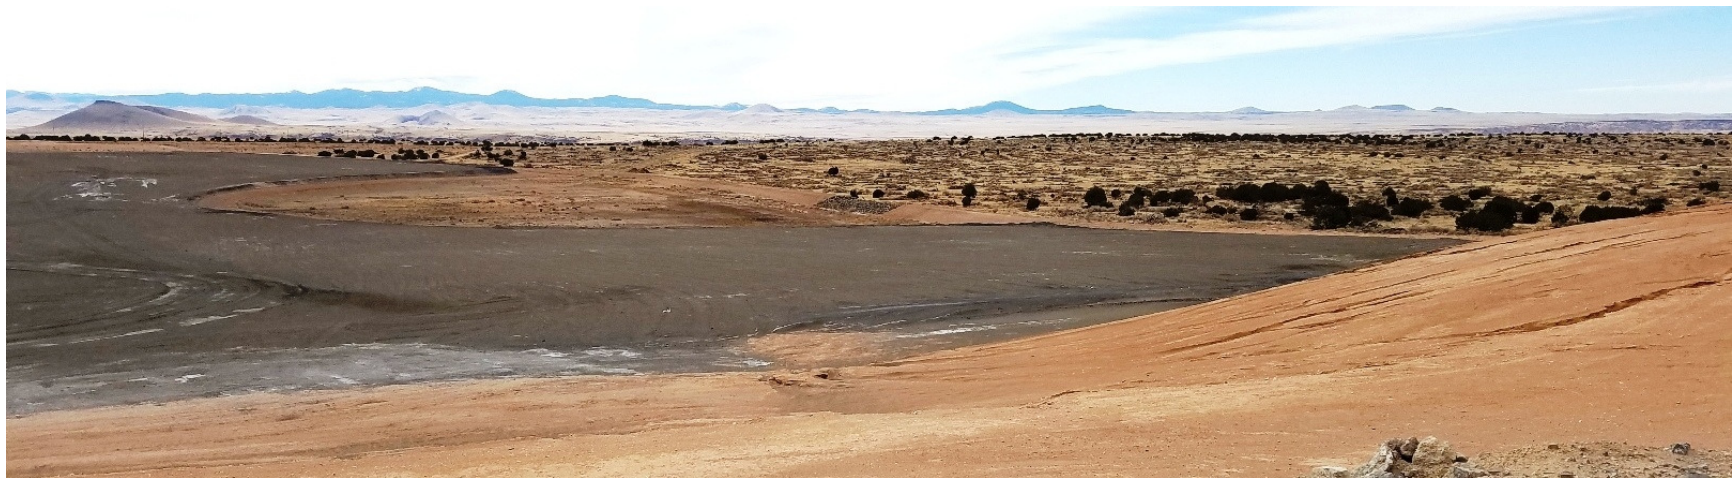
PHOTOGRAPH 2.

West end of the Ash Landfill showing a portion of the keyway, runoff retention area, and runoff retention area dam. View looking Northeast to Southwest.
