ANNUAL INSPECTION REPORT
ASH LANDFILL AREA
SPRINGERVILLE GENERATING STATION
SPRINGERVILLE, ARIZONA

Prepared for
Tucson Electric Power Company

January 18, 2022

Prepared by
AMTECH Associates, L.L.C.
8666 E. San Alberto Drive
Scottsdale, Arizona 85258

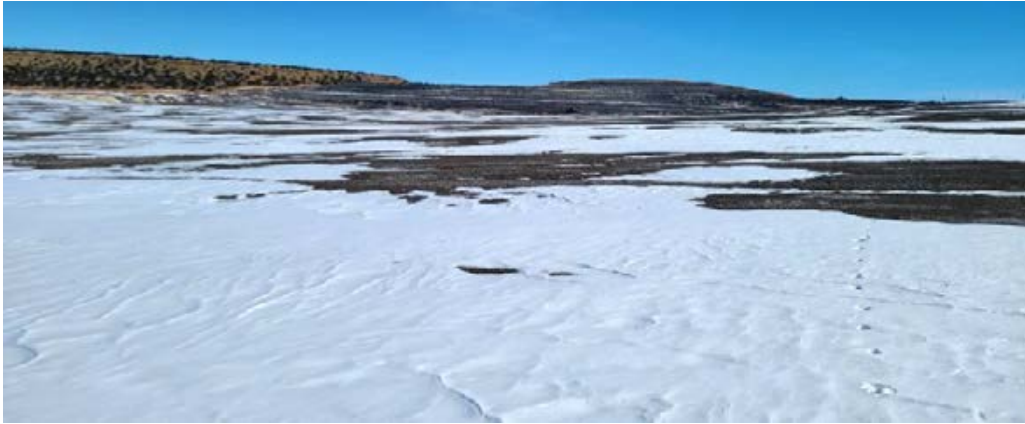
PHOTOGRAPH 1.

South area of the Ash Landfill showing ash/waste deposition. View looking from the Southwest to the Northeast.

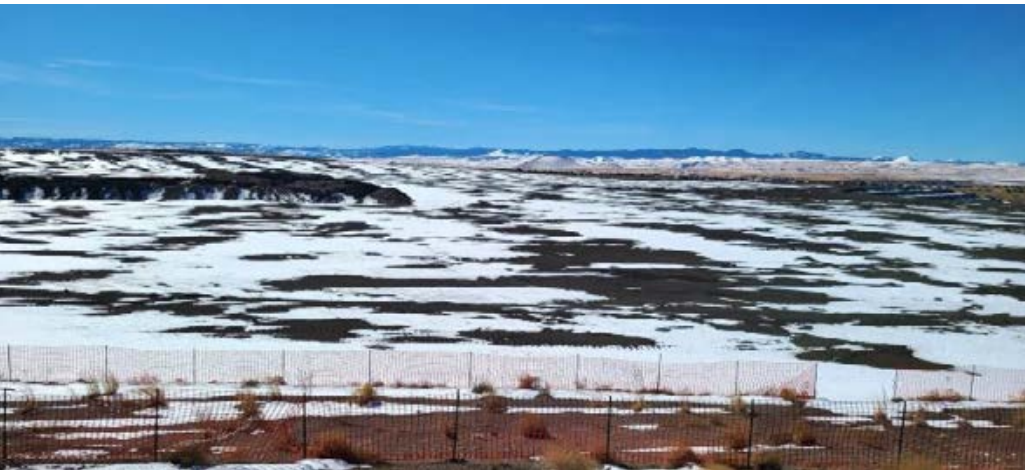
PHOTOGRAPH 2.

Also since the previous annual inspection, TEP installed silt fences along the north perimeter to retain wind-blown Ash material within the landfill boundary and away from the perimeter channel. As observed during the annual site inspection, there was no sign of any ash material migrating off the property boundary.

North area of the Ash Landfill. View looking from the North to the South. A portion of the Silt fences shown along the northern perimeter.

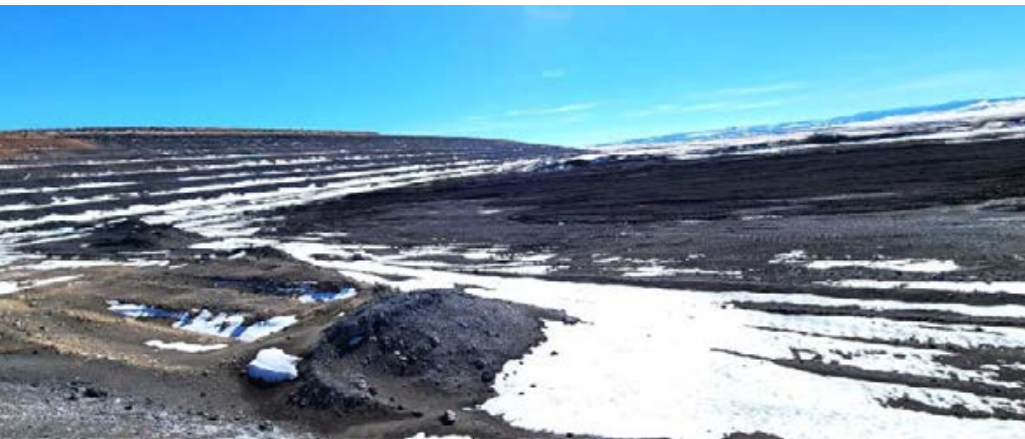
PHOTOGRAPH 3.

annual inspection, the current working face of 8-foot ash/waste lifts continues to be built out towards the west. Overall, the working face of the Ash Landfill was observed to be consistent in its grading and slopes, which would allow for a straightforward, immediate closure, if necessary.

West slope (current working face) of the Ash Landfill. View looking from the North to the Southeast.

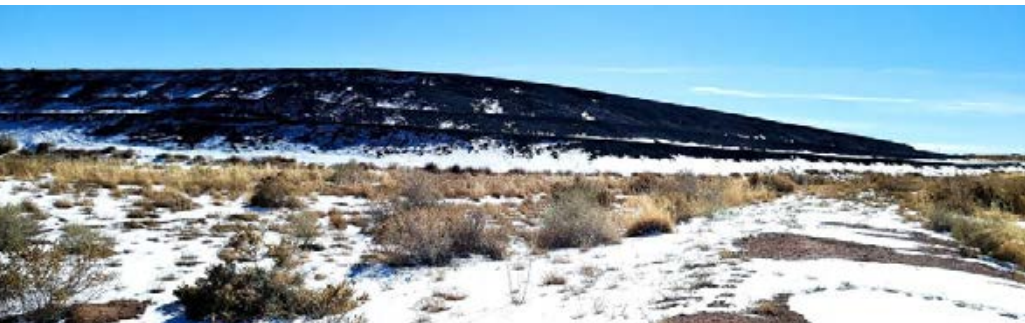
PHOTOGRAPH 4.

Since the previous annual inspection, ash material was placed in the west end of the Ash Landfill to create a keyway to anchor and provide a stabilized area for future deposition of ash/waste from the current working face to the west end. A few of the benches along the west end of the Ash Landfill were observed to be slightly inconsistent in bench height and width. TEP will correct the benches in order to maximize the volume in the west end of Ash Landfill. Correcting these bench areas will maximize the usable space in the existing Ash Landfill footprint and will prevent the need for expansion beyond the existing Ash Landfill footprint.

Benches on the West end of the Ash Landfill. View looking from the Northwest to the Southeast.
