Subject: 2025 Annual Inspection by a Qualified Professional Engineer
Ash Landfill, Springerville Generating Station
Springerville, Arizona

REPORT ON
2025 ANNUAL INSPECTION BY A QUALIFIED PROFESSIONAL
ENGINEER
ASH LANDFILL
SPRINGERVILLE GENERATING STATION
SPRINGERVILLE, ARIZONA

File No. 0213269
January 2026

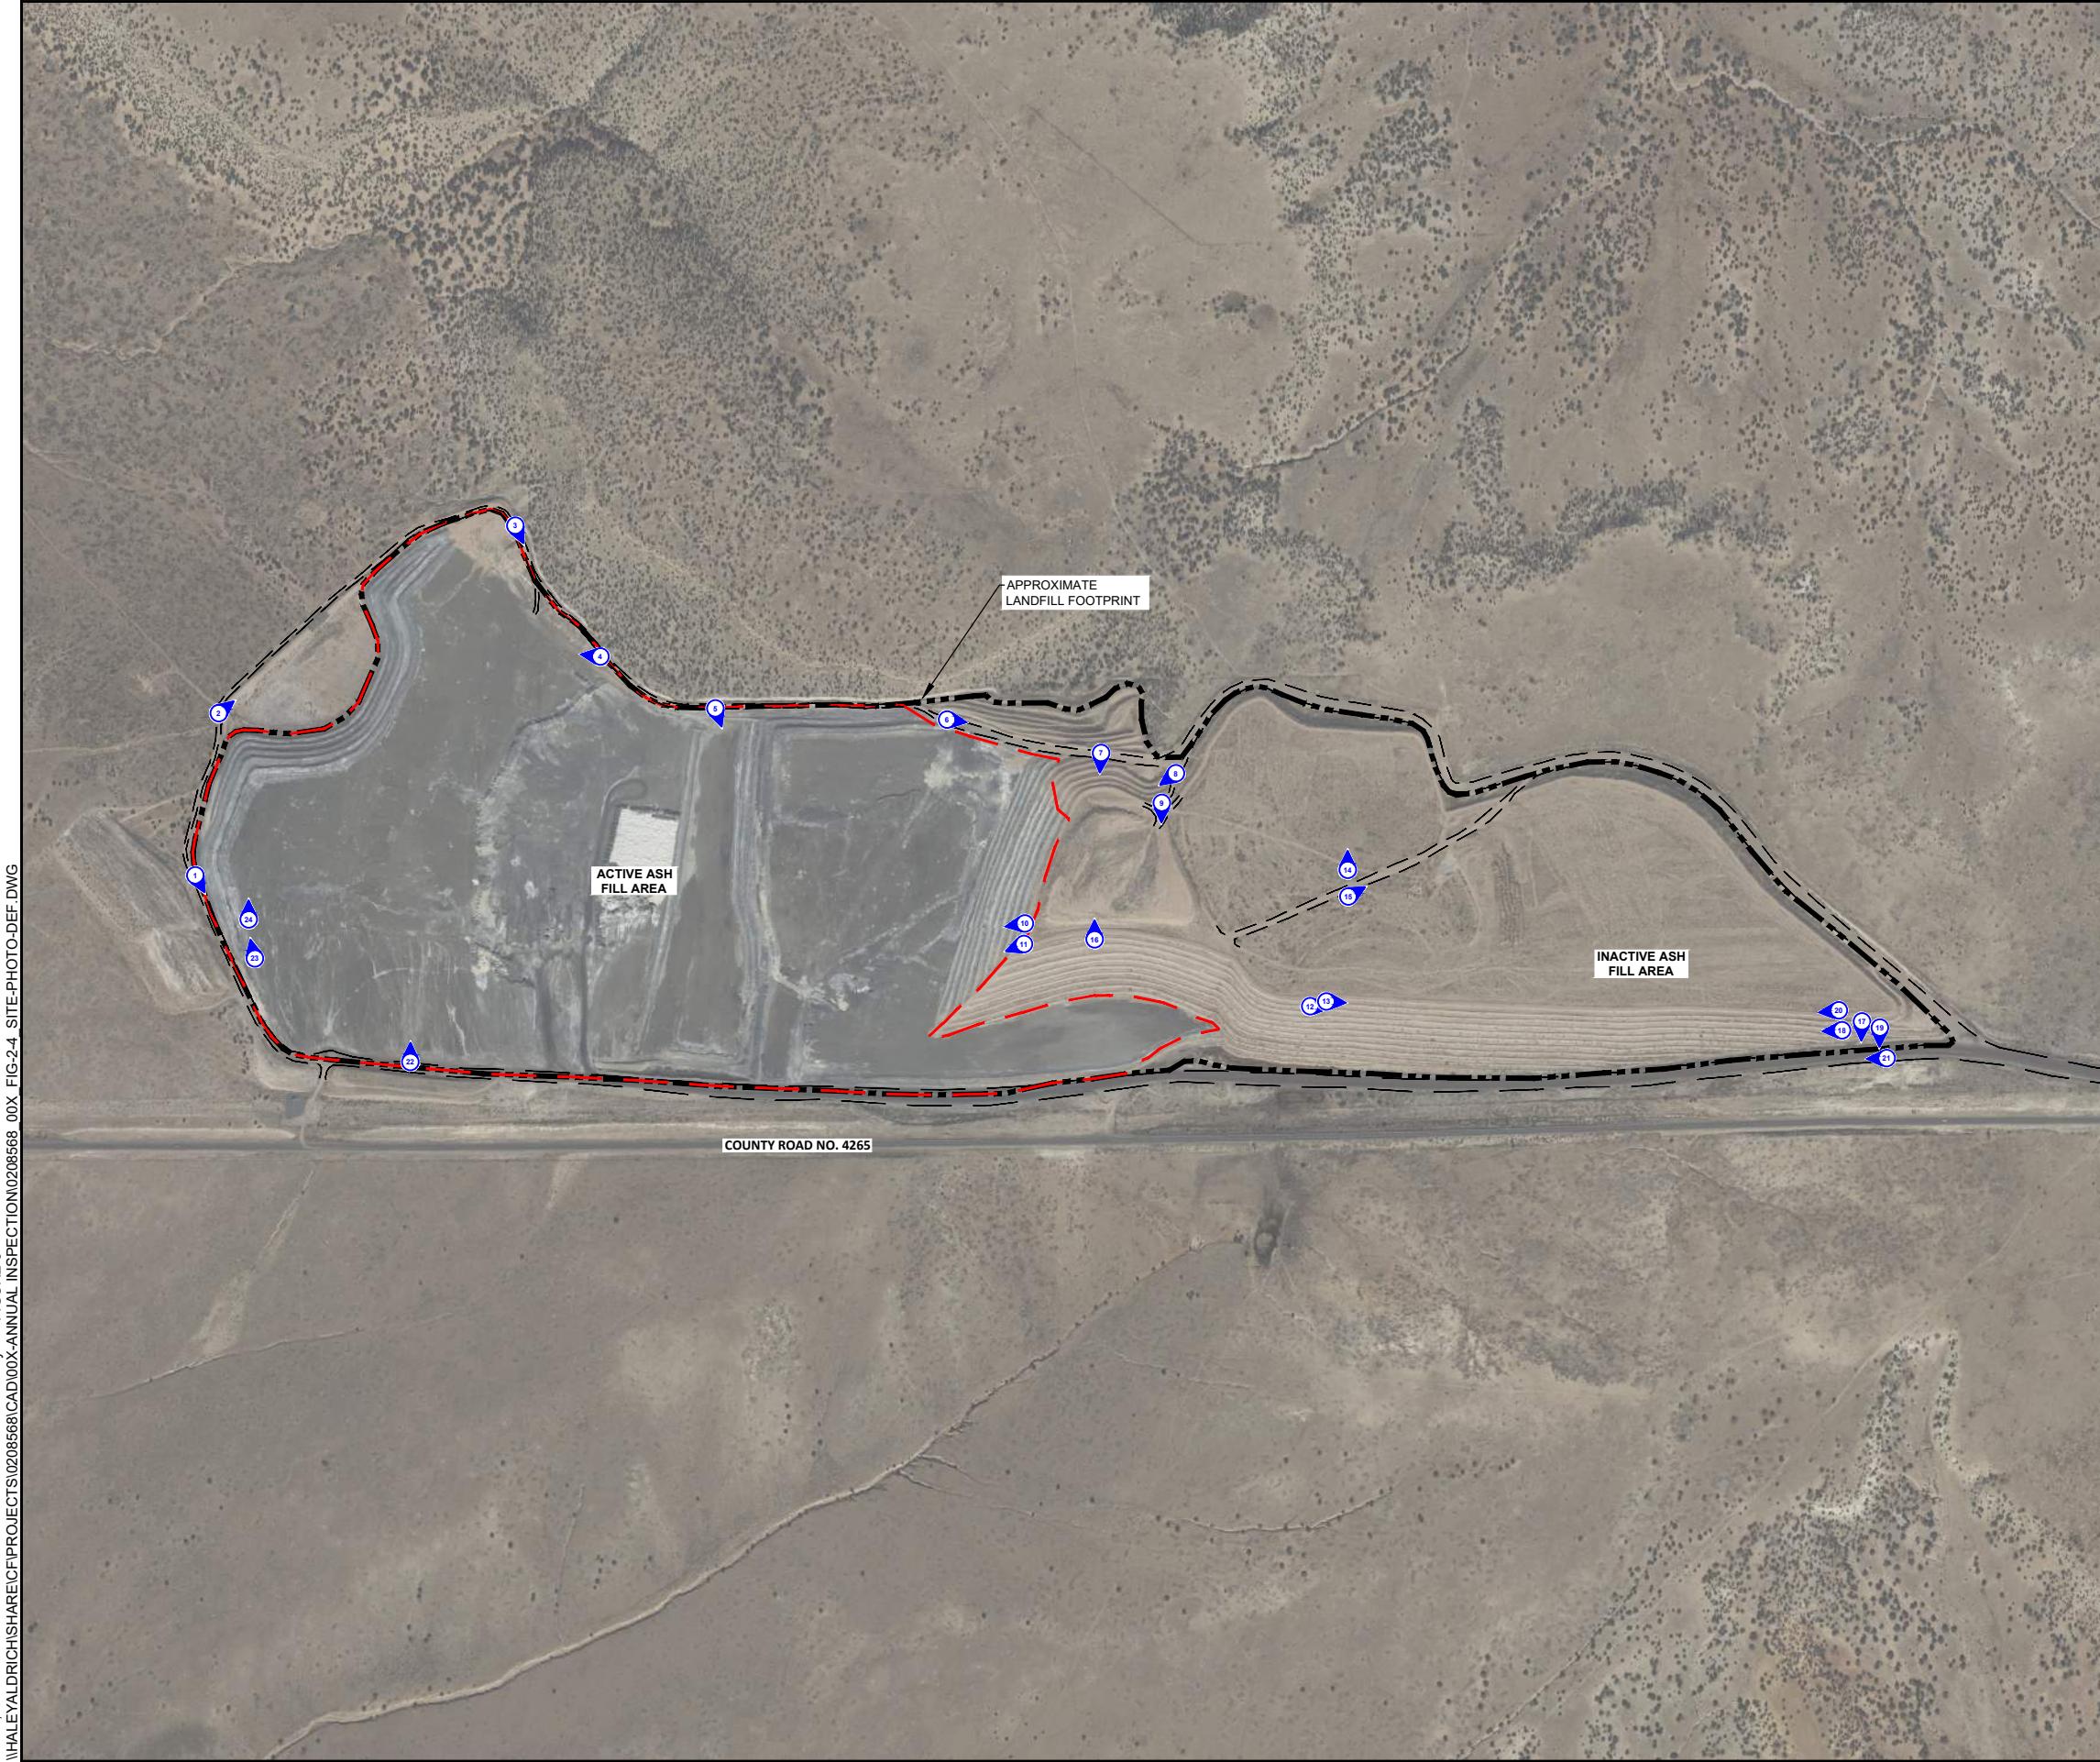
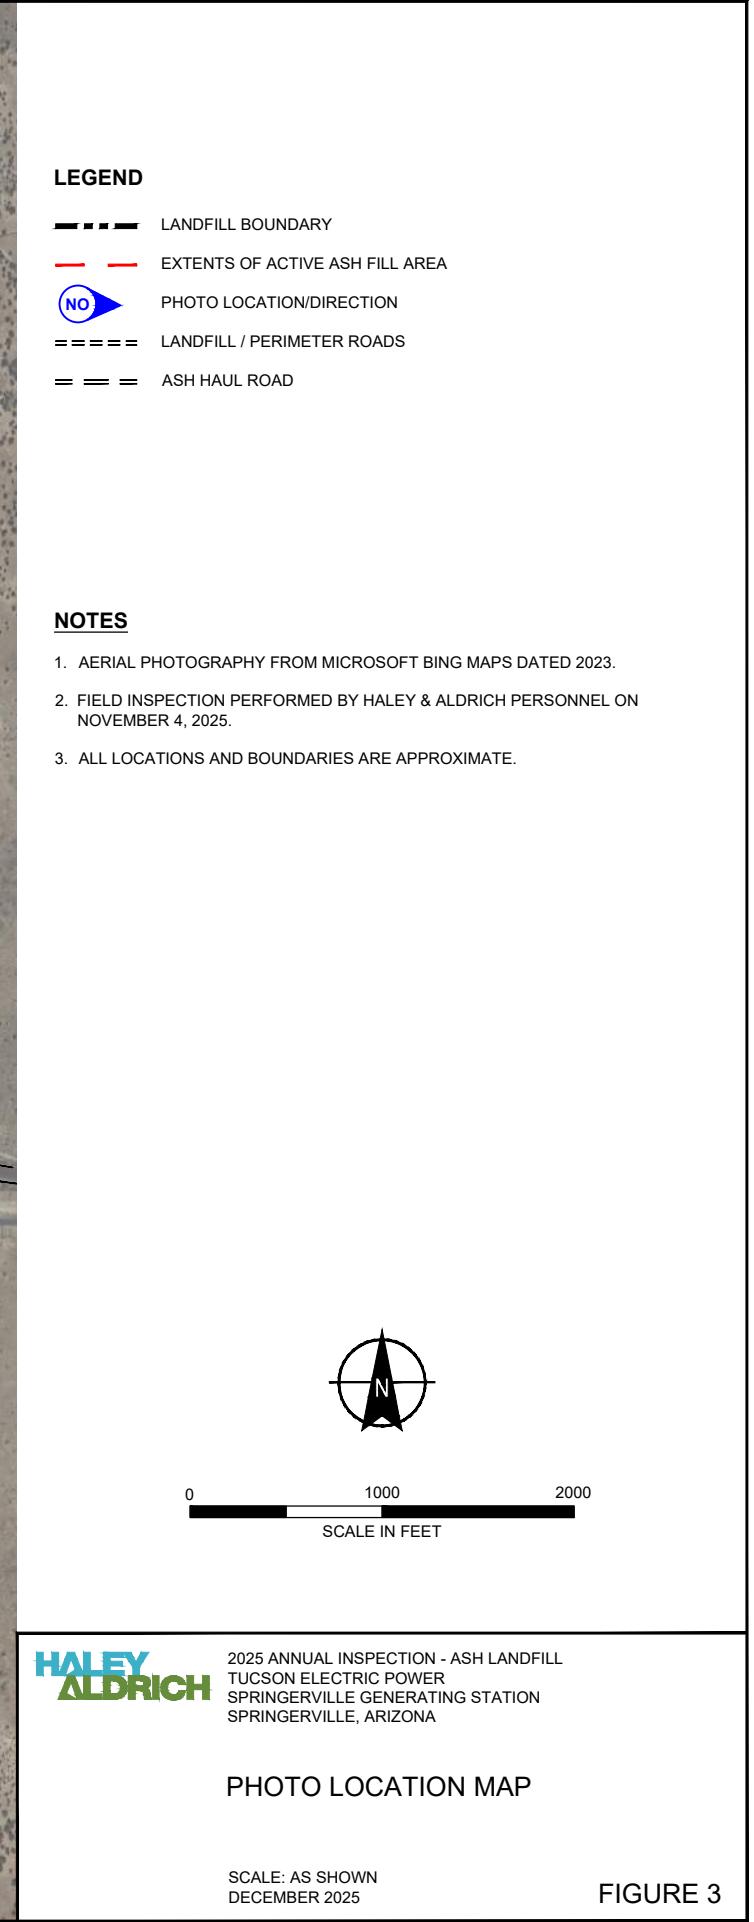
RECOMMENDED MAINTENANCE
AREAS

- LANDFILL BOUNDARY
- EXTENTS OF ACTIVE ASH FILL AREA
- AREAS OF EROSION ON ASH AND IN INTERIM COVER
- AREAS OF EXPOSED ASH
- POTENTIAL SLOUGH AND CRACKING
- ANIMAL BURROWS PRESENT
- LANDFILL / PERIMETER ROADS
- ASH HAUL ROAD

- Re-evaluate landfill operations for potential improvements associated with the ongoing CCR placement activities and long-term closure planning, with considerations such as, but not limited to:
 - reduced active footprint with exposed CCR materials,
 - modified side slopes and benching configuration for increased stability of interim and future final cover systems, and
 - reduced potential for stormwater ponding within the landfill waste boundary.
- Monitor surface cracking (e.g., along southern upper bench of the Inactive Fill Area) for any changes in size, shape, or extent. If cracking significantly changes or worsens, consult qualified geotechnical engineer for further assessment of landfill structural stability and conditions.
- Continue to monitor erosion of the southern slopes and implement repairs of rills and gullies that exceed 12 inches in depth.
